Arboricultural Report

Proposed Replacement Garage

30 Hollow Lane, Hayling Island, Hampshire PO11 9EX.

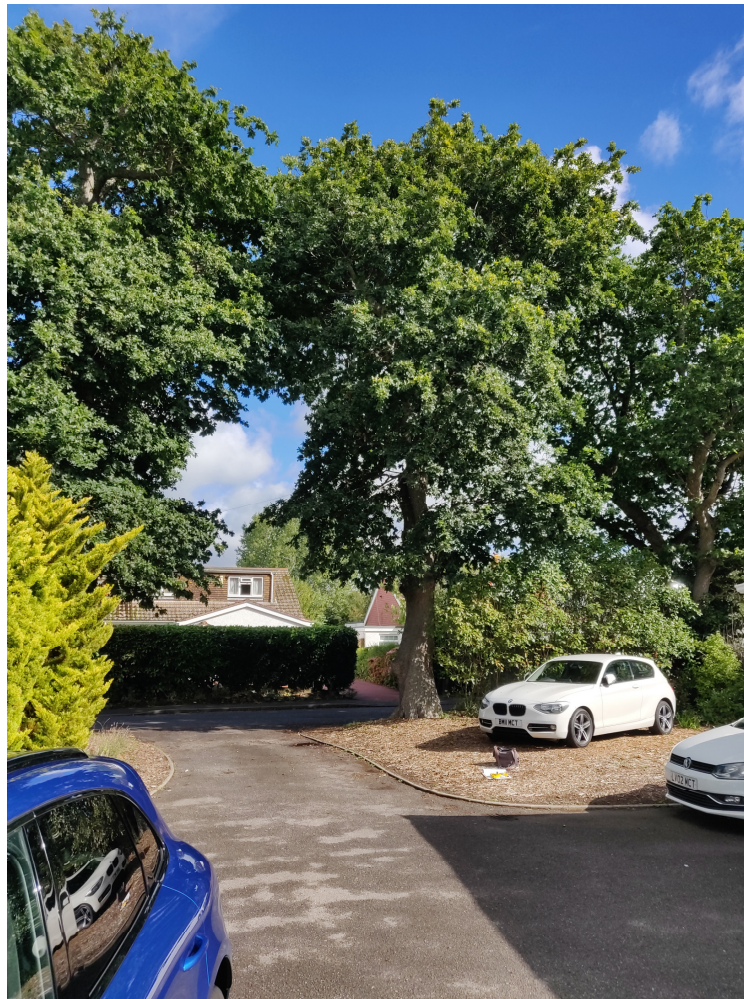
Photos taken from the front door of the house looking north and showing the three Oak Trees which this statement refers to. The furthest white car shows roughly the location of the proposed garage.

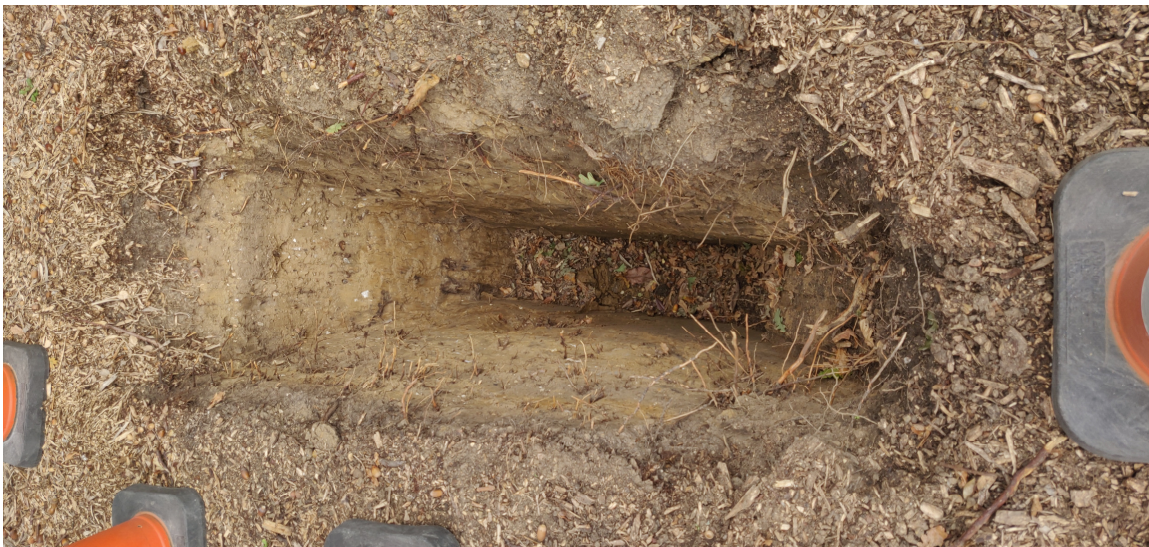
Trial pit 2

- Pits were dug carefully with a machine with hand / visual inspection prior to each bucket scoop.
- Pits have been excavated to 2m deep (footing depth).
- Width is 1500mm
- Soil is heavy clay down to 1.8m then hard ground.
- Only fine fibrous roots found less than 10mm in diameter, most likely from previously cleared shrubs in this location.

- The trees on the site are of good quality.
- Trial Pits show no significant Oak Tree Roots and are available to be viewed at any time by the Tree Officer given suitable notice. Pits are currently covered with Sheets to protect from falling.

- Further excavations will be undertaken by hand under supervision to determine the rooting patterns continue as determined by the existing Trial Pits.
