January 2016  
CBA10529 v1

Mipa Paints Limited

# ARBORICULTURAL DEVELOPMENT STATEMENT

Site:  
Dunsbury Business Park

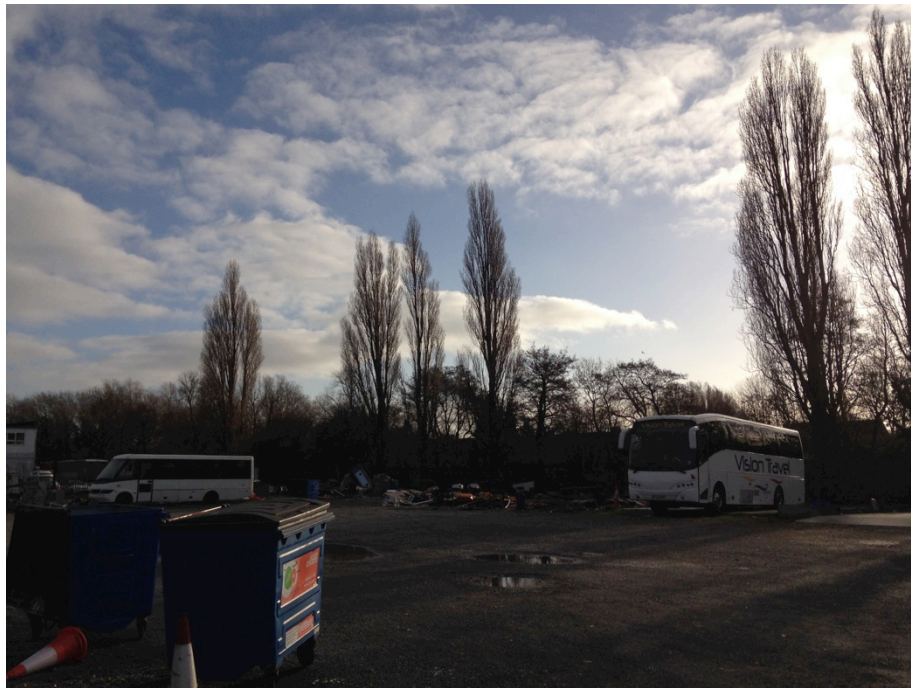
- 3.1 The site appears to be used for the storage of vehicles and materials. The site is relatively flat and there are no buildings or trees on site. There is a linear group of trees located along the southern boundary. These trees are located off site in an area that is open to the public. There is an existing retaining wall along half of the southern boundary (central to western side).
- 3.2 **Photograph 1:** A view of the site from the west

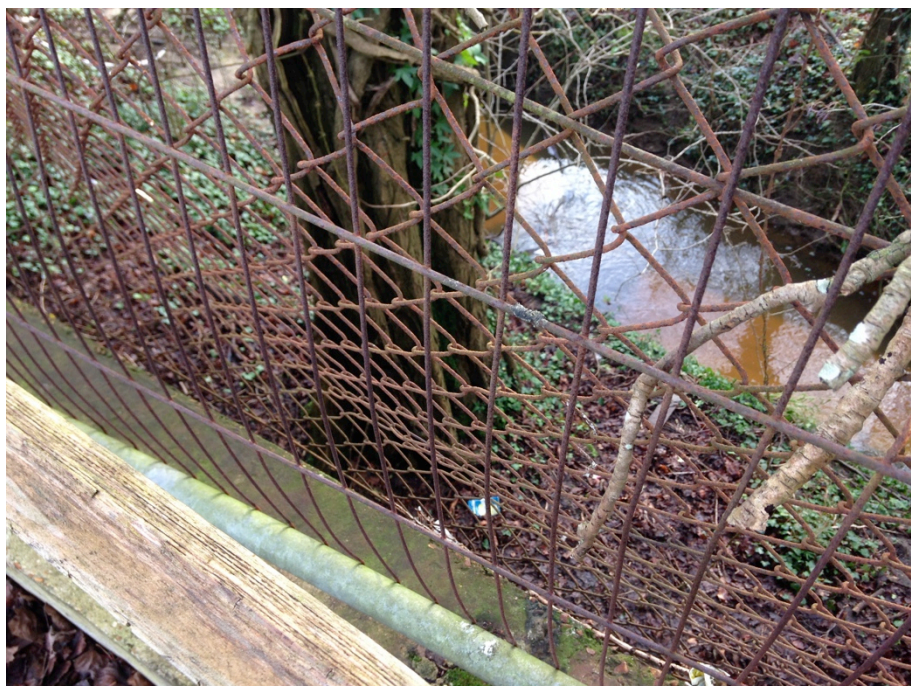
- 3.3 **Photograph 2:** A view of the retaining wall and drop in level to the south
