# Tree Survey Report

Proposed Home Shopping Works

Asda Havant Superstore, Larchwood Avenue, Havant, PO9 3QW

14th September 2021

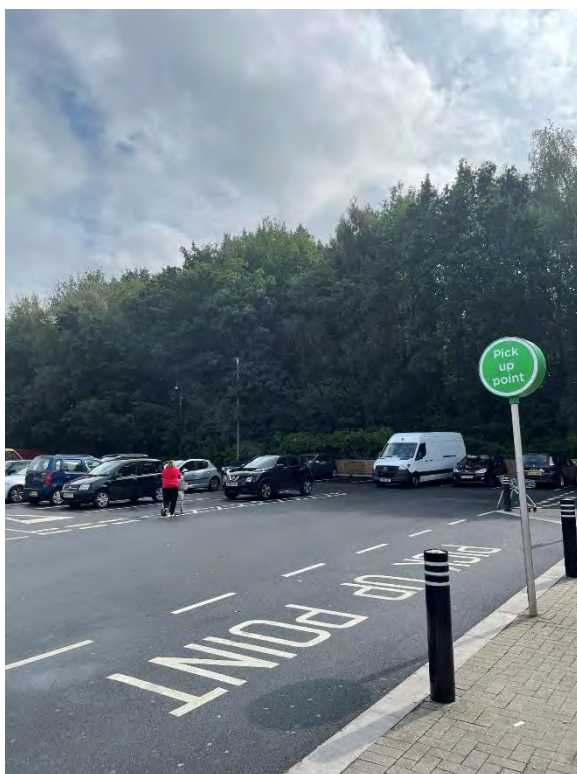
**Photo 1** - View of G1, mixed deciduous woodland above the 1.2m high brick retaining wall around the car park

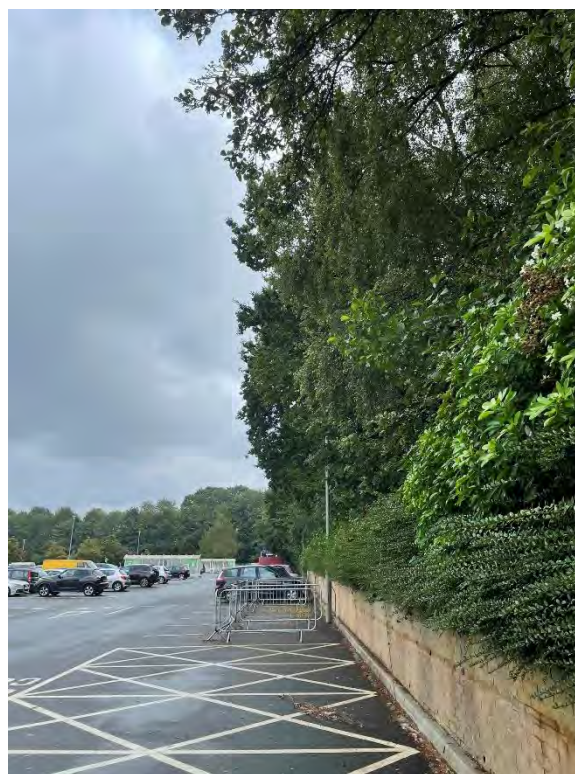
**Photo 2** – Another view of G1, mixed deciduous woodland above the 1.2m high brick retaining wall showing the canopy overhang

- Crownlift to achieve a clearance of 5m above ground level to include complete removal of the lowest primary branches and thereafter secondary and tertiary branches (not exceeding 50mm diameter cuts). When pruning branches back to the main stem or fork, the branch will be removed in small sections using the step cut method leaving a small stub before carrying out the final cut.

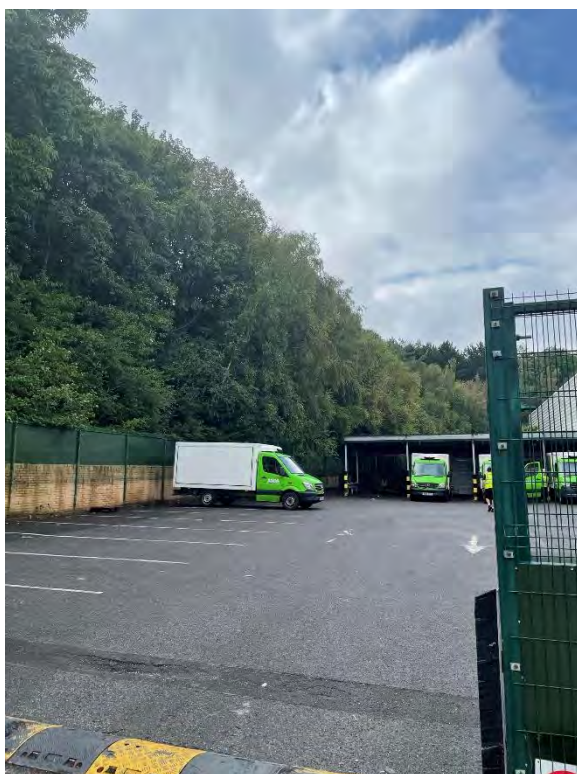
**Photo 3** – View of G2, mixed deciduous woodland above the 1.8m high brick retaining wall with welded mesh fencing around delivery van parking and loading area

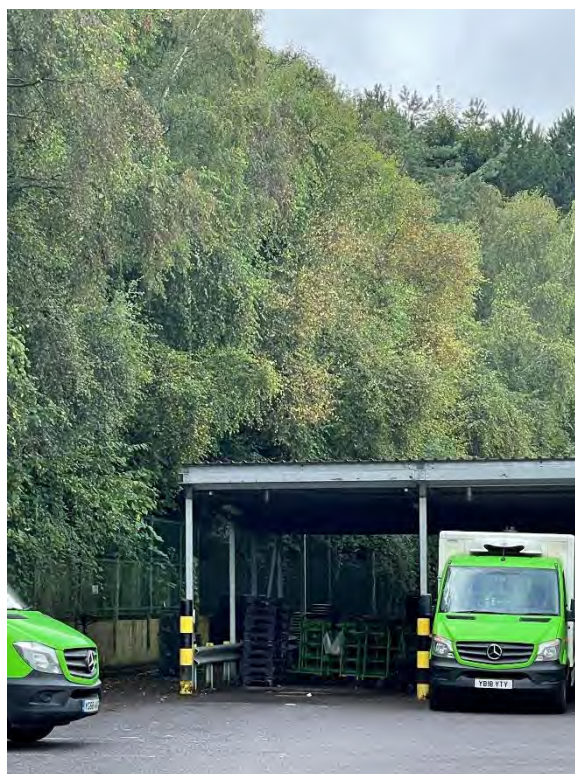
**Photo 4** – Another view of G2, mixed deciduous woodland showing the overhanging tree canopy close to the van loading canopy

- 6.2 The crowns of some trees within the group may conflict with the proposed chiller units. The working and access space needed for construction will require “access facilitation pruning” carried out to prevent injurious contact between construction plant and the tree canopy. A one-off tree pruning operation, which is directly necessary to provide access for operations on site, is acceptable in accordance with BS5837 as long as “the nature and effects of the pruning are without significant adverse impact on the tree physiology or amenity value”.
- 6.3 The trees on site are protected by a TPO therefore an application is required to carry out work to them. The trees must also be within the applicant’s ownership or
