**LARCHWOOD AVENUE,  
BEDHAMPTON, HAVANT**

**PRE-DEVELOPMENT  
ARBORICULTURAL SURVEY AND  
IMPACT ASSESSMENT**

Report No: RT-MME-122638-02

Date: May 2016

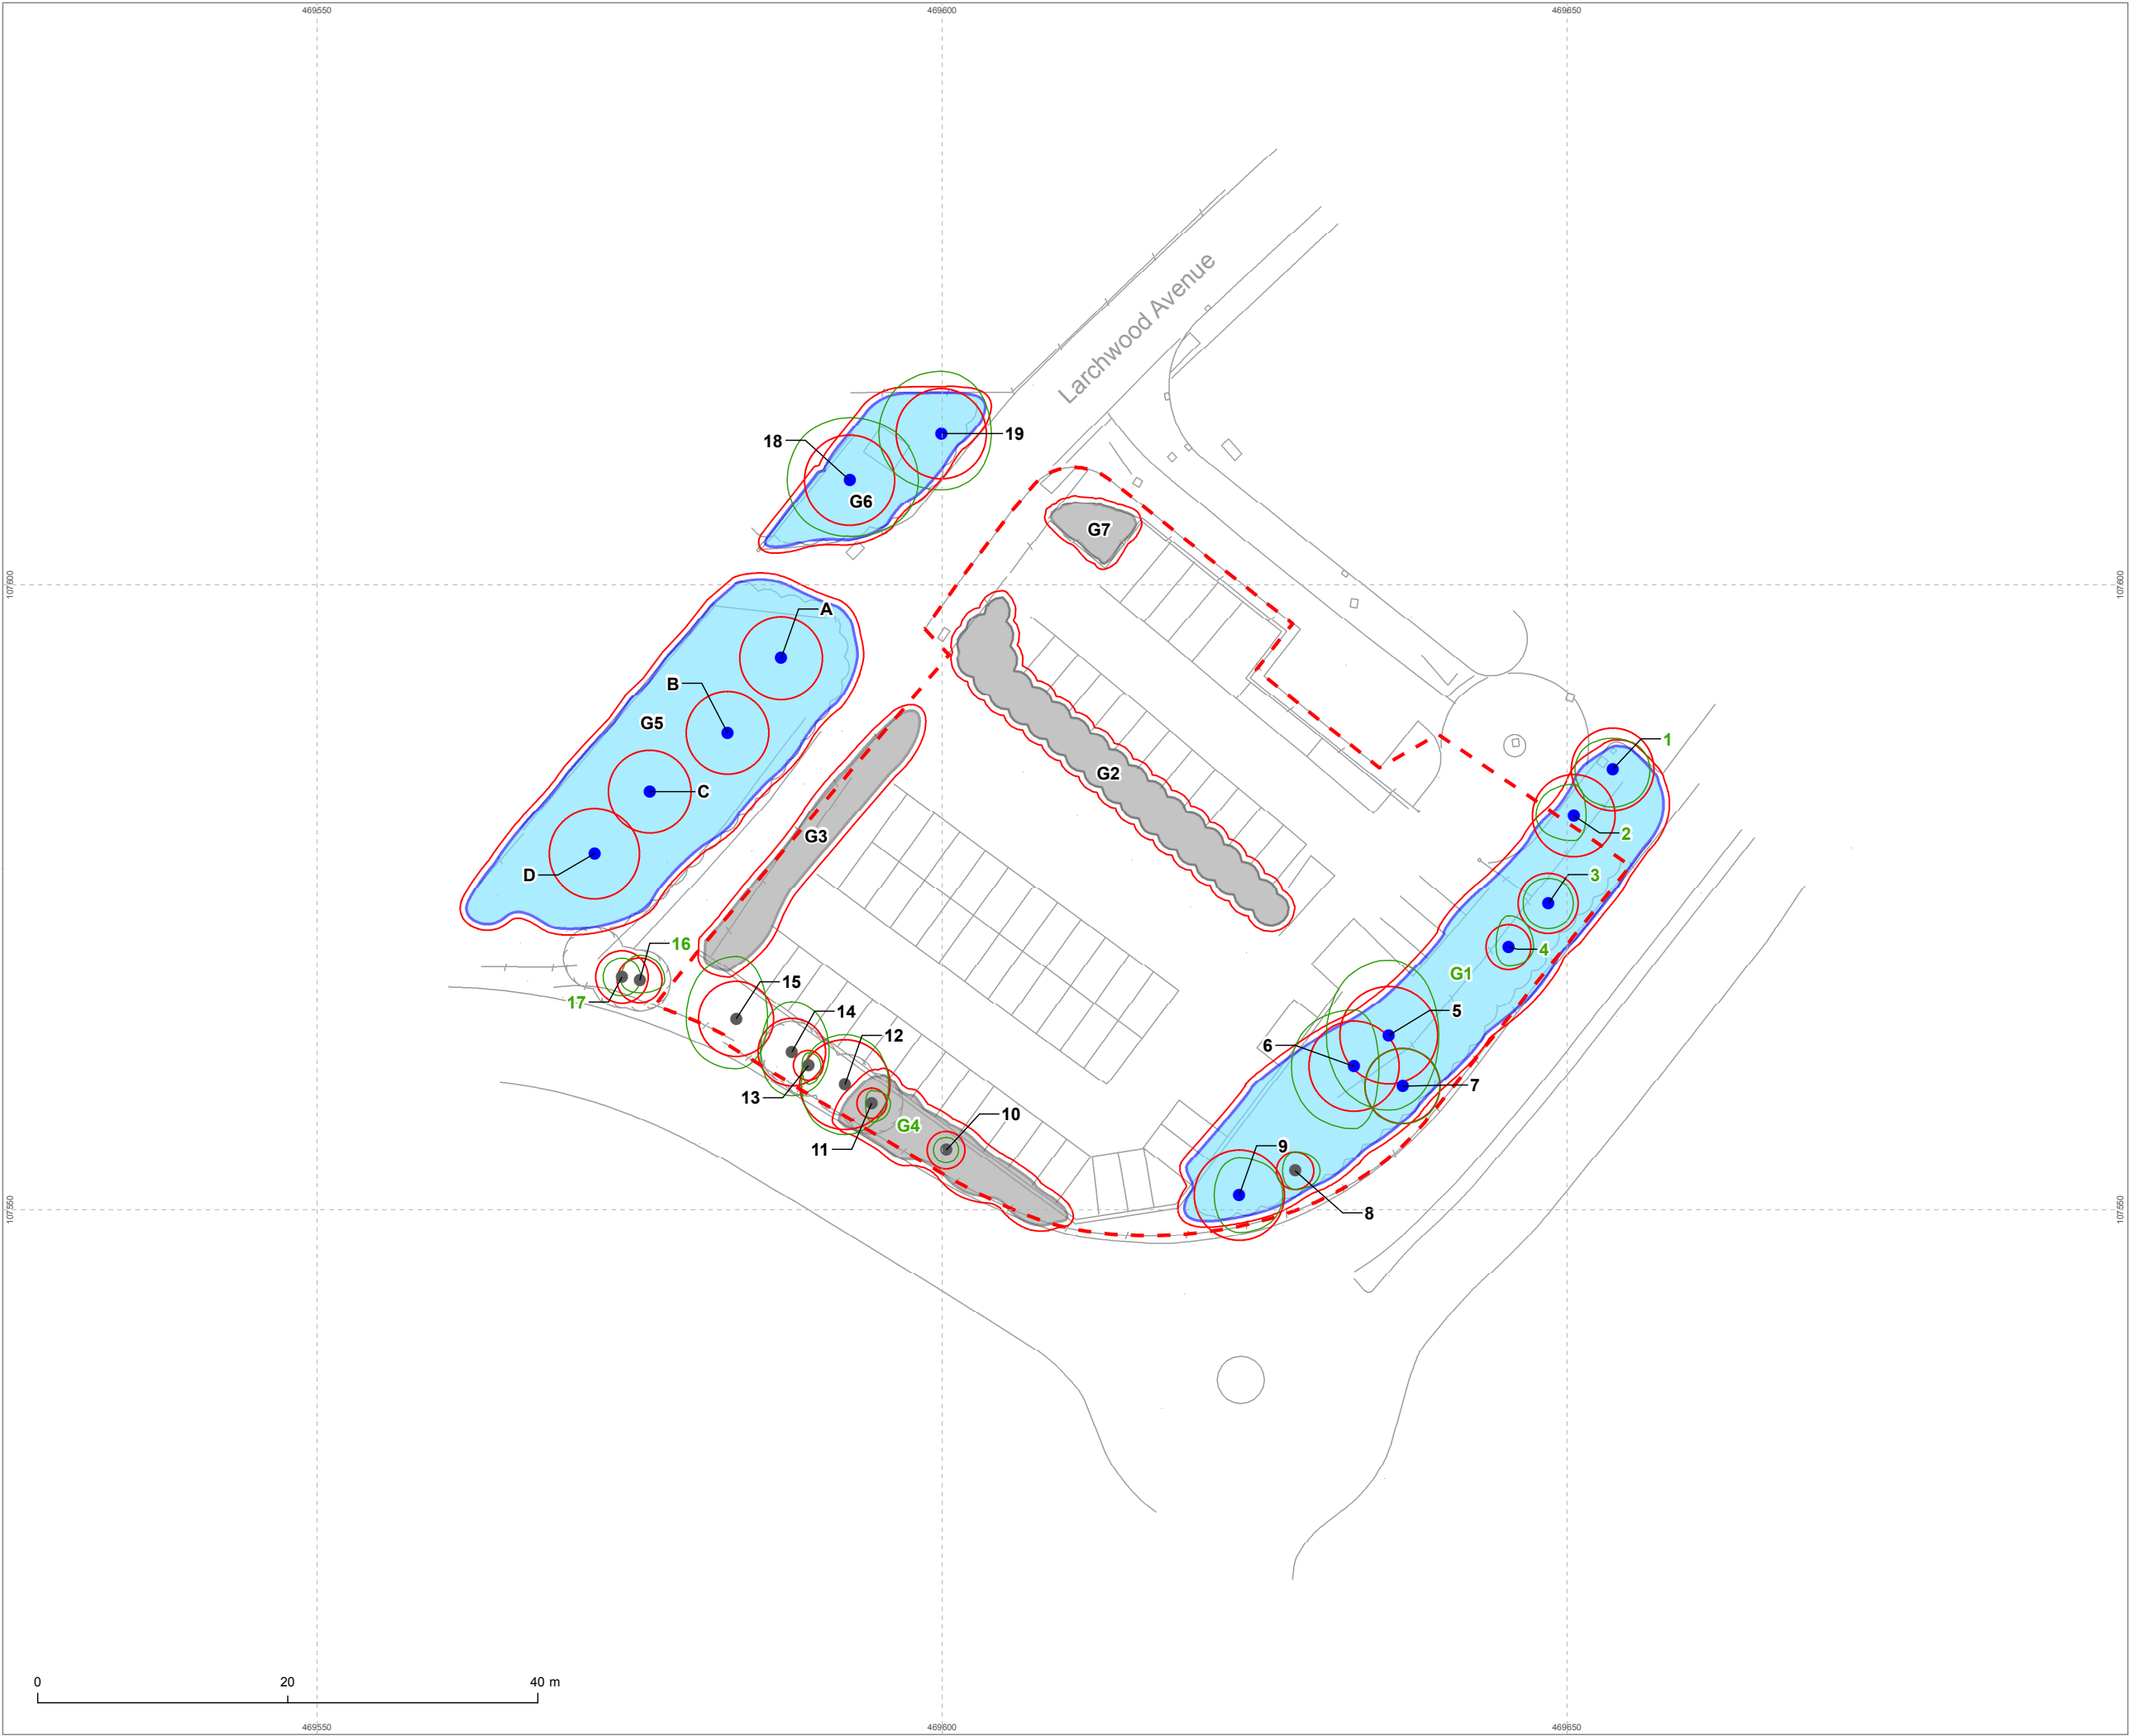
122638-02-01

The locations of the trees surveyed can be found on Middlemarch Environmental Ltd Drawing Number C122638-02-01 in Section 8 of this report.

The location of the trees can be found on Drawing Number C122638-02-01 in Section 8 and a schedule of the trees surveyed can be found within Section 4.
