Planning Ref: APP/21/00405

## Arboricultural Impact Assessment

Langstone Technology Park  
2B Langstone Road  
Havant  
PO9 1SA

Survey Date: 7<sup>th</sup> June 2021  
Report Date: 11<sup>th</sup> June 2021  
Project no: 1746

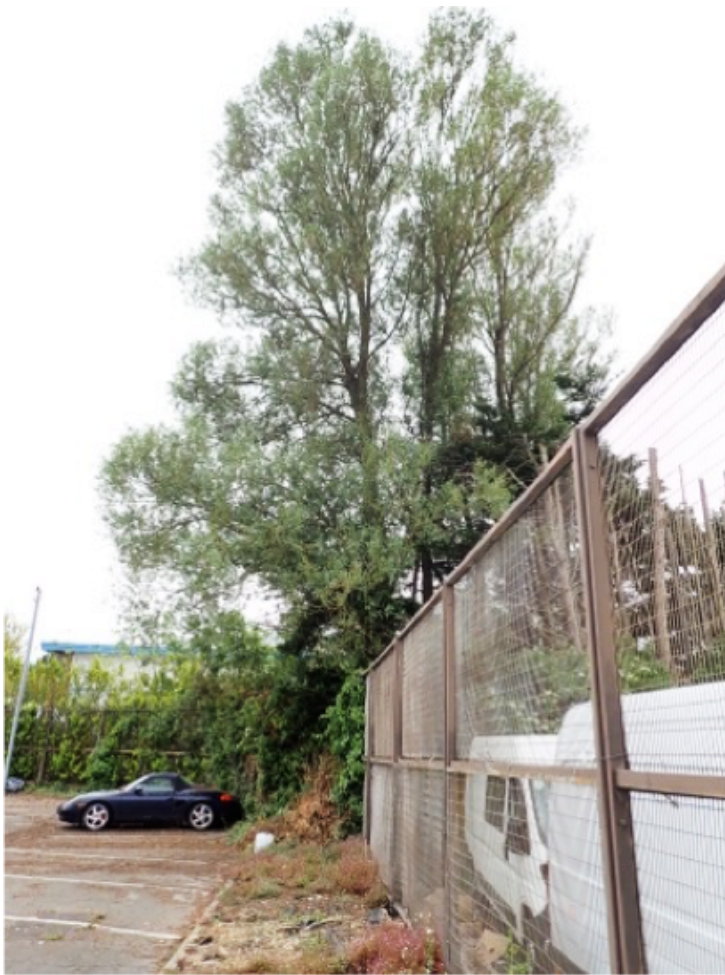
G25, White willow, growing outside site, with roots likely to be extending beneath existing hard surfacing. Hand dig excavation has been specified for the part of the new building foundation within the projected root protection area.

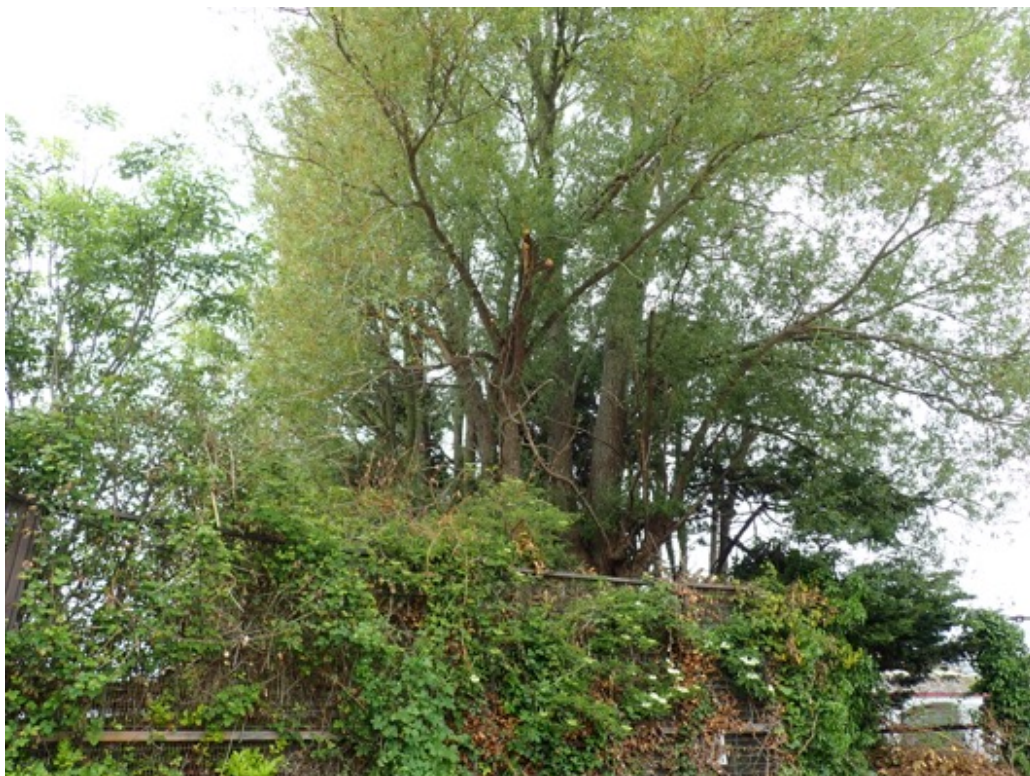
Overhanging branches from trees within G25 are of generally small diameter. Pruning work has been specified to provide clearance for construction of the new building.

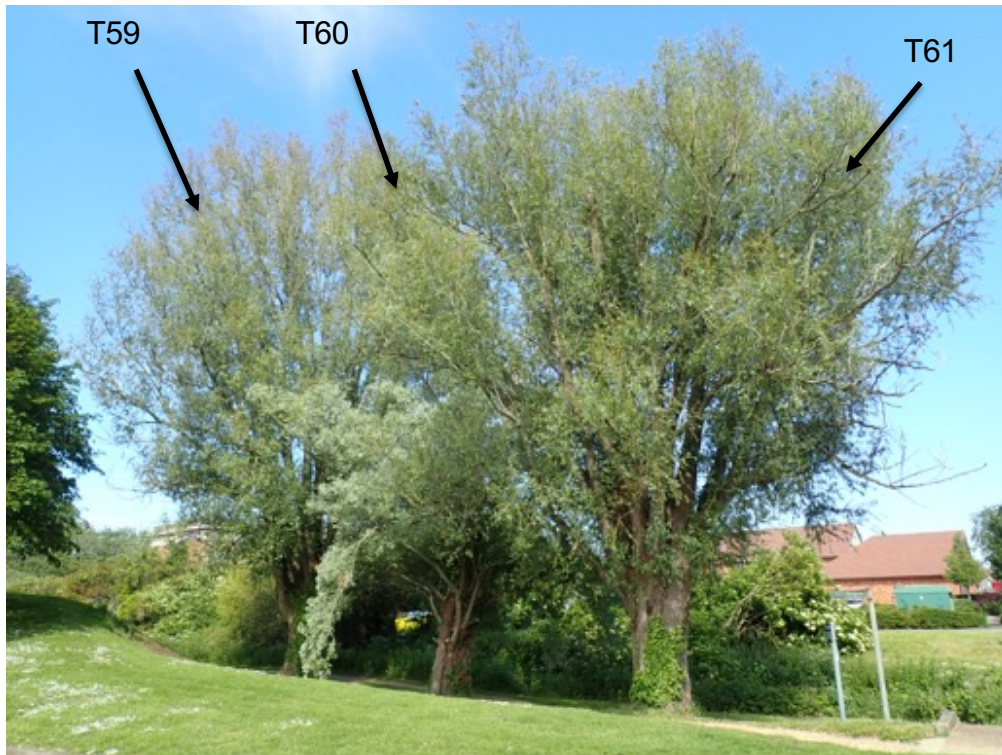
White willow, alongside footpath. Roots are projected to spread into the area where the car park is to be extended.

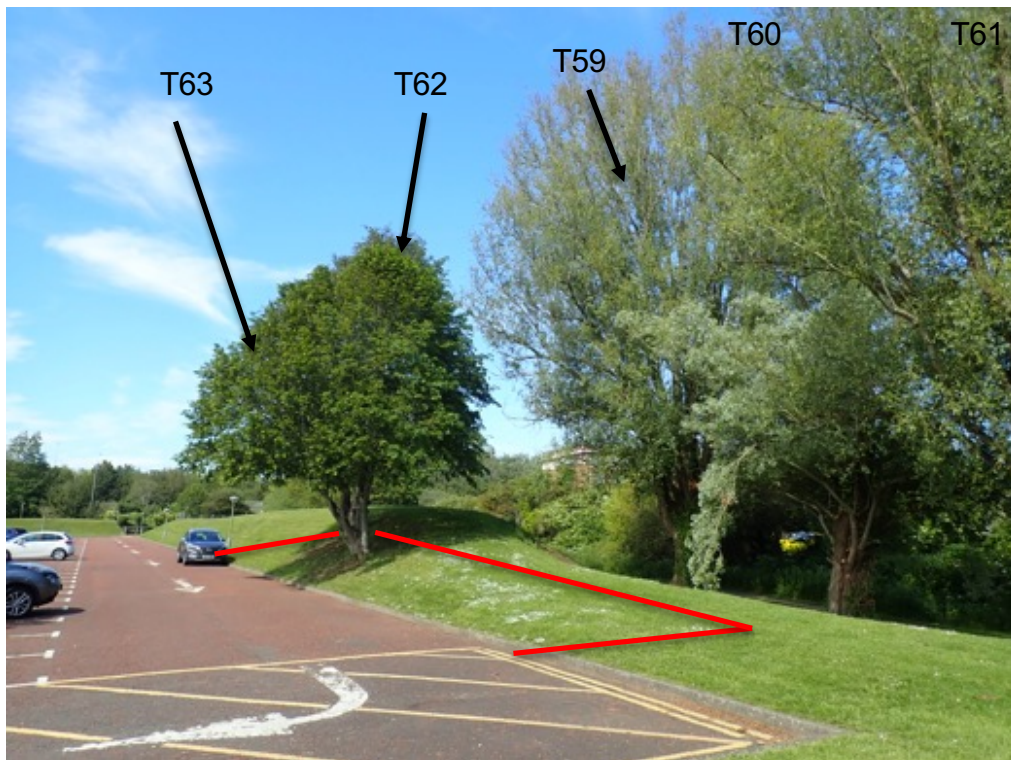
View to north along existing berm. The berm is to be excavated back and re-profiled to allow extension of the car park. Lime trees T62 and T63 to be removed. Within the root protection area of T59, T60 and T61, in the area indicated in red, there must be hand dig excavation and the cut back area of the berm must be retained by a supporting structure, rather than re-profiled.

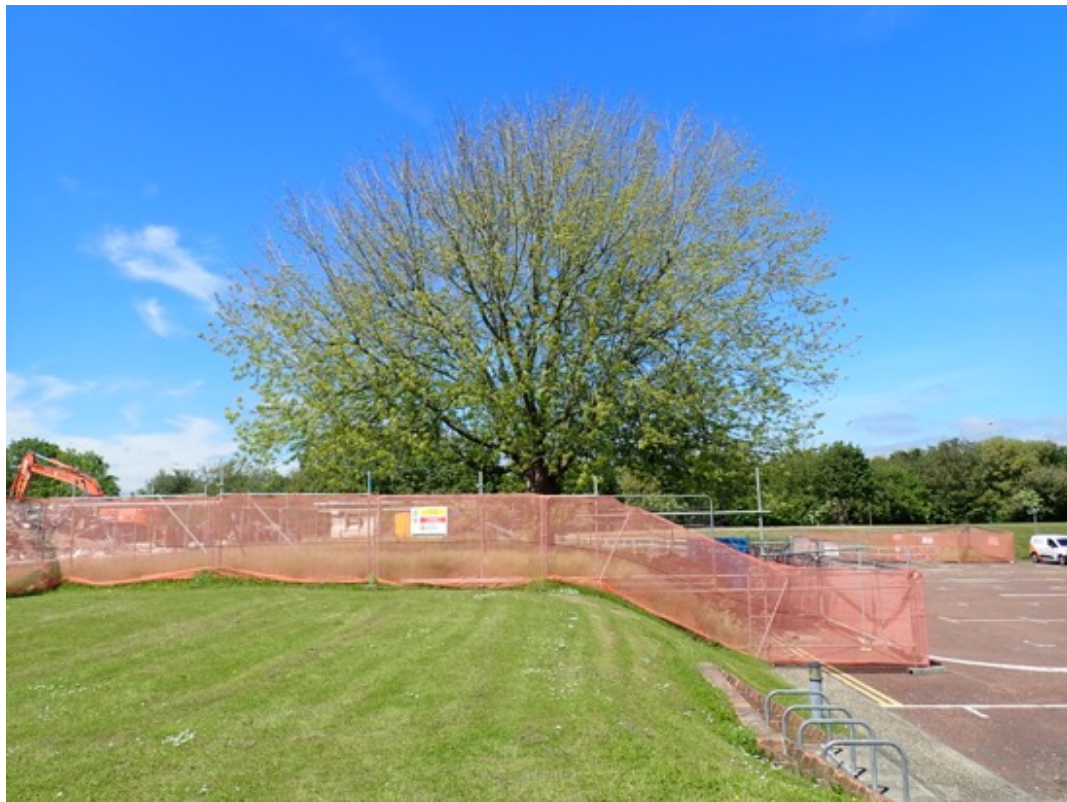
Silver maple, T46, to be retained. Foliage growth in mid to upper crown is stunted. Possibly wind damaged following recent removal of building to west side.

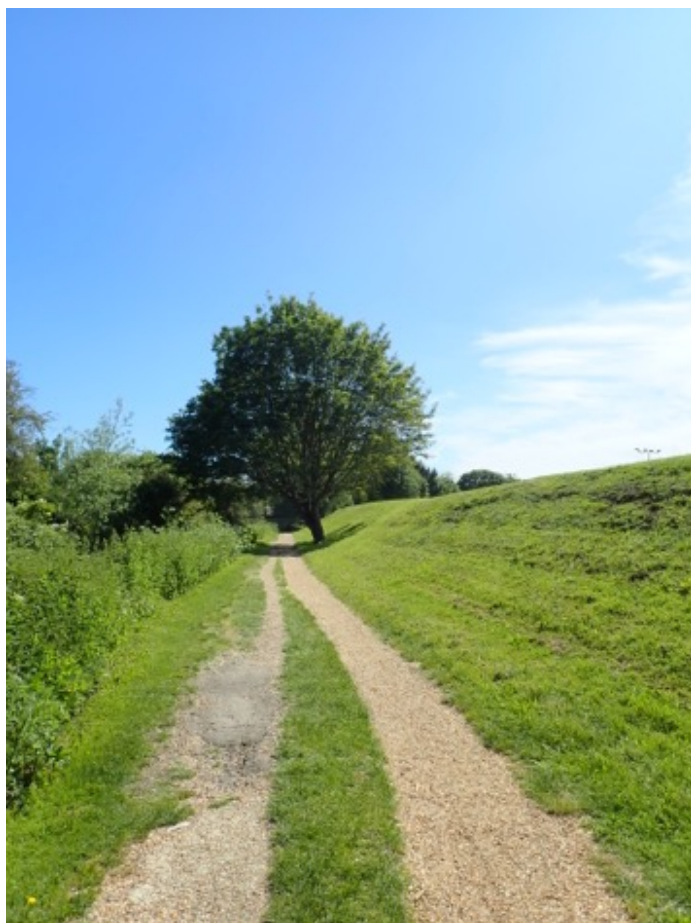
| Tree/<br>Group<br>No. | Species | Height<br>(m) | Stem<br>Diam. at<br>1.5m<br>(mm) | Branch Spread (m) | | | | Canopy<br>Clearance<br>(m) | Age<br>Class | Observations | Management<br>Recommendations | Estimated<br>Remaining<br>Contribution<br>(years) | BS 5837<br>Category<br>Grading | Protect-<br>ion<br>Distance<br>(m) | Root<br>Protect.<br>Area<br>(m2) |
|---|---|---|---|---|---|---|---|---|---|---|---|---|---|---|---|
| T58 | Norway maple | 13 | 810 | 7 | 8 | 8 | 6.5 | 2.5 | Mature | Four main stems from 1.2m - 350, 410, 420 & 430mm, with further decaying stem 180mm. Decay point at 1.2m to east. Occasional deadwood and foliage damage but a reasonable tree. | | 15-30 | B2 | 9.7 | 297 |

Norway maple, T58, alongside footpath, to east side of berm.

THERE MUST BE NO EXCAVATION WITHIN THE ROOT PROTECTION AREA OF T58. THE BERM MUST BE RE-PROFILED TO ACCOMMODATE THE RPA, OR IF NECESSARY A RETAINING WALL CAN BE CONSTRUCTED OUTSIDE THE RPA TO SUPPORT THE SOIL.
