**ARBORICULTURAL SURVEY  
AND ASSESSMENT OF IMPACT**

**27 WARBLINGTON AVENUE,  
HAVANT, PO9 2SD**

Report Number: MB1414

June 2015

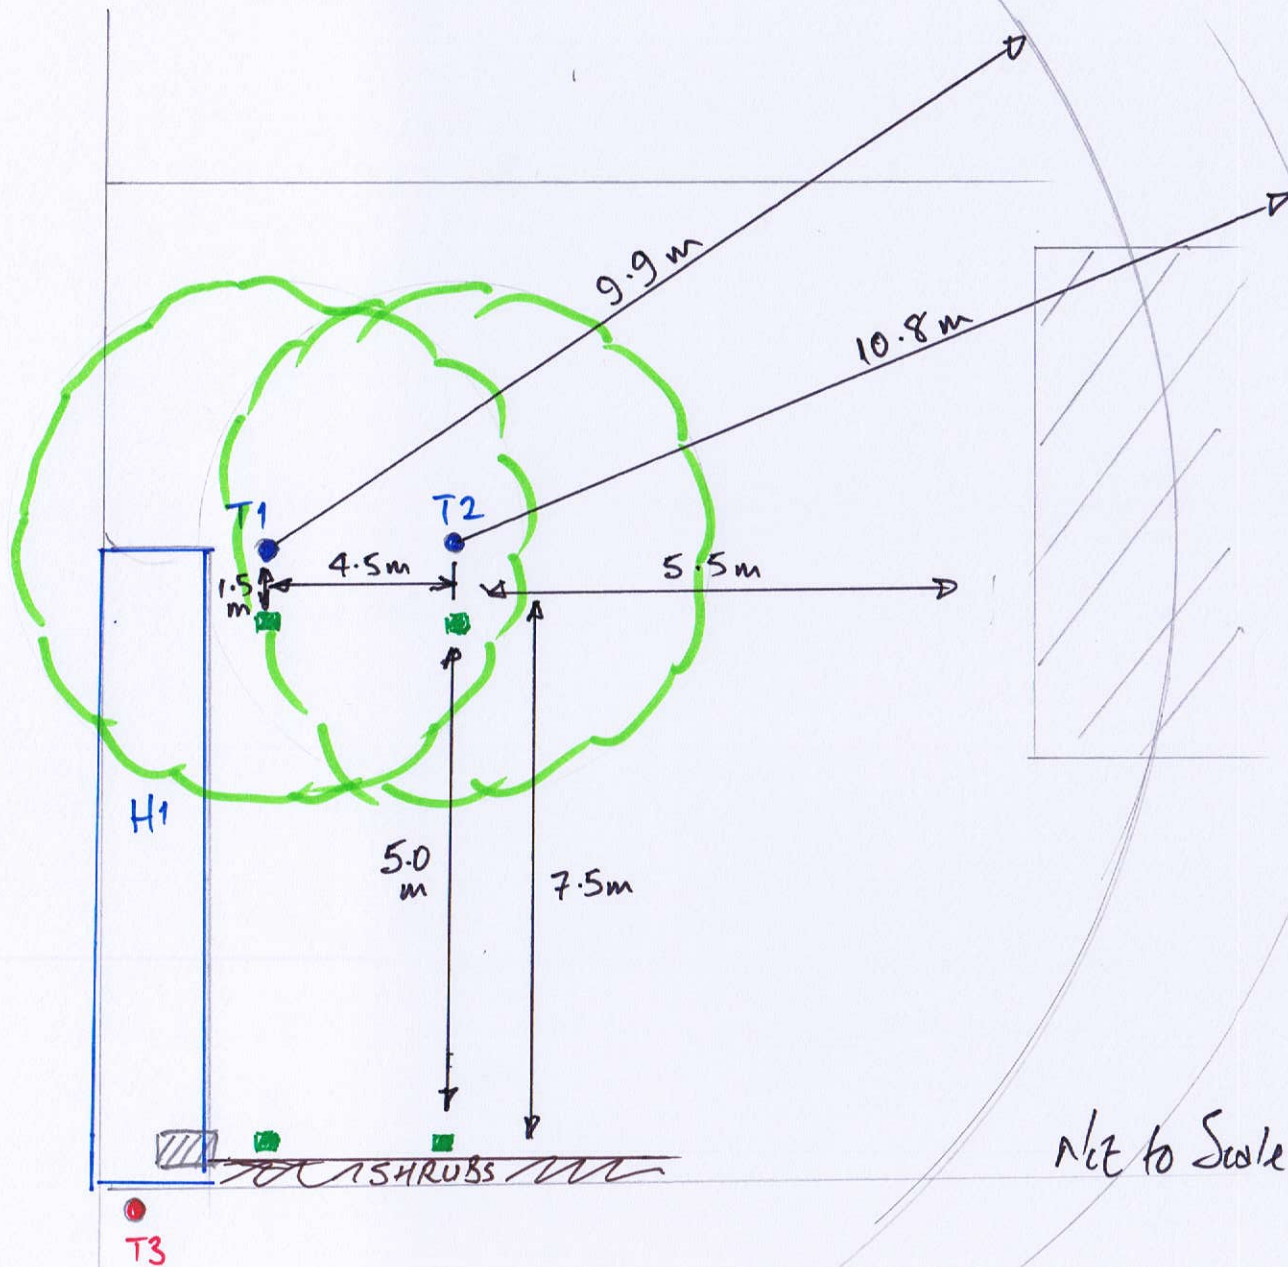
Drawing Number MB1441.01 Tree Constraints Plan

- B Category tree
- U Category tree
- B Category hedgerow
