BS 5837 Report on the Trees in Relation to  
Emsworth Primary School 0.5 FE expansion

| <b>Document Reference:</b> | P11226-L- BS 5837 Report on the Trees in Relation to Emsworth Primary School 0.5 FE expansion |

**Client: Hampshire County Council**

**Date: September 2016**

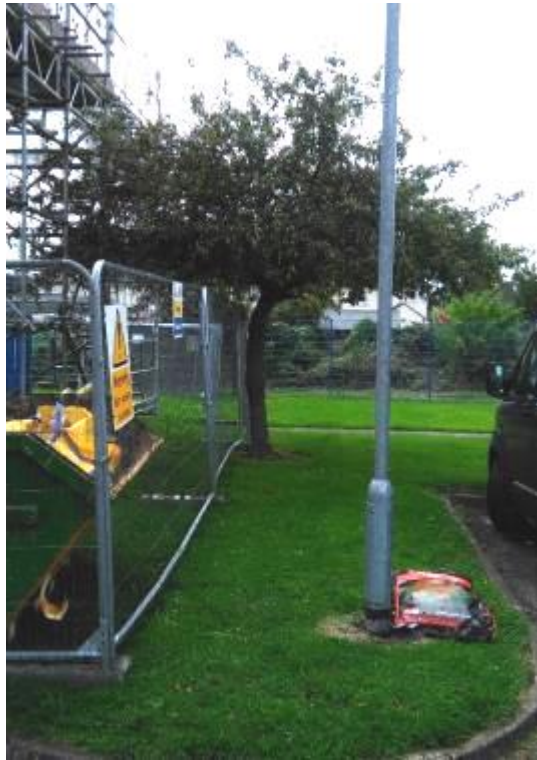
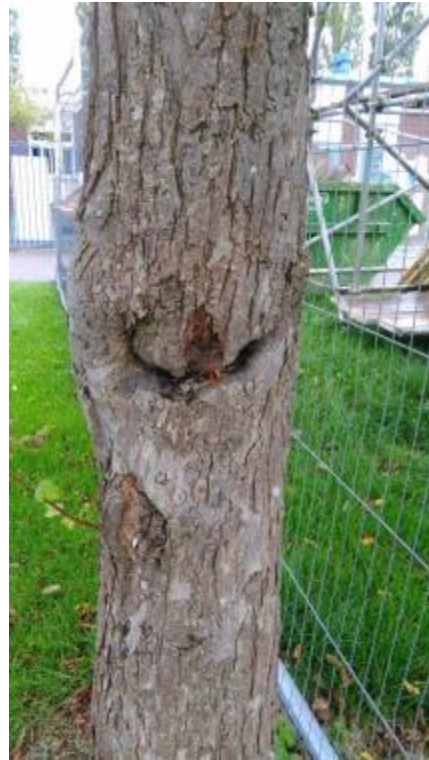
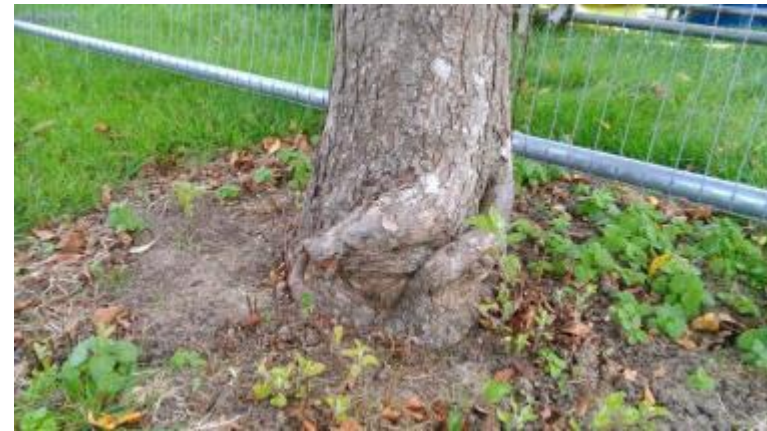
T25 – *Malus sp.*

- 7.3 Trees T25 and T27 within the school grounds are both planted *Malus* species. T25 was considered in poor condition due to twisted roots incorrect potting on at nursery stage and a cut wound most probably caused by failure to remove staking wire. T 27 was with good/fair condition and vigour. These trees will unfortunately have to be removed for the new proposed development. (See **Appendix 1**: Photographs of Surveyed Trees).

Picture 1: Looking south from the school building

Picture 2: Showing damage caused by failure to remove tree staking wire

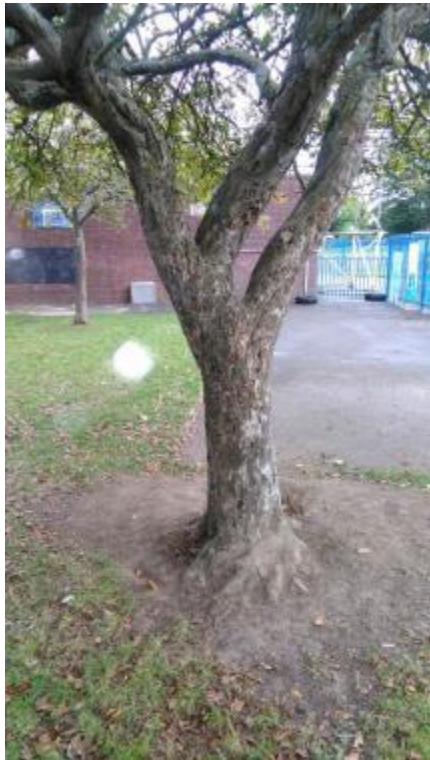
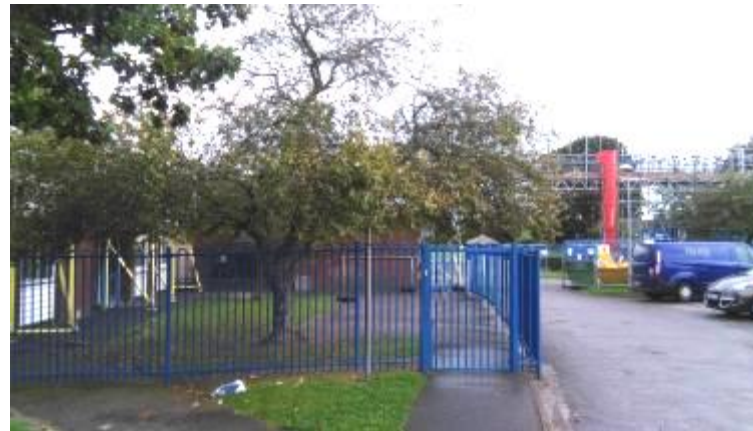
T27 *Malus sp*

Picture 1: Trunk and branch structure as well as compacted earth around base.

The exact location of the relocation is to be agreed with the school but will most likely be in the wildlife area on the eastern side of the north boundary. It is recommended that the relocation of these two trees form part of a 12 months maintenance/defects period and be replaced with like species/size should the relocation fail.

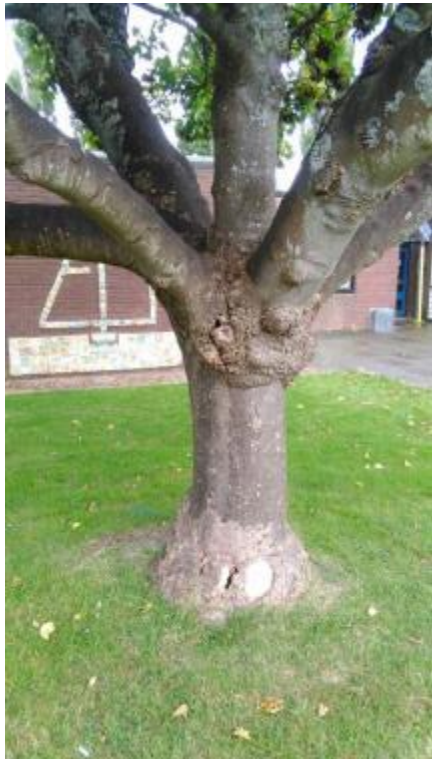
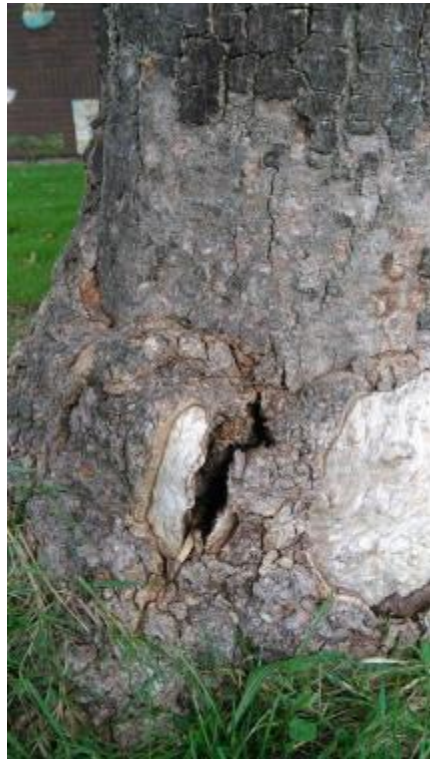
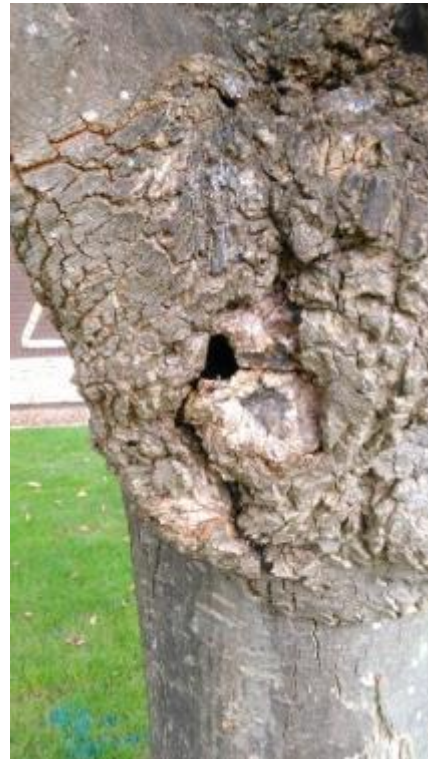
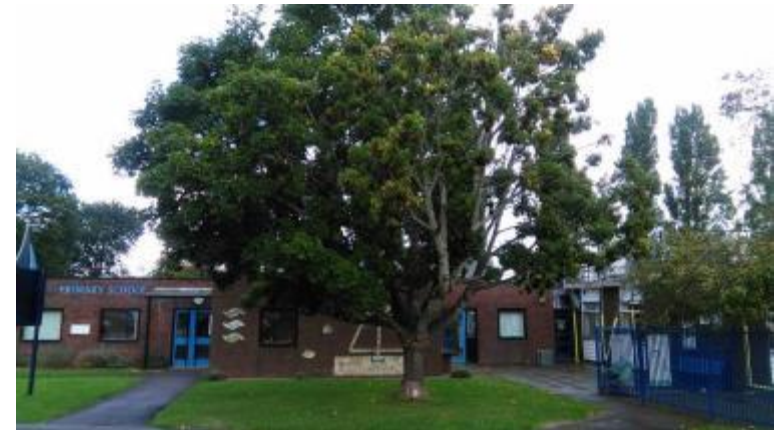
T28 *Acer sp.*

- It has been noted that Tree T28 is in poor health, as there is decay at the base of the trunk and at the main branch junction where the main leader is absent, and will require extra monitoring.

Picture 1: T28 Trunk and branch structure as well holes in trunk base and branches

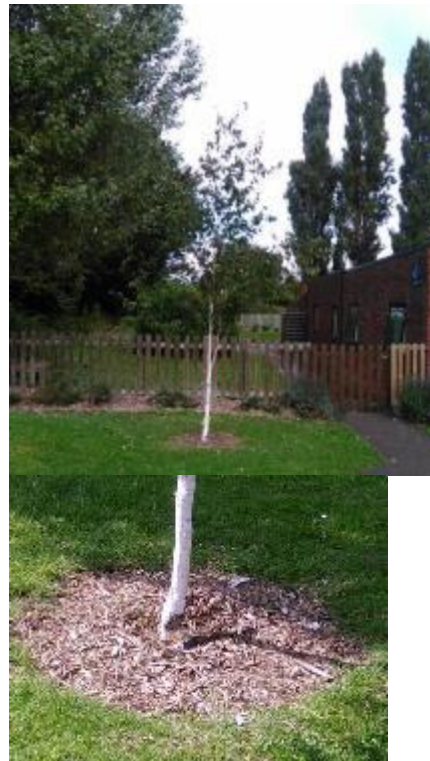
T30 + inset *Betula utilis 'Jacquemontii'*

Picture 2: T30 Young birch with damage to trunk at base (looking north)

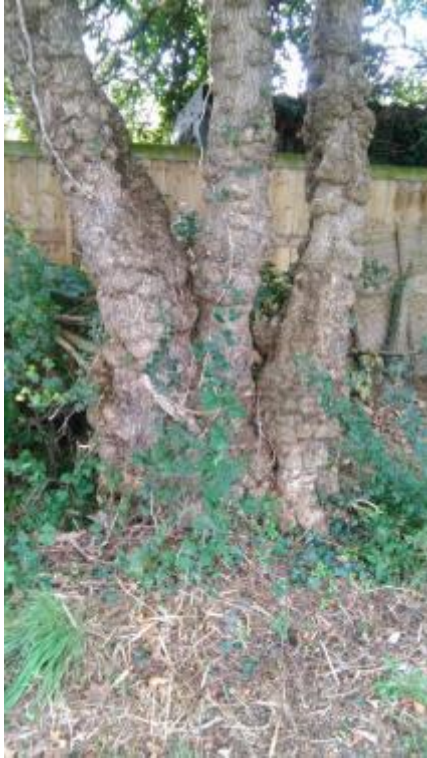
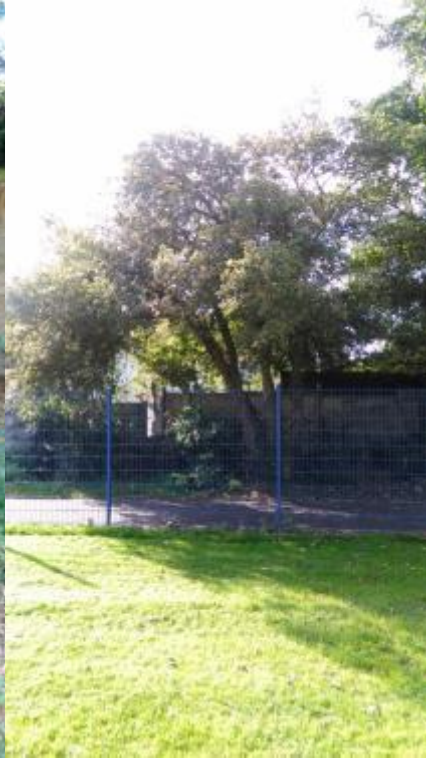
T9 Acer sp

Picture 1: T9 Over-mature small leaved maple close up of base

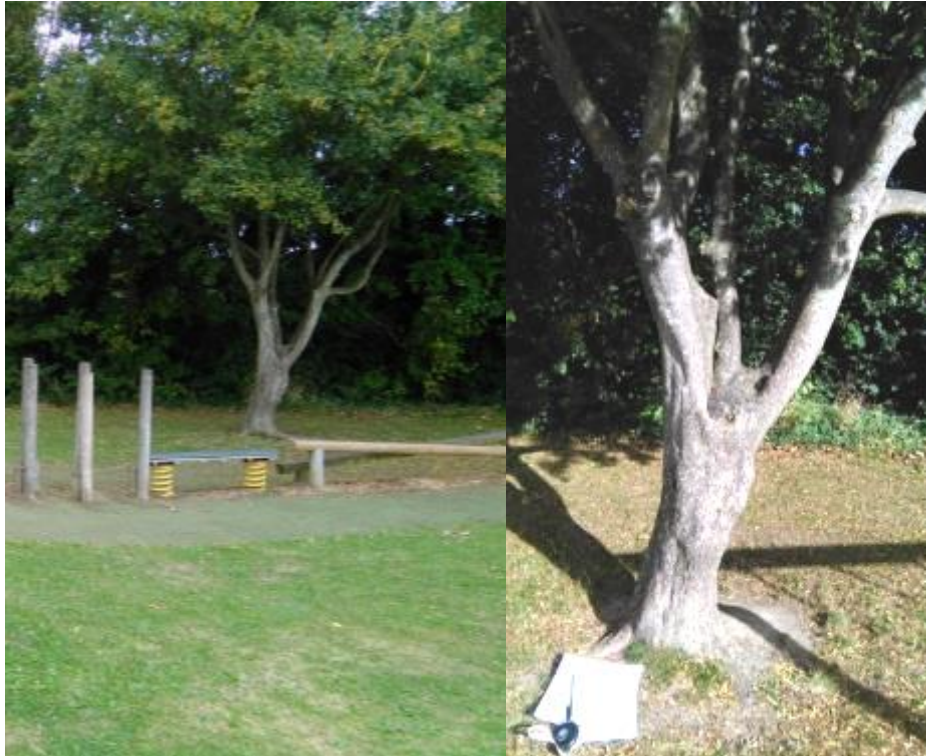
T11 Acer sp

- 7.9 The RPA of Tree 11 (Small leaved maple) falls outside the development area, however, due to the close nature of this tree it is recommended that a TPF be installed for the duration of the proposed development works.

Picture 2: T11 Small leaved maple showing branching at 1.2m

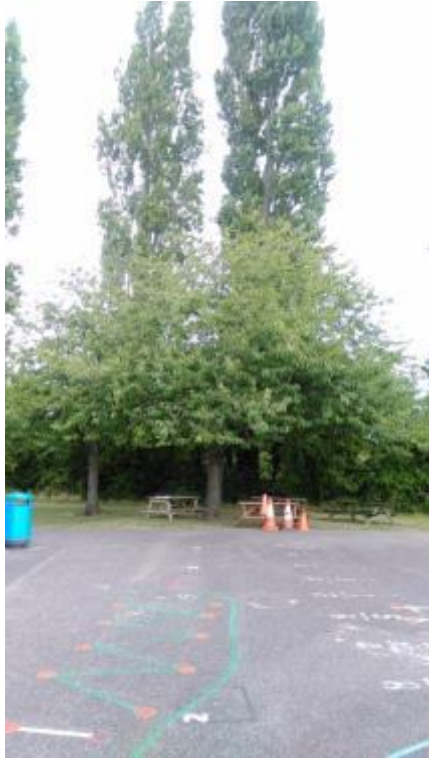
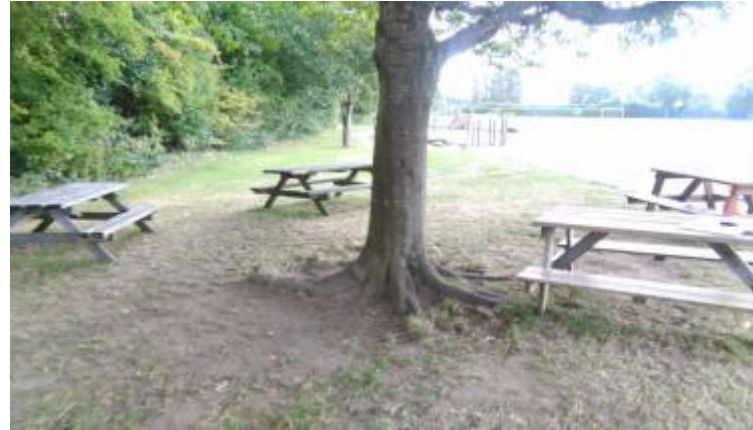
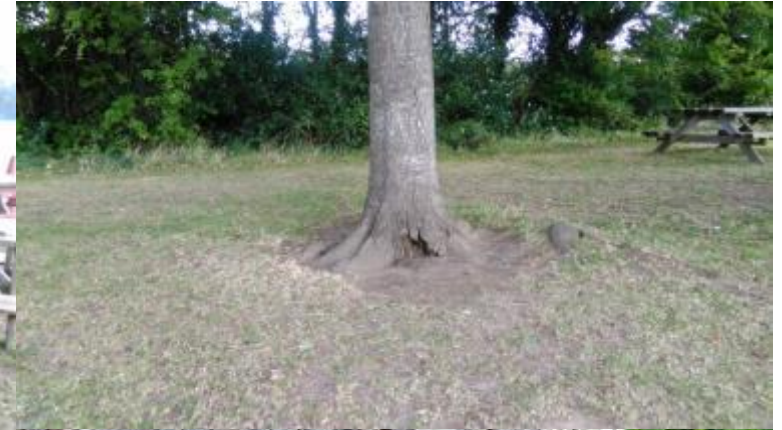
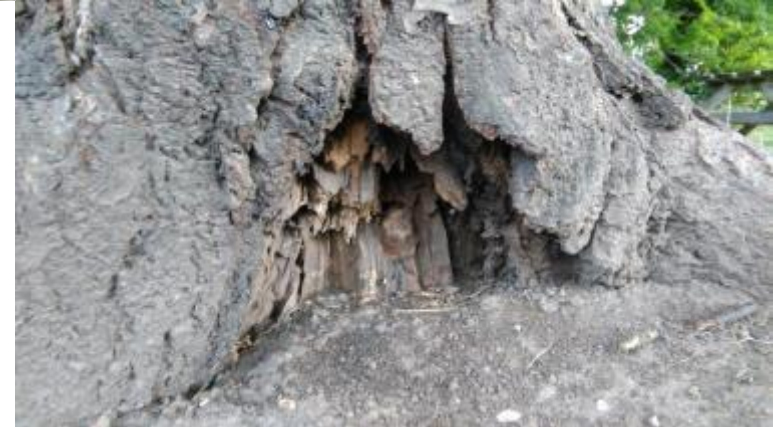
Left to right T23 and T22  
*Prunus* sp

- 7.11 The RPA of trees T22 and T23 fall within the development boundary and within the area of the proposed works: resurfacing of the existing asphalt play area. A TPF is required for the duration of the development but the TPF will need to be moved to allow resurfacing works to proceed. All work within this TPF/RPA is to be appropriately supervised.
- It has been noted that Tree T22 is in poor health, as there is decay at the base of the trunk, and will require extra monitoring.

Picture 1: T3 and T22 Picture 2: *Prunus avium* looking north from school building  
Picture 2: T22 showing compaction around base exposed roots  
Picture 3&4: T23 showing decay at trunk base
