# Arboricultural Report

**48 Hart Plain Avenue, Waterloooville, PO88RX**

**26/08/2015**

### **Proposed development on land to the rear of 48 Hart Plain Avenue, Waterloo, PO88RX**

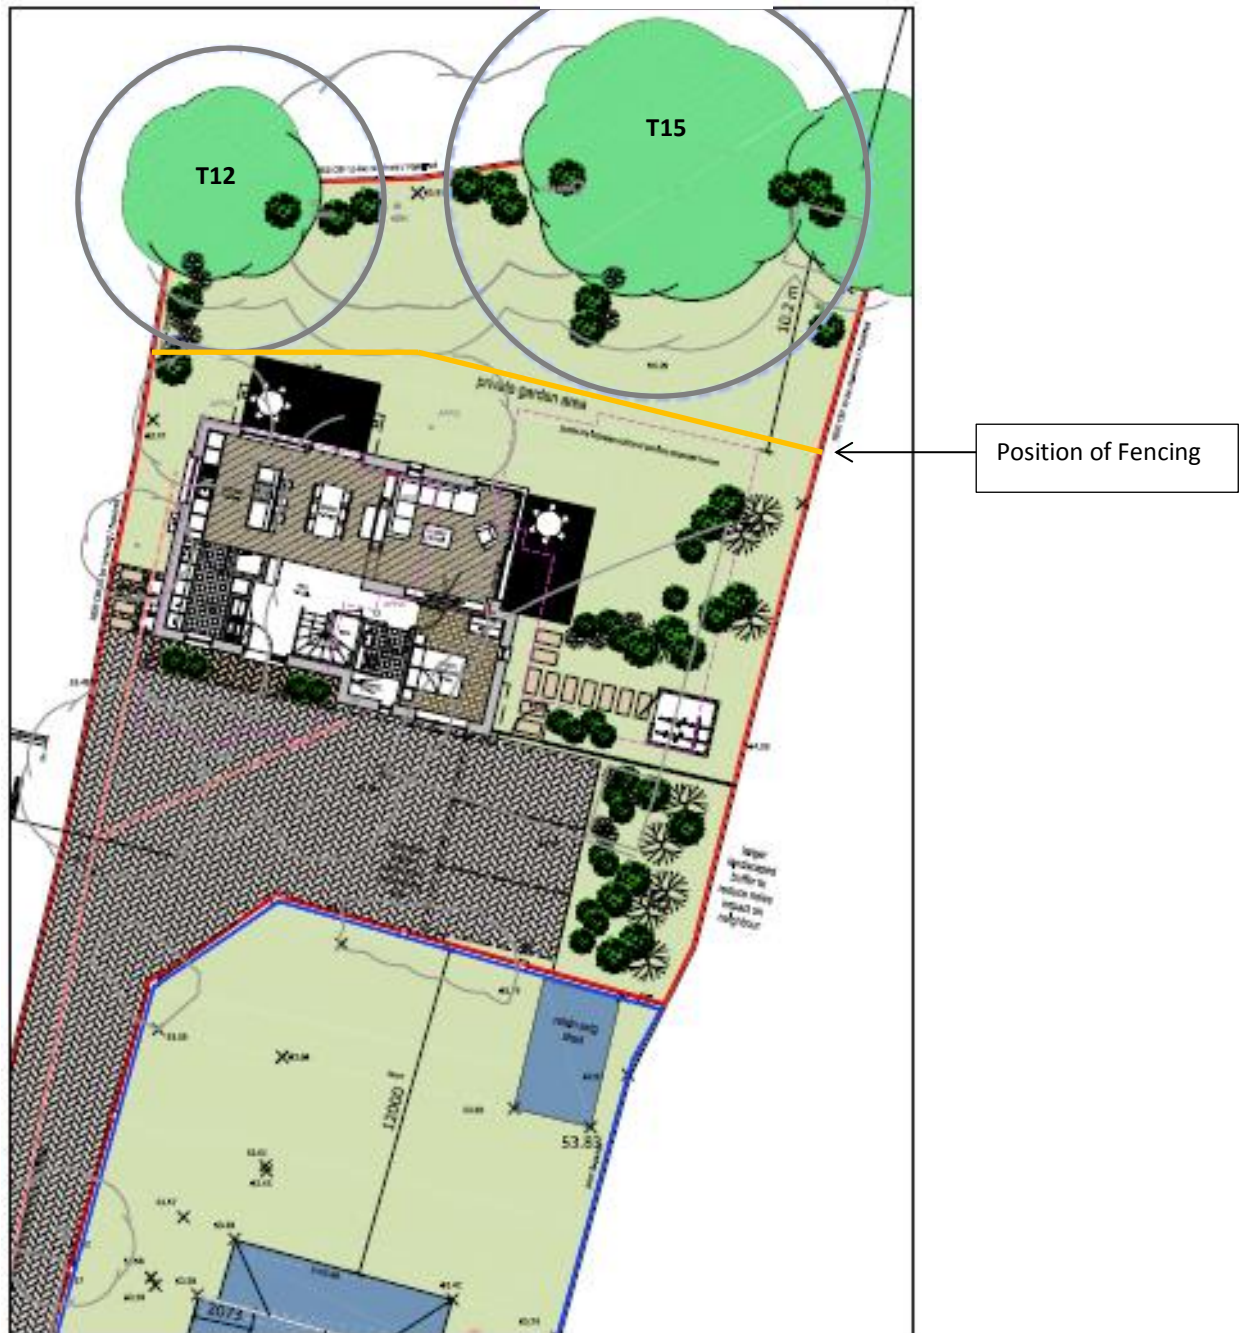
### Appendix 3: Tree Protection Plan

- Trees recorded on the Tree Survey Schedule identified by a blue, grey or red circle dependant on the classification and number
- Protective fence positions to provide a CEZ identified by an orange line on the plan annexed

- 2.2 The protective fencing is required to be sited in accordance with the Tree Protection Plan enclosed with this method statement at appendix 1. All Protective fencing must ideally be constructed as per figure 2 in BS 5837 2005 and be fit for the purpose of excluding any construction activity (See Appendix 4). Any alternative fence/barrier used must be fit for this purpose.
