## TECHNICAL NOTE

**Project:** 108-110 Elm Grove, Hayling Island- APP/15/00950

**Subject:** Response to LPA Comments – Assessment of Bat Potential in Trees

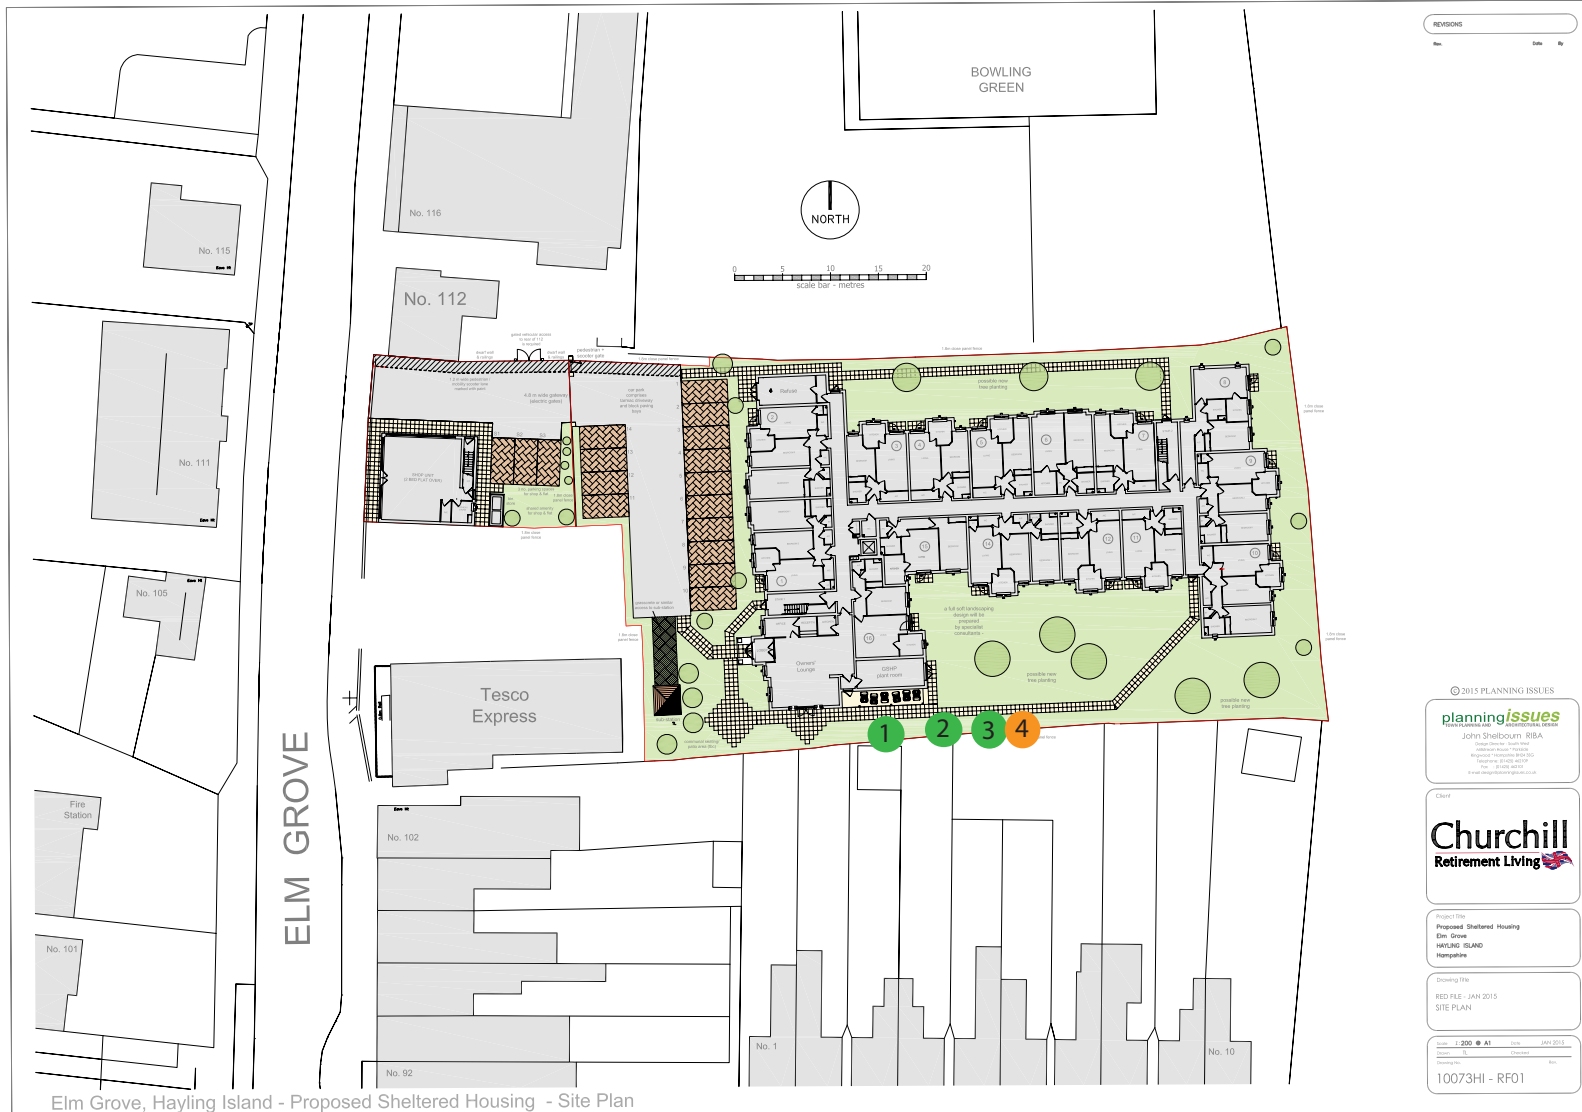
## Map 1 - Assessment of Trees For Bat Roosting Potential

Only one of the trees surveyed is considered to have potential for supporting bat roosts as it supports two callus rolls that lead to voids and hollows suitable for bats, this is the eastern most of the four trees on the southern site boundary. During the assessment the holes within this tree were found to be cobwebbed indicating that bats have not been active within the features, furthermore, no evidence of bats was recorded from within the holes present. **Table 2** provides a BCT category for each tree in-line with current best practice guidelines.

| Tree Number | Species | Potential Roosting Features | BCT Category <sup>3</sup> |
|---|---|---|---|
| 4 | Horse-chestnut | Two callus rolls, one 2m on west aspect, one 2m on north aspect, loose bark, hollow trunk, rot hole in north aspect callus roll leads back to small voids suitable for bats, west aspect callus roll rotted out to form hollow trunk suitable for bats. Holes heavily cobwebbed and no evidence of bats present. | 1 |

Three of the trees proposed to be felled were assessed as having negligible potential for roosting bats (BCT category 3) and therefore no further recommendations are required in regards to these trees and one tree was assessed as having definite potential for roosting bats (BCT category 1). It is recommended that the BCT category 1 tree should be soft felled under the supervision of an ecologist and two Schwegler bat boxes (in trees) or bat roost units (in buildings) should be installed to compensate for the loss of roosting opportunities.
