Arboricultural Report

45 HULBERT ROAD  
WATERLOOVILLE  
HAMPSHIRE  
PO7 7NX

MAY 2015

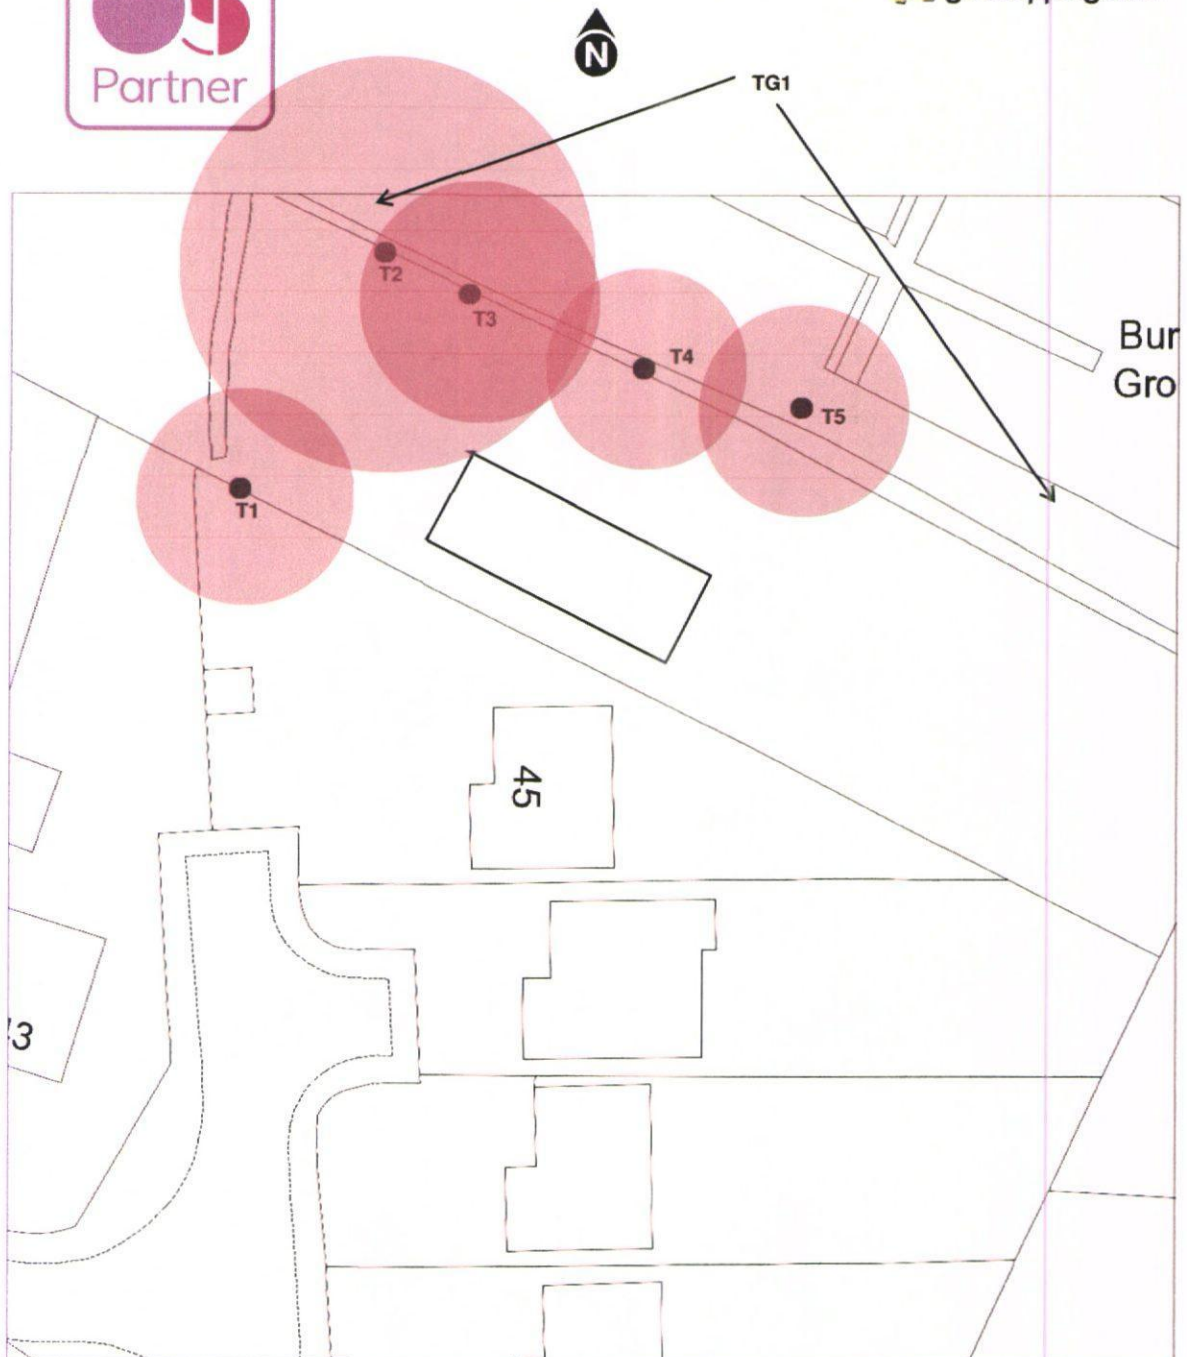
## APPENDIX 2 - ROOT PROTECTION AREA PLAN

- 6.1 In accordance with BS5837: 2012, the root protection area (RPA) of the trees has been calculated and shown in the following table and on the plan attached at **Appendix 2**.

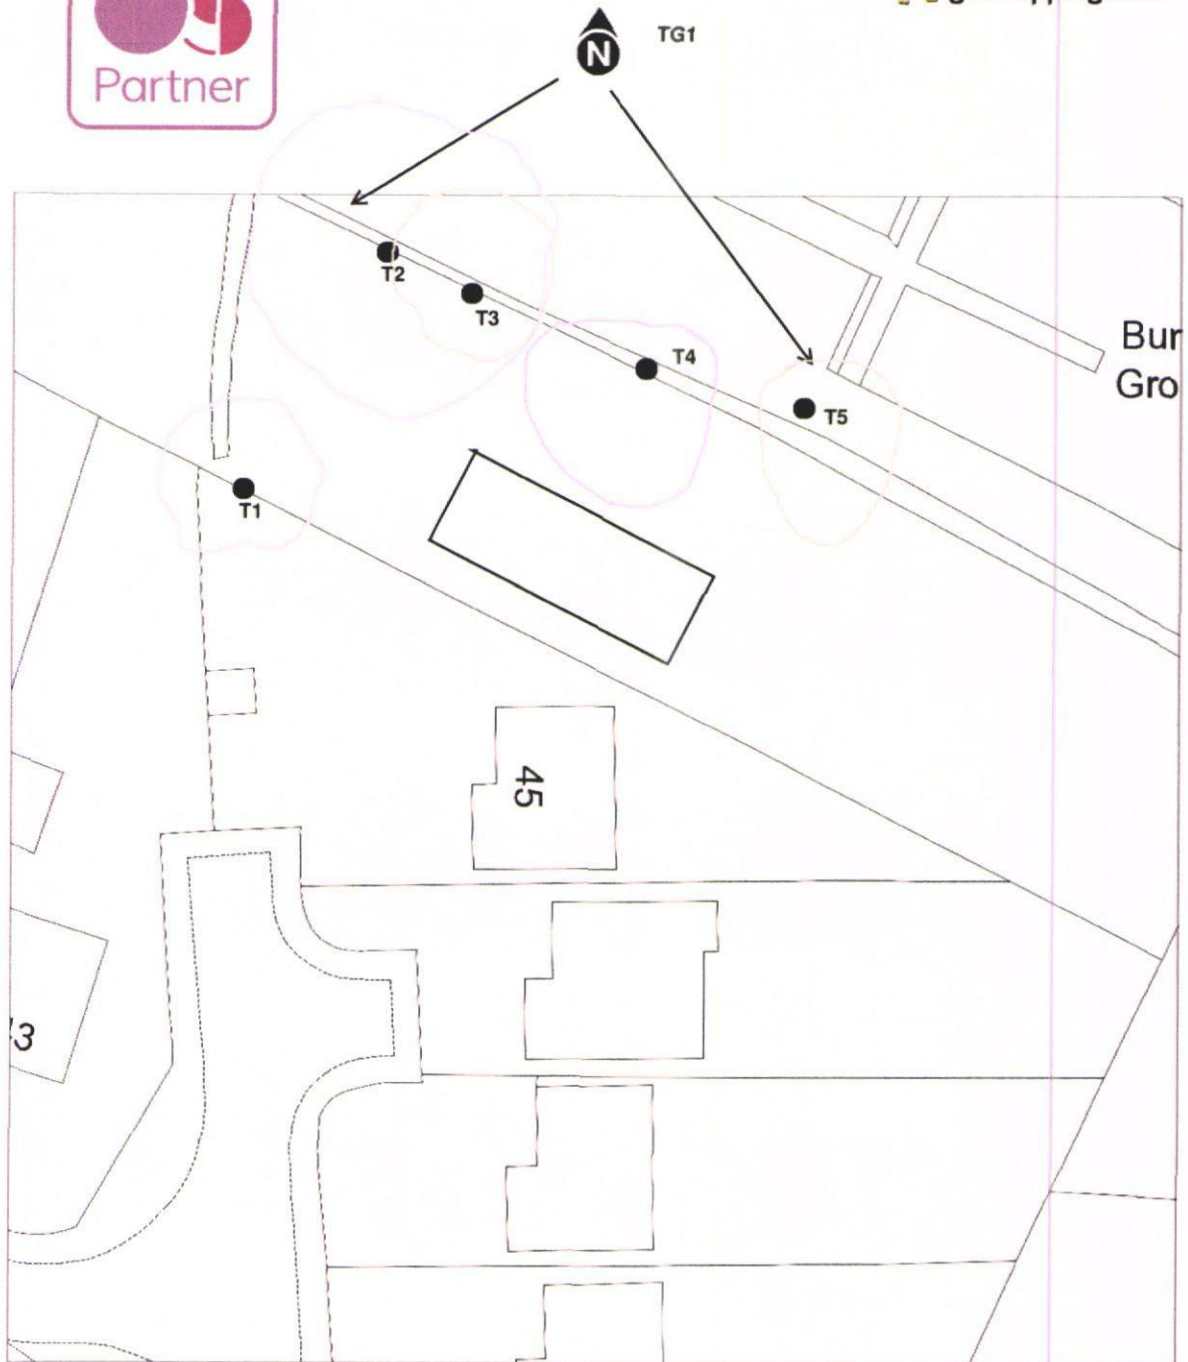
## APPENDIX 1 - TREE QUALITY ASSESSMENT PLAN

- 5.1 The trees have been categorized according to BS5837: 2012 as a guide to their condition and value in terms of visual amenity.
- 5.2 The trees are coloured on the plan attached at **Appendix 1** and the colours are explained in the key of the plan.
