# Arboricultural Report

**48 Hart Plain Avenue, Waterloooville, PO88RX**

**02/10/2014**

### **Proposed development on land to the rear of 48 Hart Plain Avenue, Waterloooville, PO88RX**

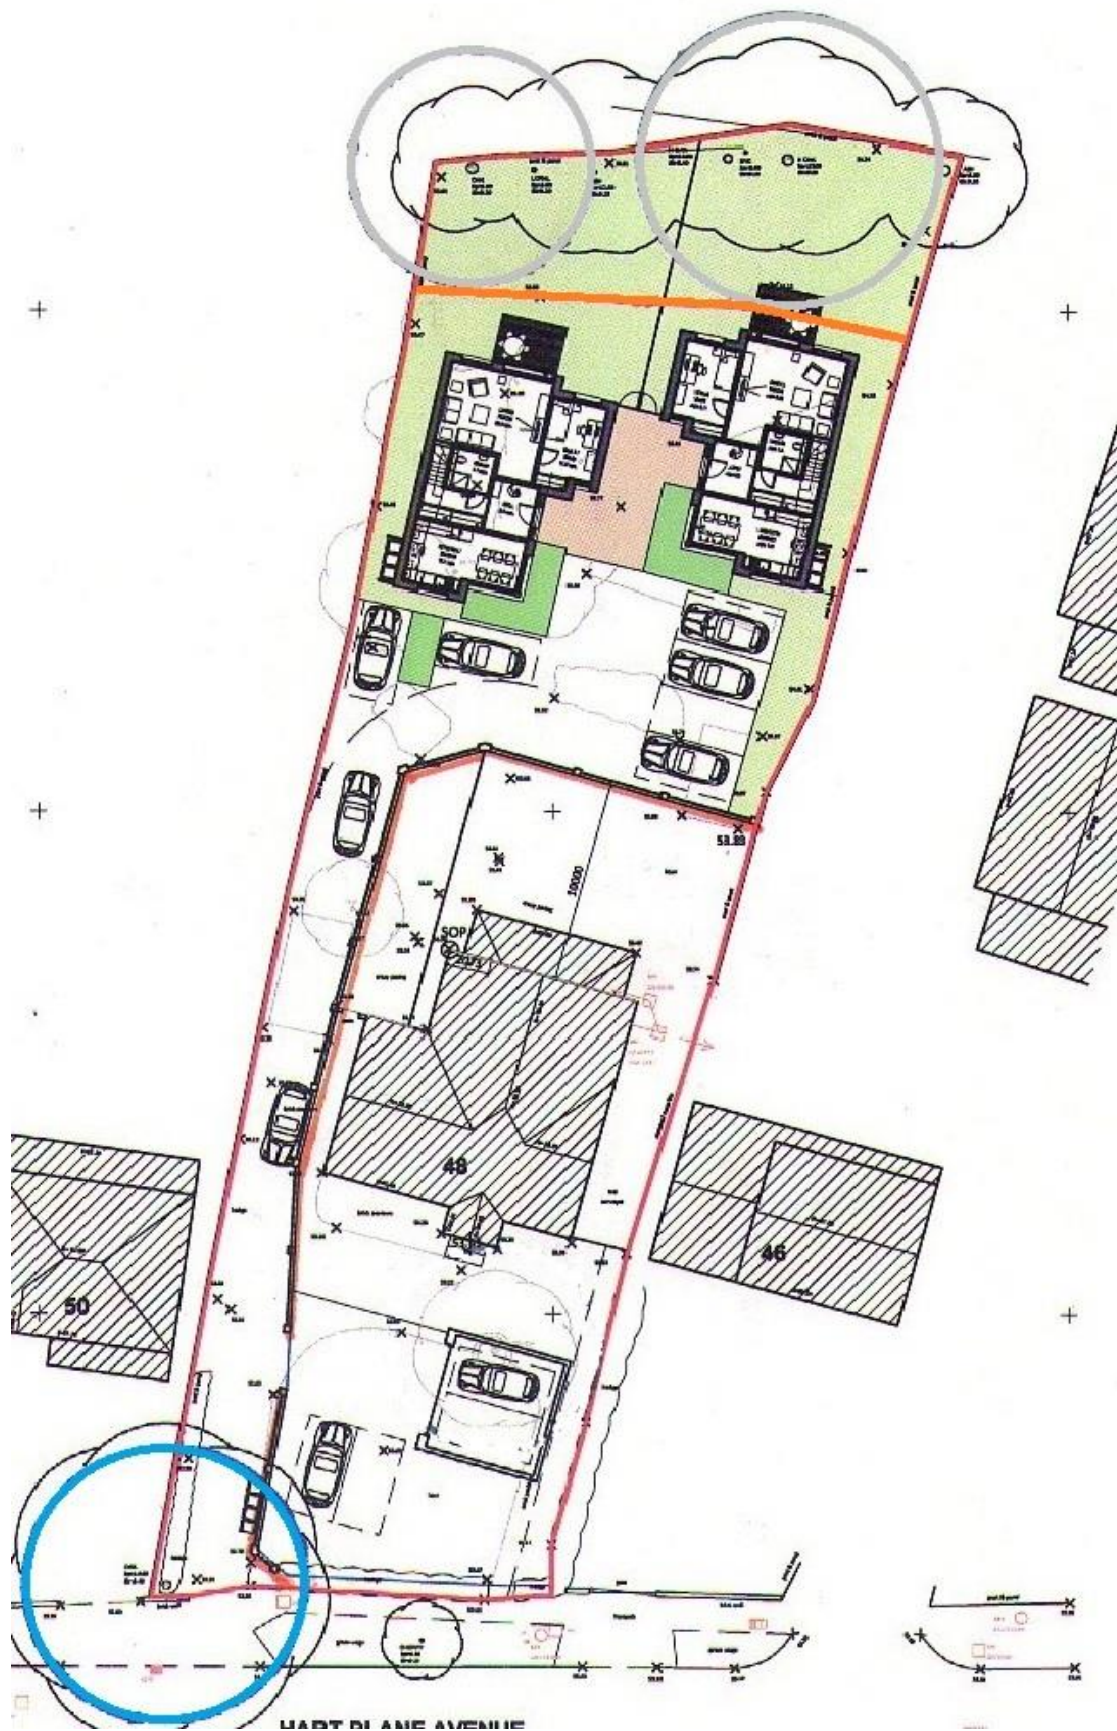
### Appendix 3: Tree Protection Plan

- 3.5.1 The proposed position of the replacement dwelling dispenses with a need to modify building construction to accommodate retained trees. The retained trees are far enough away from the location of the proposed dwellings to permit light infiltration to windows. This will negate the need for subsequent calls for tree pruning due to shading
- 3.5.2 The position of the patio that is within the RPA of T.15 (see appendix 3) will be moved to ensure that it no longer extends to within the RPA of T.15
