### Information to support application for tree works

14, Nore Farm Avenue, Emsworth, PO10 7NA, subject to a tree preservation order (TPO) no.1981.

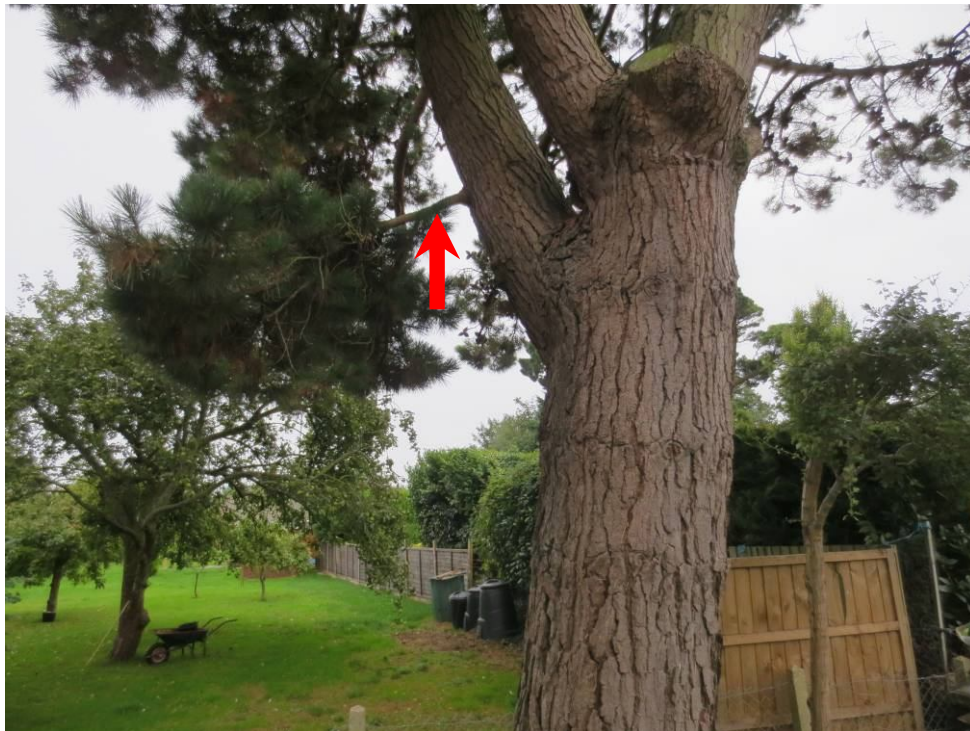
- a) The Pine tree had minor works (approved by HBC) to remove specified lower branches in 2010, i.e. crown lift). For unknown reason (probably lack of time) the tree surgeon failed to remove a couple of the smaller diameter and lowest branches under these works. It would improve the look and overall shape of the tree to remove these lower small diameter branches. As the branches are

*Figure 1 – Pine tree, looking South. Removable of small diameter, lowest branch as indicated.*

- Visual inspection to confirm general health and safety of the tree;
- Removal of approx. 4 small branches as indicated on following photographs;
- Removal of dead-wood where easily accessible;
- Works in accordance to best practice BS3998:1989 'Recommendations for tree work'.

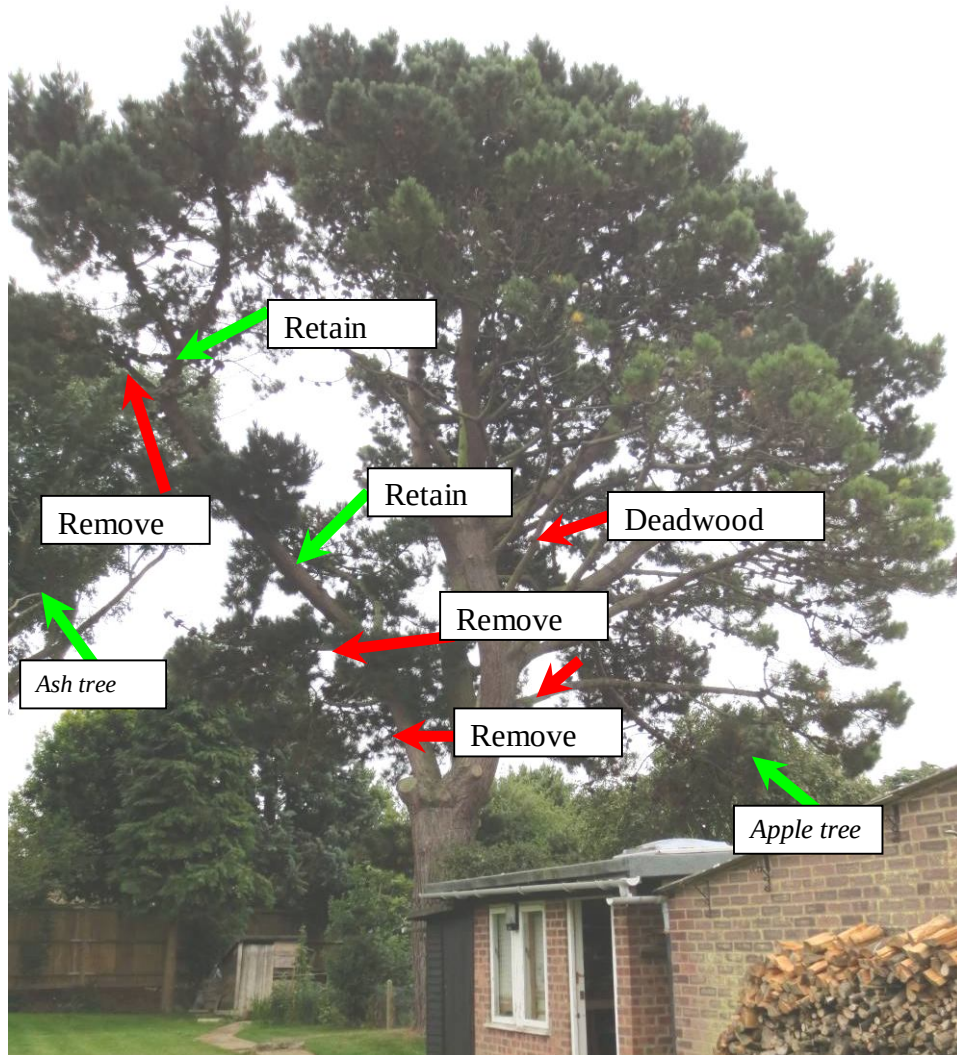
- b) Storm damage (notified to Mr.Skeet at HBC) in November 2010 removed one of the lower large branches of the tree, having a minor impact on the shape of the tree, works proposed would improve the shape of the tree at the lower level. It would reduce minor interference with neighbour's mature Apple tree;
- c) Works would offer some very minor improvement to excessive periodic fouling of the garden by pigeons which use noted branches as roosts;
- e) Removal of deadwood;
- f) Reduce loading on northern-most main branch (due to excessive movement this branch appears to be vulnerable in stormy weather).

Figure 2 –Pine tree, looking East, retain/remove as indicated. (noting that part of the adjacent Ash tree is visible in the background of the photograph on the left-hand side).
