## **Tree Survey and Arboricultural Impact Assessment**

**BP Park Lane Service Station,  
Park Lane,  
Bedhampton,  
Havant,  
Hants. P09 3HQ.**

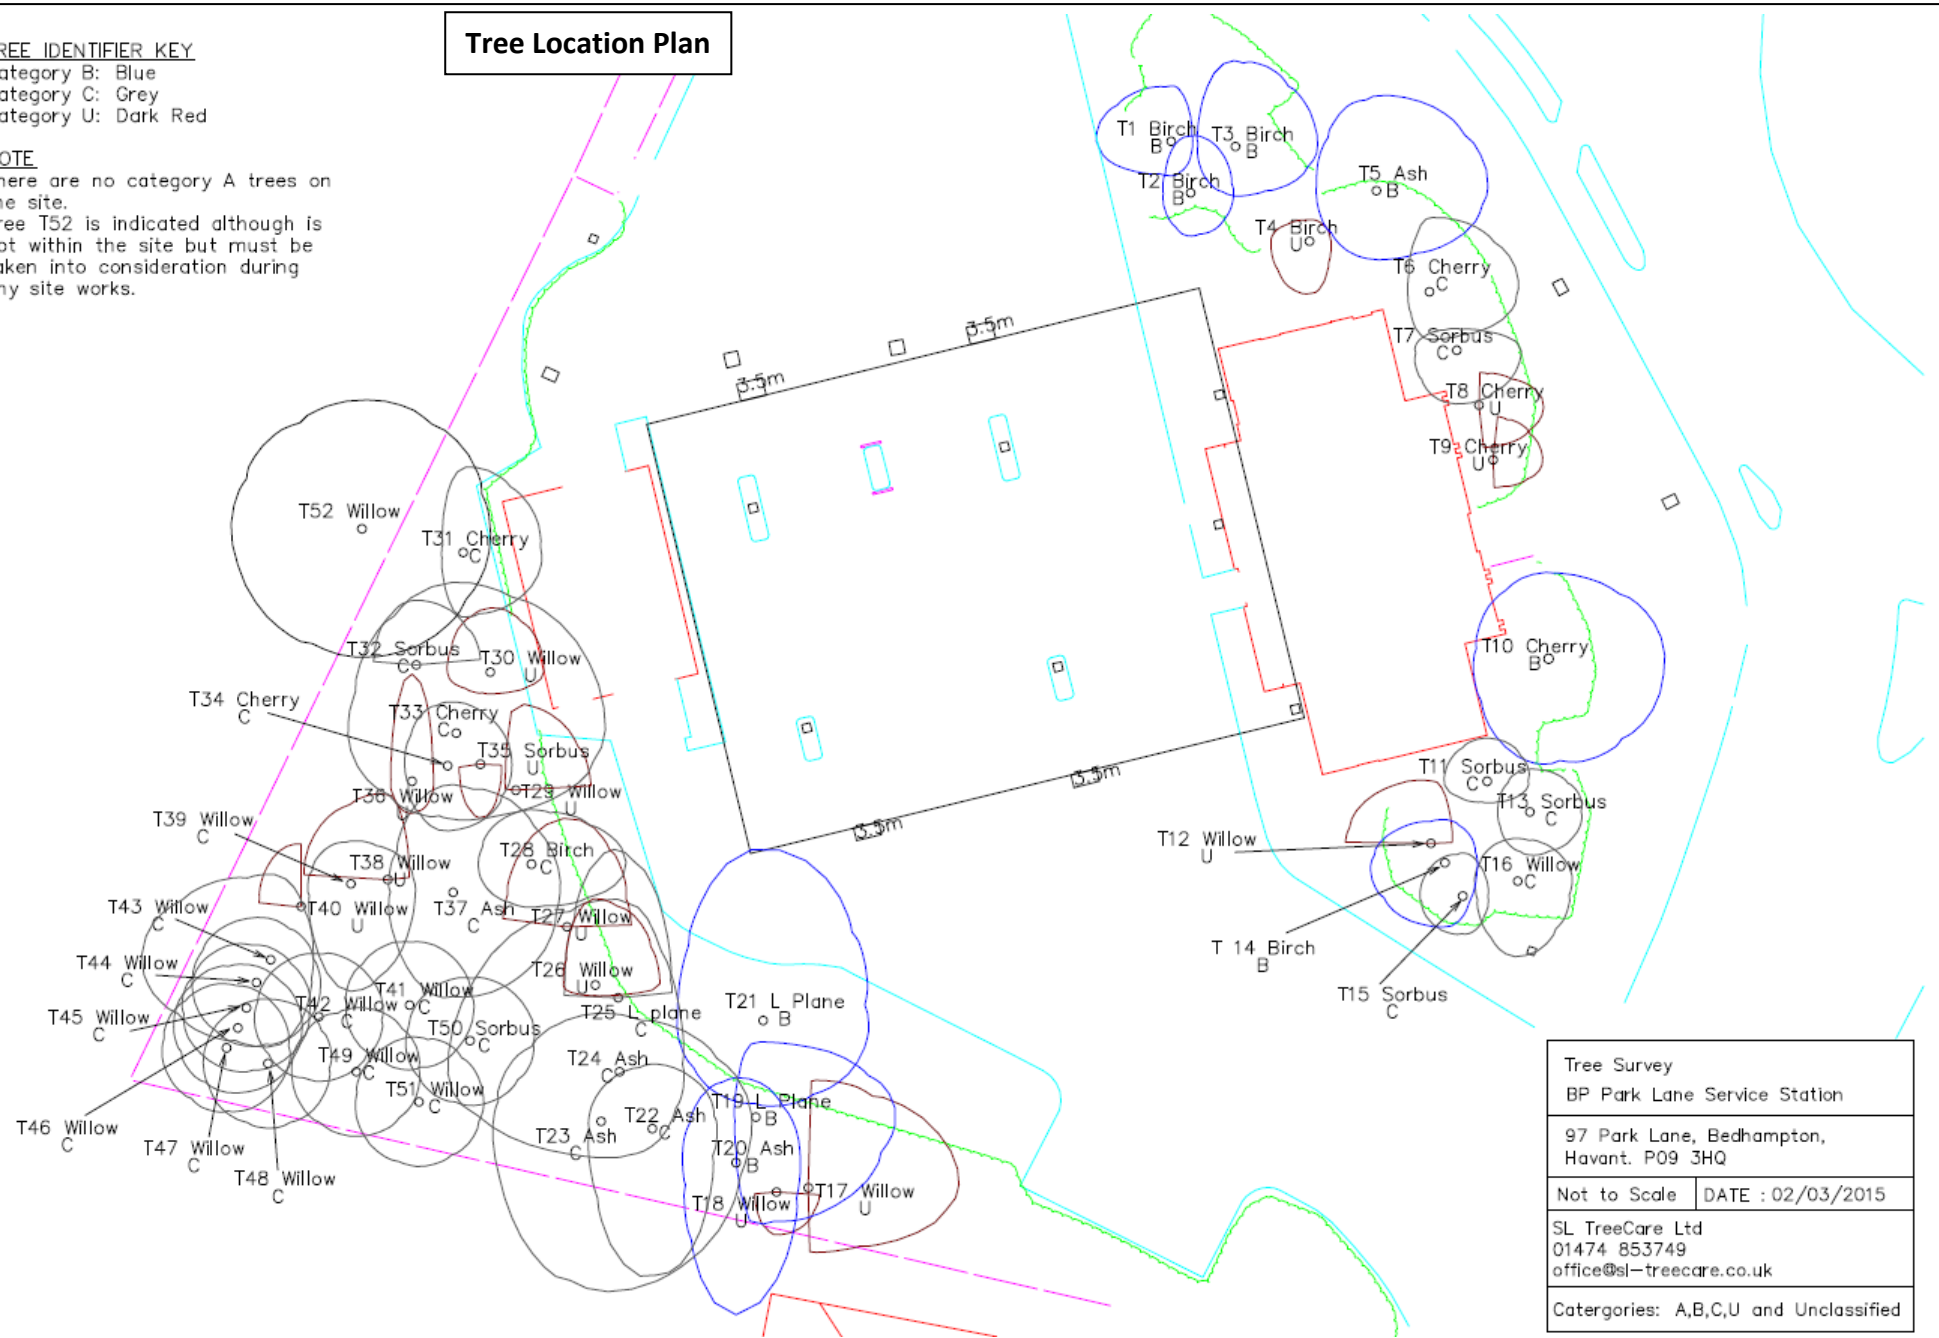
## Tree Location Plan

Tree T52 is indicated although is not within the site but must be taken into consideration during any site works.

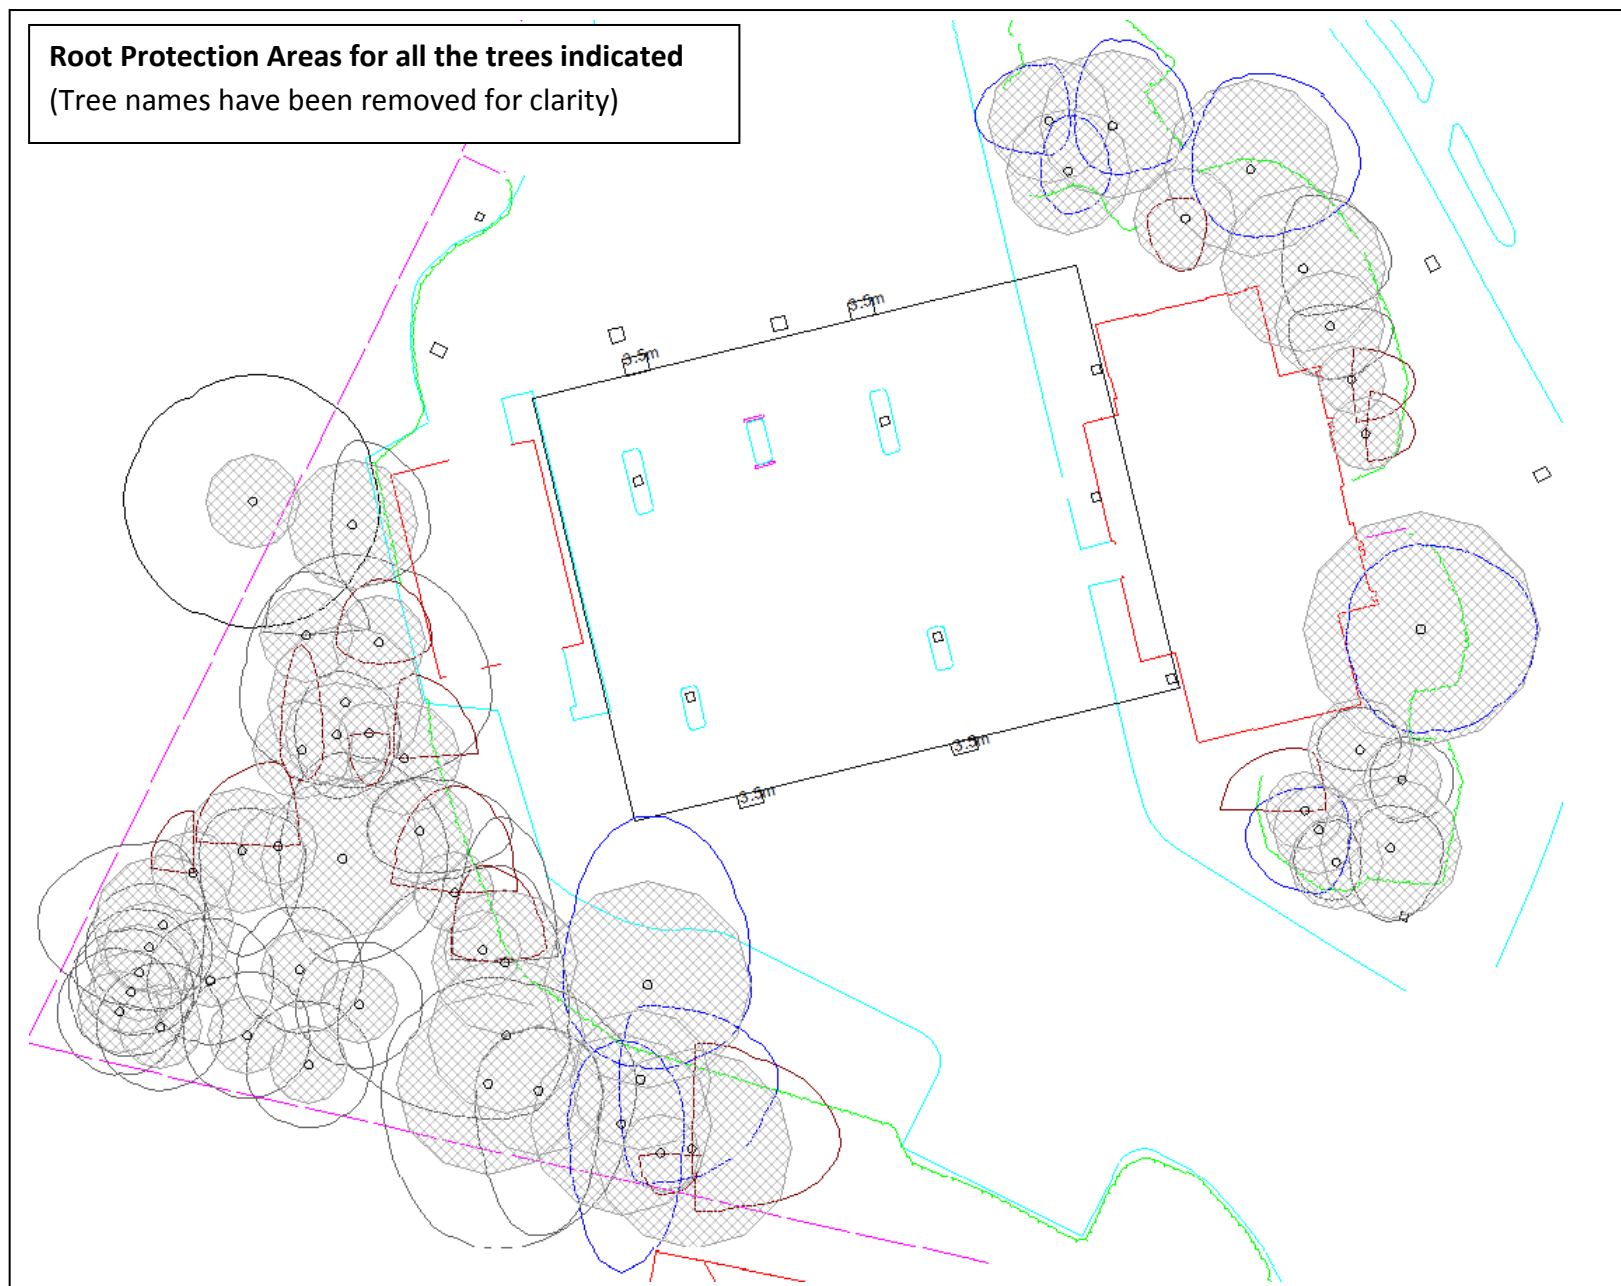
RPA (Root Protection Area) for the individual trees are shown on the RPA drawing, but at this Pre Planning stage are for indication only. Depending on the plans submitted, the RPA's can be plotted accurately.

The trees in particular to be protected during the proposed plan's building phase would be T5 Ash, T10 Cherry and a line from the carwash corner to safeguard T28 and others to the fence by T 51. Details of this would in any case be detailed in a later Method statement.
