Ref: A081595

Date: 8<sup>th</sup> July 2013

### **Bartons Road, Havant: Internal Roof Void and Endoscopic Inspection of Buildings**

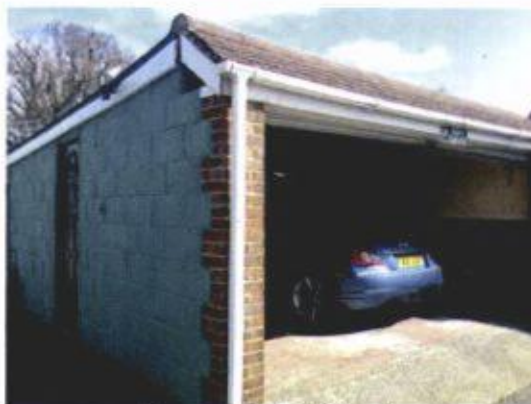
**Images 1:** Building 1

This is a garage type building of brick built construction with a sloped felt clad roof, with four rows of tiles to the southern elevation. The building was open to the front at the time of the survey. No roof void appeared to be present. However, a small gap under the roofing felt was identified at the western elevation.

The gap beneath the roofing felt at the western elevation was inspected with an endoscope to identify the presence, or likely absence, of roosting bats. The gap was found to be heavily covered with cobwebs, indicating that it had not recently been used by bats. No signs of roosting bats, such as droppings or staining was identified within the cavity. The cavity was assessed as offering **negligible potential** to support roosting bats.

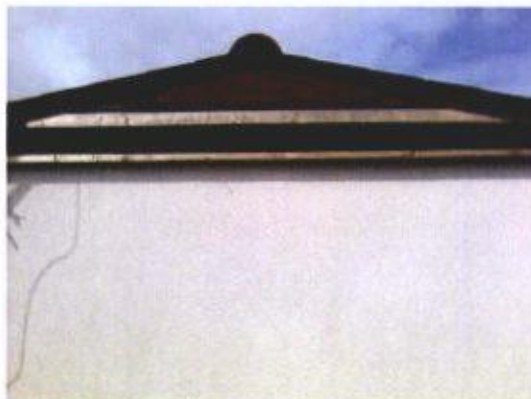
**Images 2:** Building 5

This is a static home which appeared to be new at the time of the survey, soffit boards were missing along the eastern and western elevations providing possible access into the building, otherwise the building appeared to be very intact.

An internal inspection was completed to investigate if there was any potential for roosting bats within the roof, where the soffit boards were missing. A number of cobwebs were identified within the roof void, indicating no recent bat activity. Additionally, no droppings, feeding remains or staining were identified. Due to the missing soffit boards, the roof void is likely to be draughty rendering it unsuitable for roosting bats. The building was assessed as offering **negligible potential** to support roosting bats.

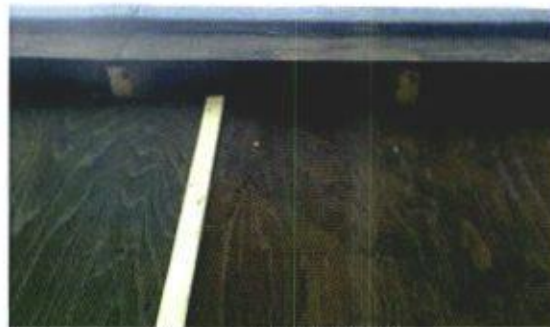
**Image 3:** Building 6

This is a wooden shed with a flat felt clad roof, with a large window along the northern elevation. Possible access points for bats into the building were identified beneath the roof.

Potential access points beneath the roof were inspected using a torch. During the inspection, the roof was found to be well sealed, with no potential access points for bats identified. The building was assessed as offering **negligible potential** to support roosting bats.

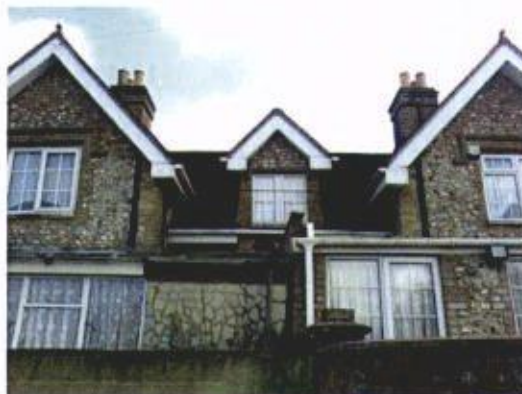
Image 4: Building 11

This is a two storey semi-detached house with a single storey flat, felt clad roofed extension to the northern elevation. The house is constructed from brick and stone, with a pitched tiled roof with a chimney. Wooden soffit boards and UPVC windows appeared to be intact; however there were a couple of missing / broken tiles on the southern elevation. Hanging tiles are present on the southern gable end of the building; however these appeared to be fairly intact. There is another sloped roof extension on the western elevation, a hole is present leading into the building but there did not appear to be a roof void within the extension.

The building comprised four roof voids. No evidence of roosting bats, such as droppings, staining or feeding remains were identified within any of the roof voids. The roof of the buildings was generally in a good state of repair, with the roofing felt mainly intact, except for a small number of holes. However, due to the presence of hanging tiles and a number of missing / broken roof tiles, which would provide potential roosting features for bats, the building was assessed as offering **moderate potential** to support roosting bats.

Building 11 was assessed as offering **moderate potential to support roosting bats**. In accordance with the Bat Conservation Trust's *Bat Surveys: Good Practice Guidelines* (2012), it is recommended that two nocturnal surveys are undertaken of the building, including one dusk and pre-dawn survey.

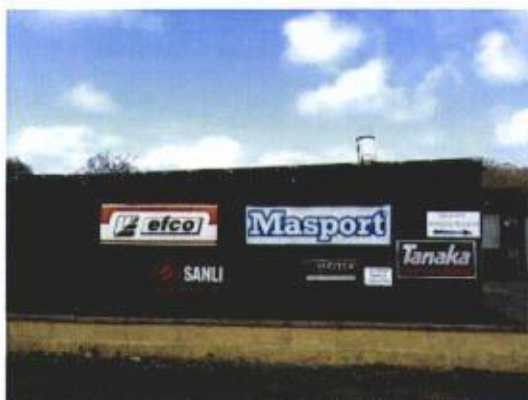
This is the Mower shop which is predominantly a single storey flat roofed building with wooden cladding providing possible roosting places for bats. One part of the building has a pitched metal roof and large UPVC windows. There is a single storey extension to the eastern elevation which is of breeze block construction with a pitched tiled roof. Some of the tiles are broken / missing along the southern elevation of the extension.

Image 4: Wooden boarding on southern elevation of mower shop

There is no separate roof void within the Mower shop or the extension. The shop is in constant use and is therefore well lit. No potential bat roosting features were identified within the building and no evidence of roosting bats was identified. However, the wooden cladding exhibited gaps beneath the wooden boards and a number of tiles on the roof of the extension were missing / broke. The building has therefore been assessed as offering **low potential** to support roosting bats.

Buildings 12 and 14 were assessed as offering **low potential to support roosting bats**. It is recommended that one nocturnal bat survey of these buildings is undertaken, comprising a dusk and pre-dawn survey.

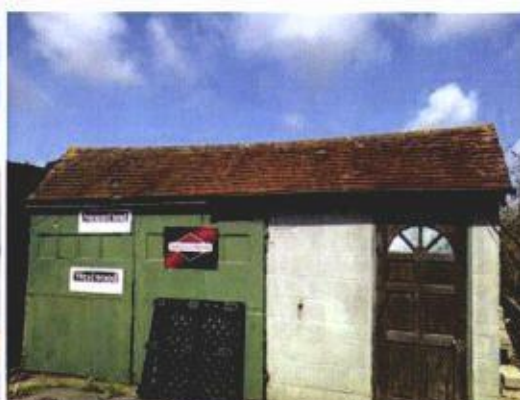
Image 5: Extension

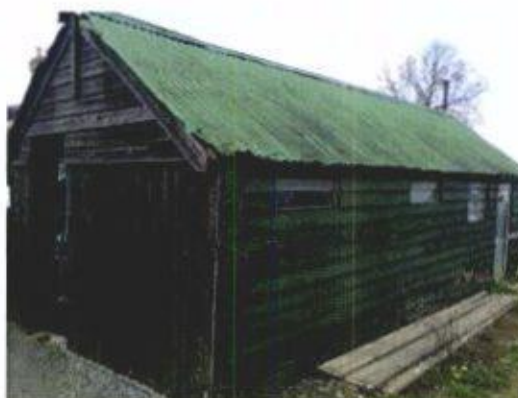
Image 6: Building 14

This is a wooden shed with a pitched tiled roof constructed from corrugated metal. There are possible access points into the building.

No evidence of roosting bats was identified within the building. However, the wooden cladding on the exterior of the building was in a poor state of repair, exhibiting a number of bat roosting features, such as gaps beneath the wooden boards. The building was assessed as offering **low potential** to support roosting bats.

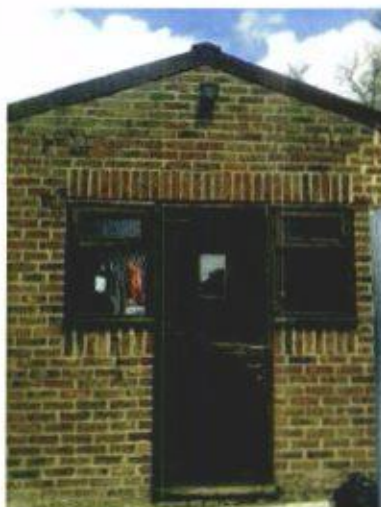
Image 7: Building 19

This is the dog kennels which are of brick built construction with a pitched tiled roof, running through the centre. There are metal mesh and brick extensions along both the eastern and western elevations.

There is no internal roof void within the building and the interior of the property is heavily disturbed as a result of its current use as a dog kennels. The roof tiles were intact and in a good state of repair, offering no features of suitability for roosting bats. The building was assessed as offering **negligible potential** to support roosting bats.

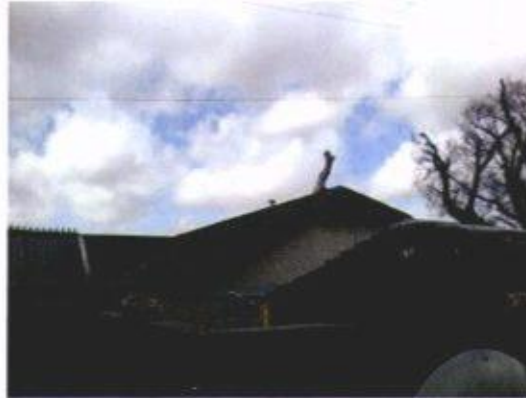
**Image 8:** Building 20

This is a prefabricated rendered bungalow under a pitched tiled roof which appeared to be intact. There is a new single-storey brick extension, to the northern elevation. This extension has a felt clad flat roof, however this appeared to be intact.

There is no internal roof void to this building. The roof is in a good state of repair, with no potential bat roosting features identified. The building was assessed as offering **negligible potential** to support roosting bats.
