Ref: SW.AMS.259.14 - The Royal Oak, 19 Langstone High St, Havant PO9 1RY

Friday, 12<sup>th</sup> December 2014

**ARBORICULTURAL INFORMATION TO SUPPORT A PLANNING APPLICATION FOR THE ROYAL OAK, 19 LANGSTONE HIGH STREET, HAVANT, HAMPSHIRE PO9 1RY**

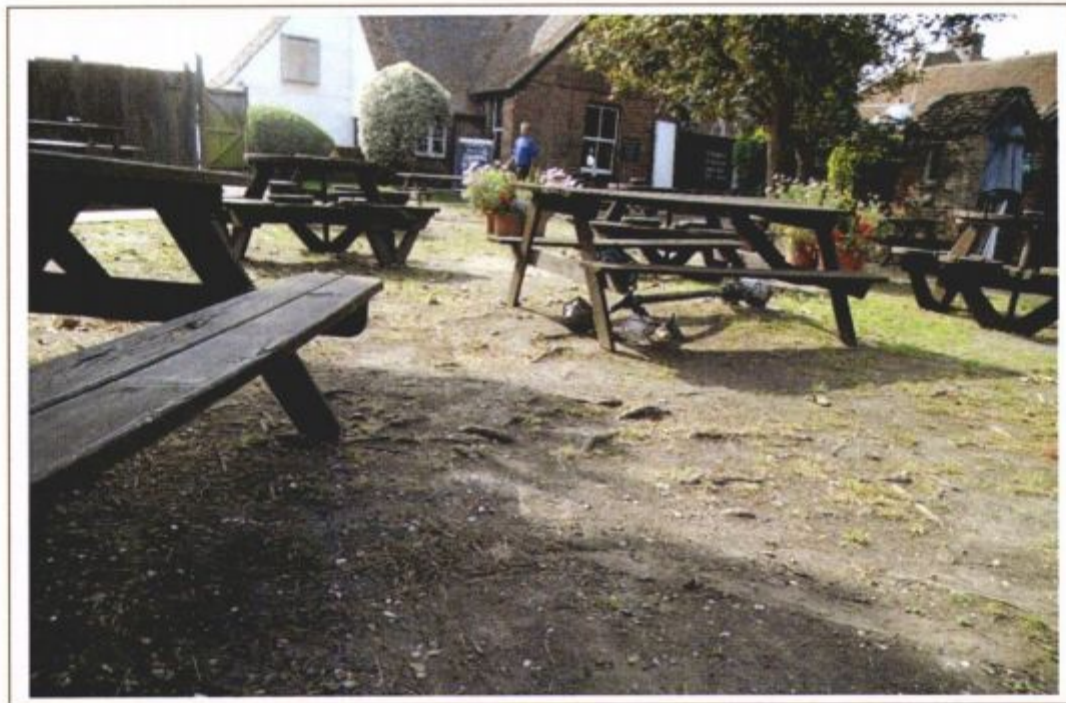
The site is reasonably level, but historic use of the seating areas has led to erosion of the lawn to bare soil and exposure of areas of surface roots from T2 Monterey pine (image 1). As will be demonstrated, all retained trees and vegetation features can be accommodated within the context of this proposed garden improvement scheme.

Image 1: Showing roots of T2 protruding above the surface of the existing worn and bare lawn

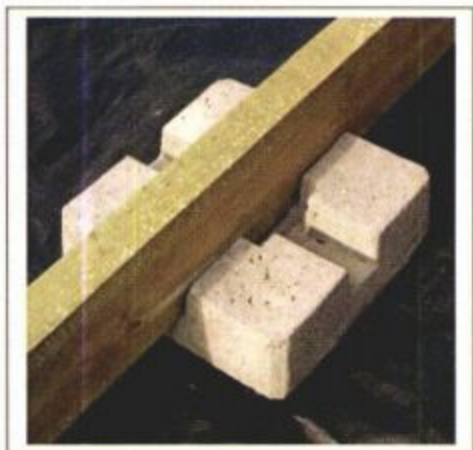
Image 2: Using pre-cast concrete Deck Block should more or less negate the need for excavations.

3. Installation of the raised decking area (T2). Excavations should if possible be avoided. Instead, it is anticipated this facility could be installed simply and securely with minimal excavation by using pre-cast Deck Blocks [www.silvatimber.co.uk](http://www.silvatimber.co.uk) (image 2), or constructing a frame of hardwood sleepers fixed with 600mm steel re-bars.

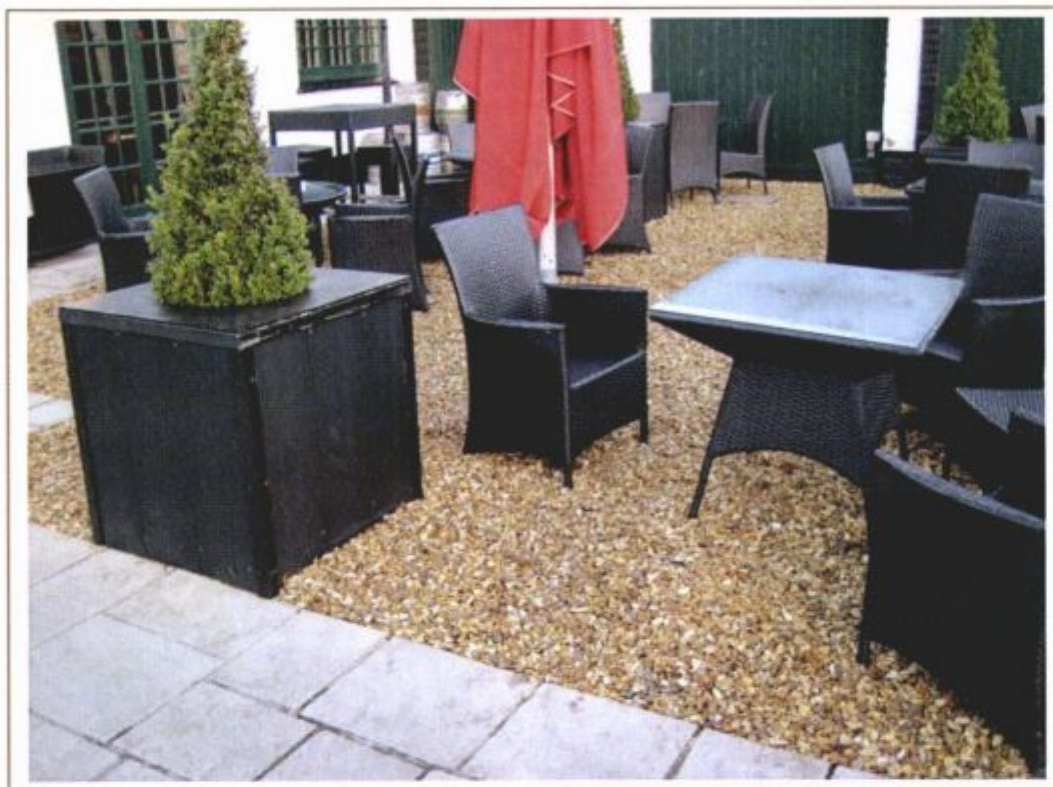
Image 3: Showing effective use of 20mm angular stone as surfacing for an outdoor seating area

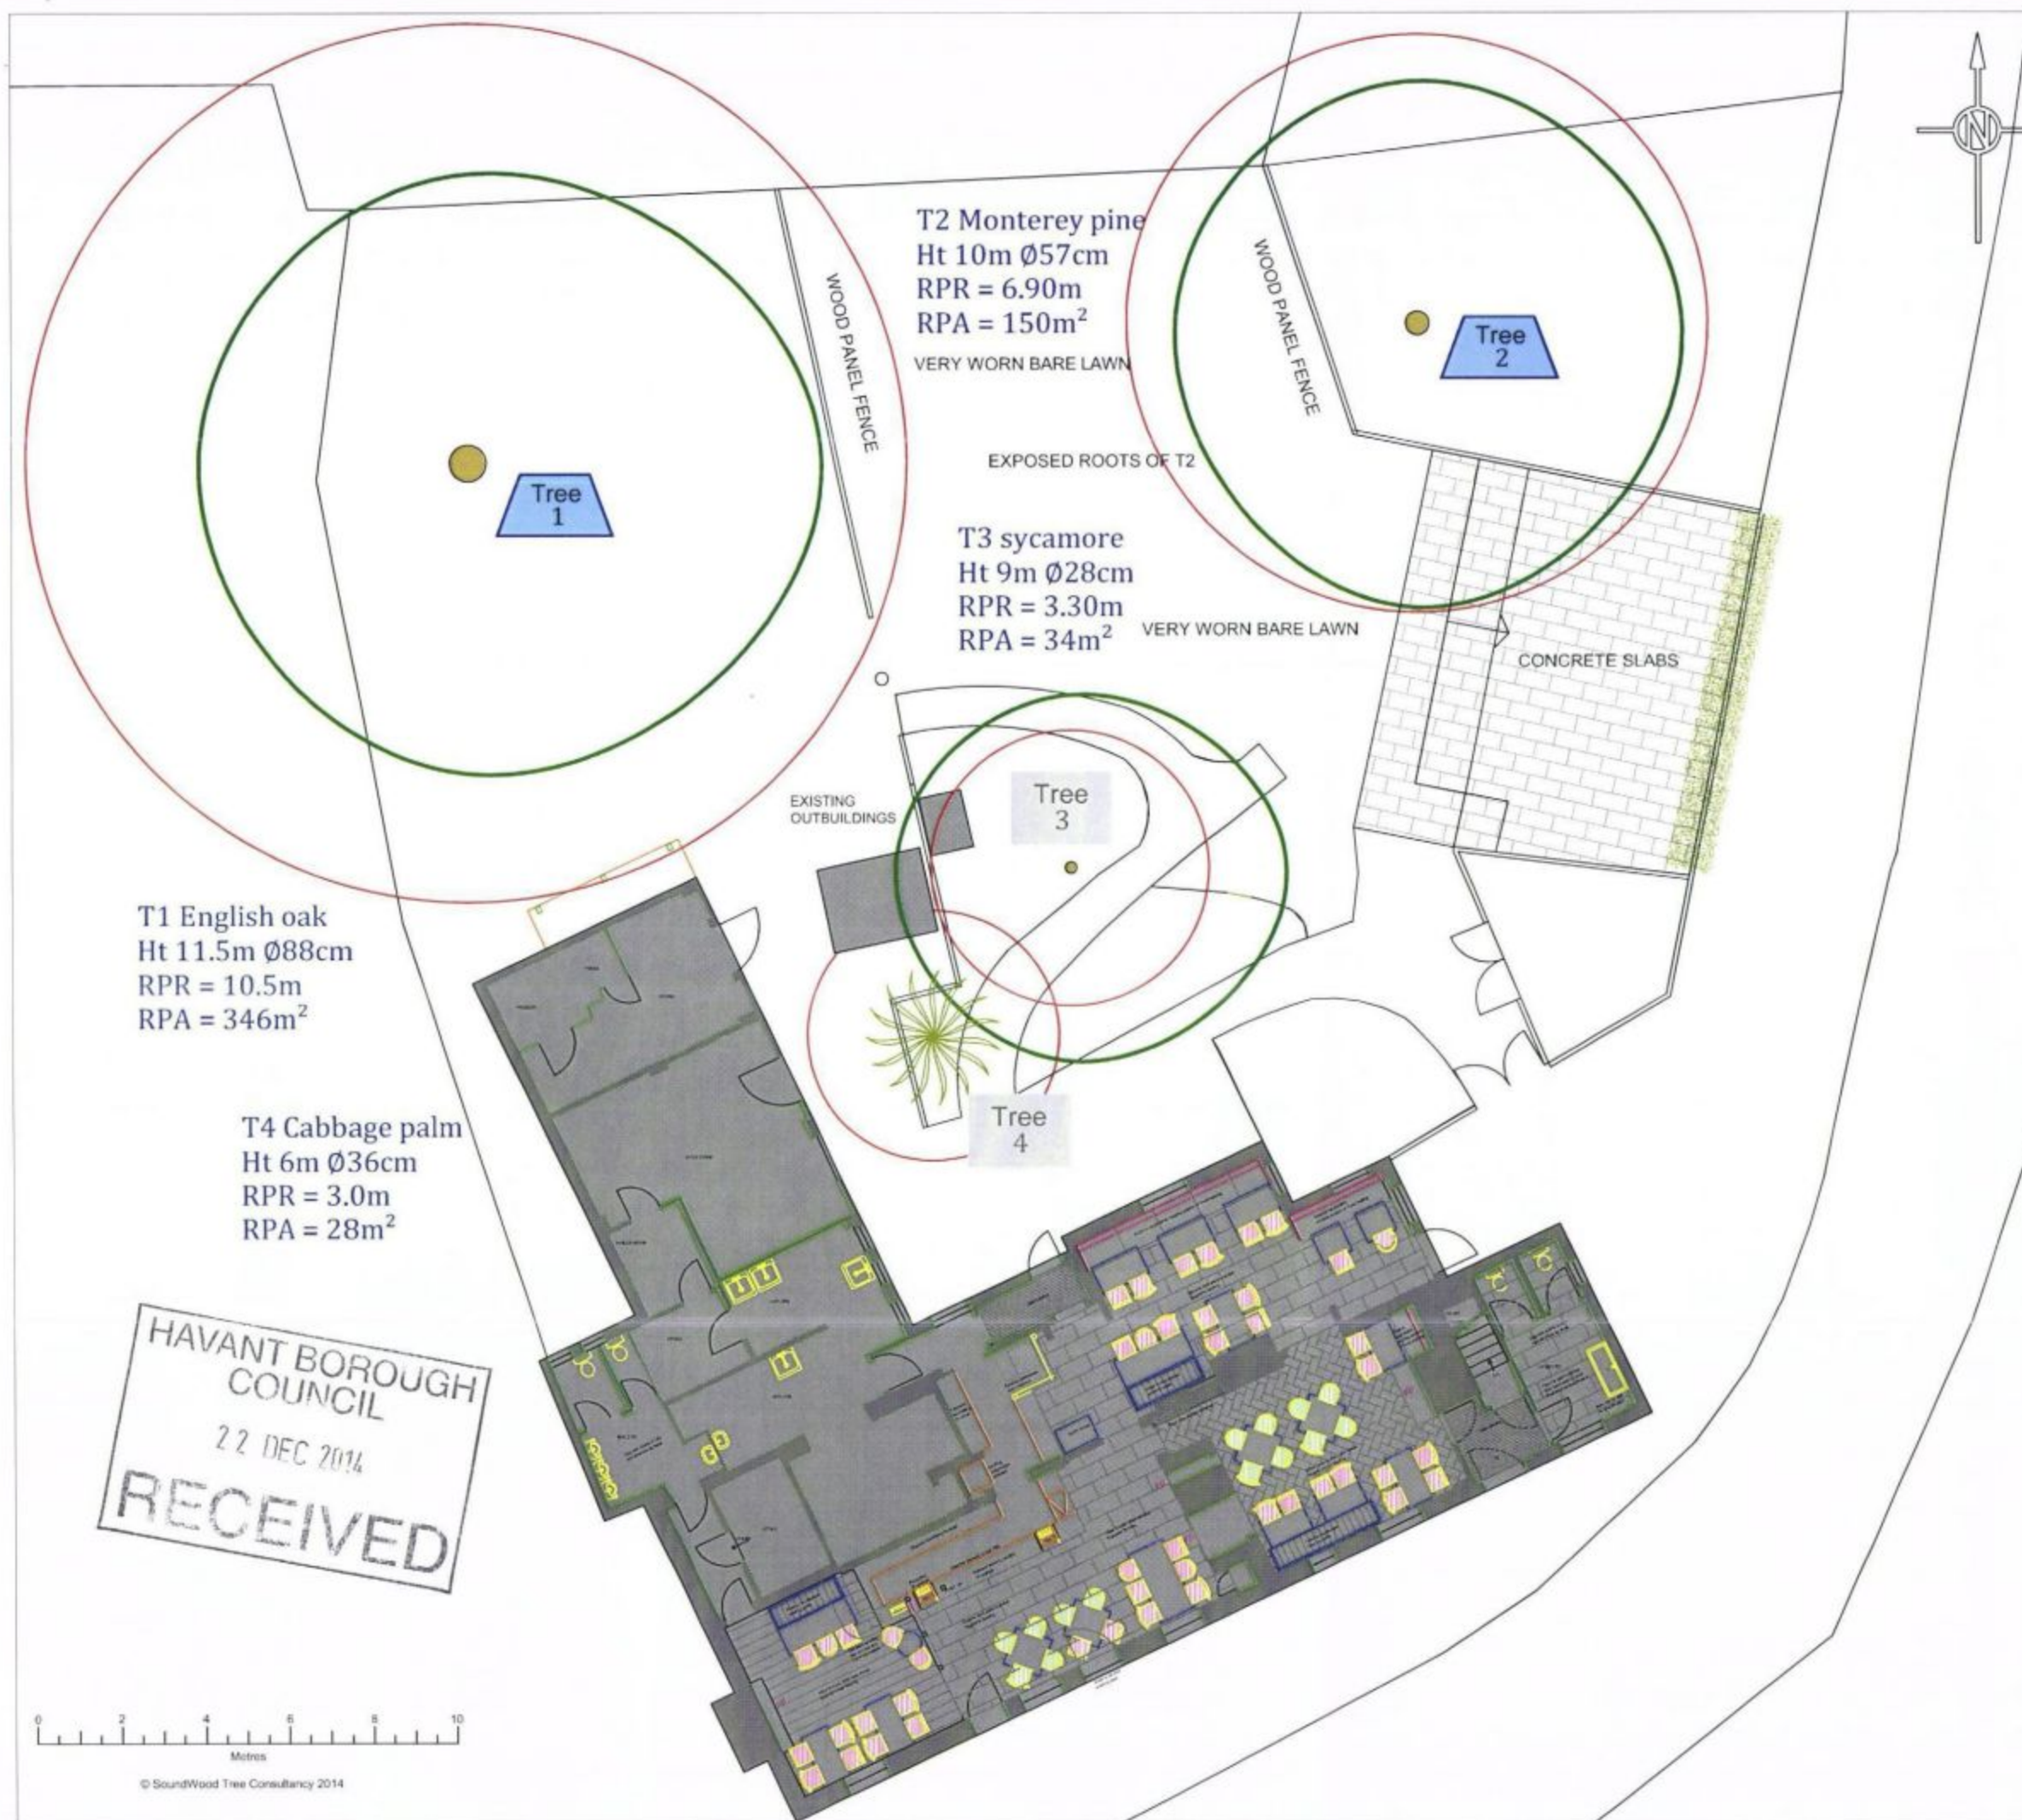
### PLAN SW 1

It is understood that the site is located within a designated conservation area, but is not subject to a tree preservation order [TPO]. No trees require removal for management or to facilitate the proposed changes (SW2). However, a range of minor tree management works, which will not adversely affect either tree health or amenity are listed at appendix 2.

Canopy spreads of A & B category trees are shown by the GREEN lines plotted in the directions of the four cardinal (and where appropriate additional inter-cardinal) points of the compass; whilst those of category C are shown in GREY. Their respective [theoretical] root protection areas are expressed in RED as a radius from the centre of each tree stem (RPR).

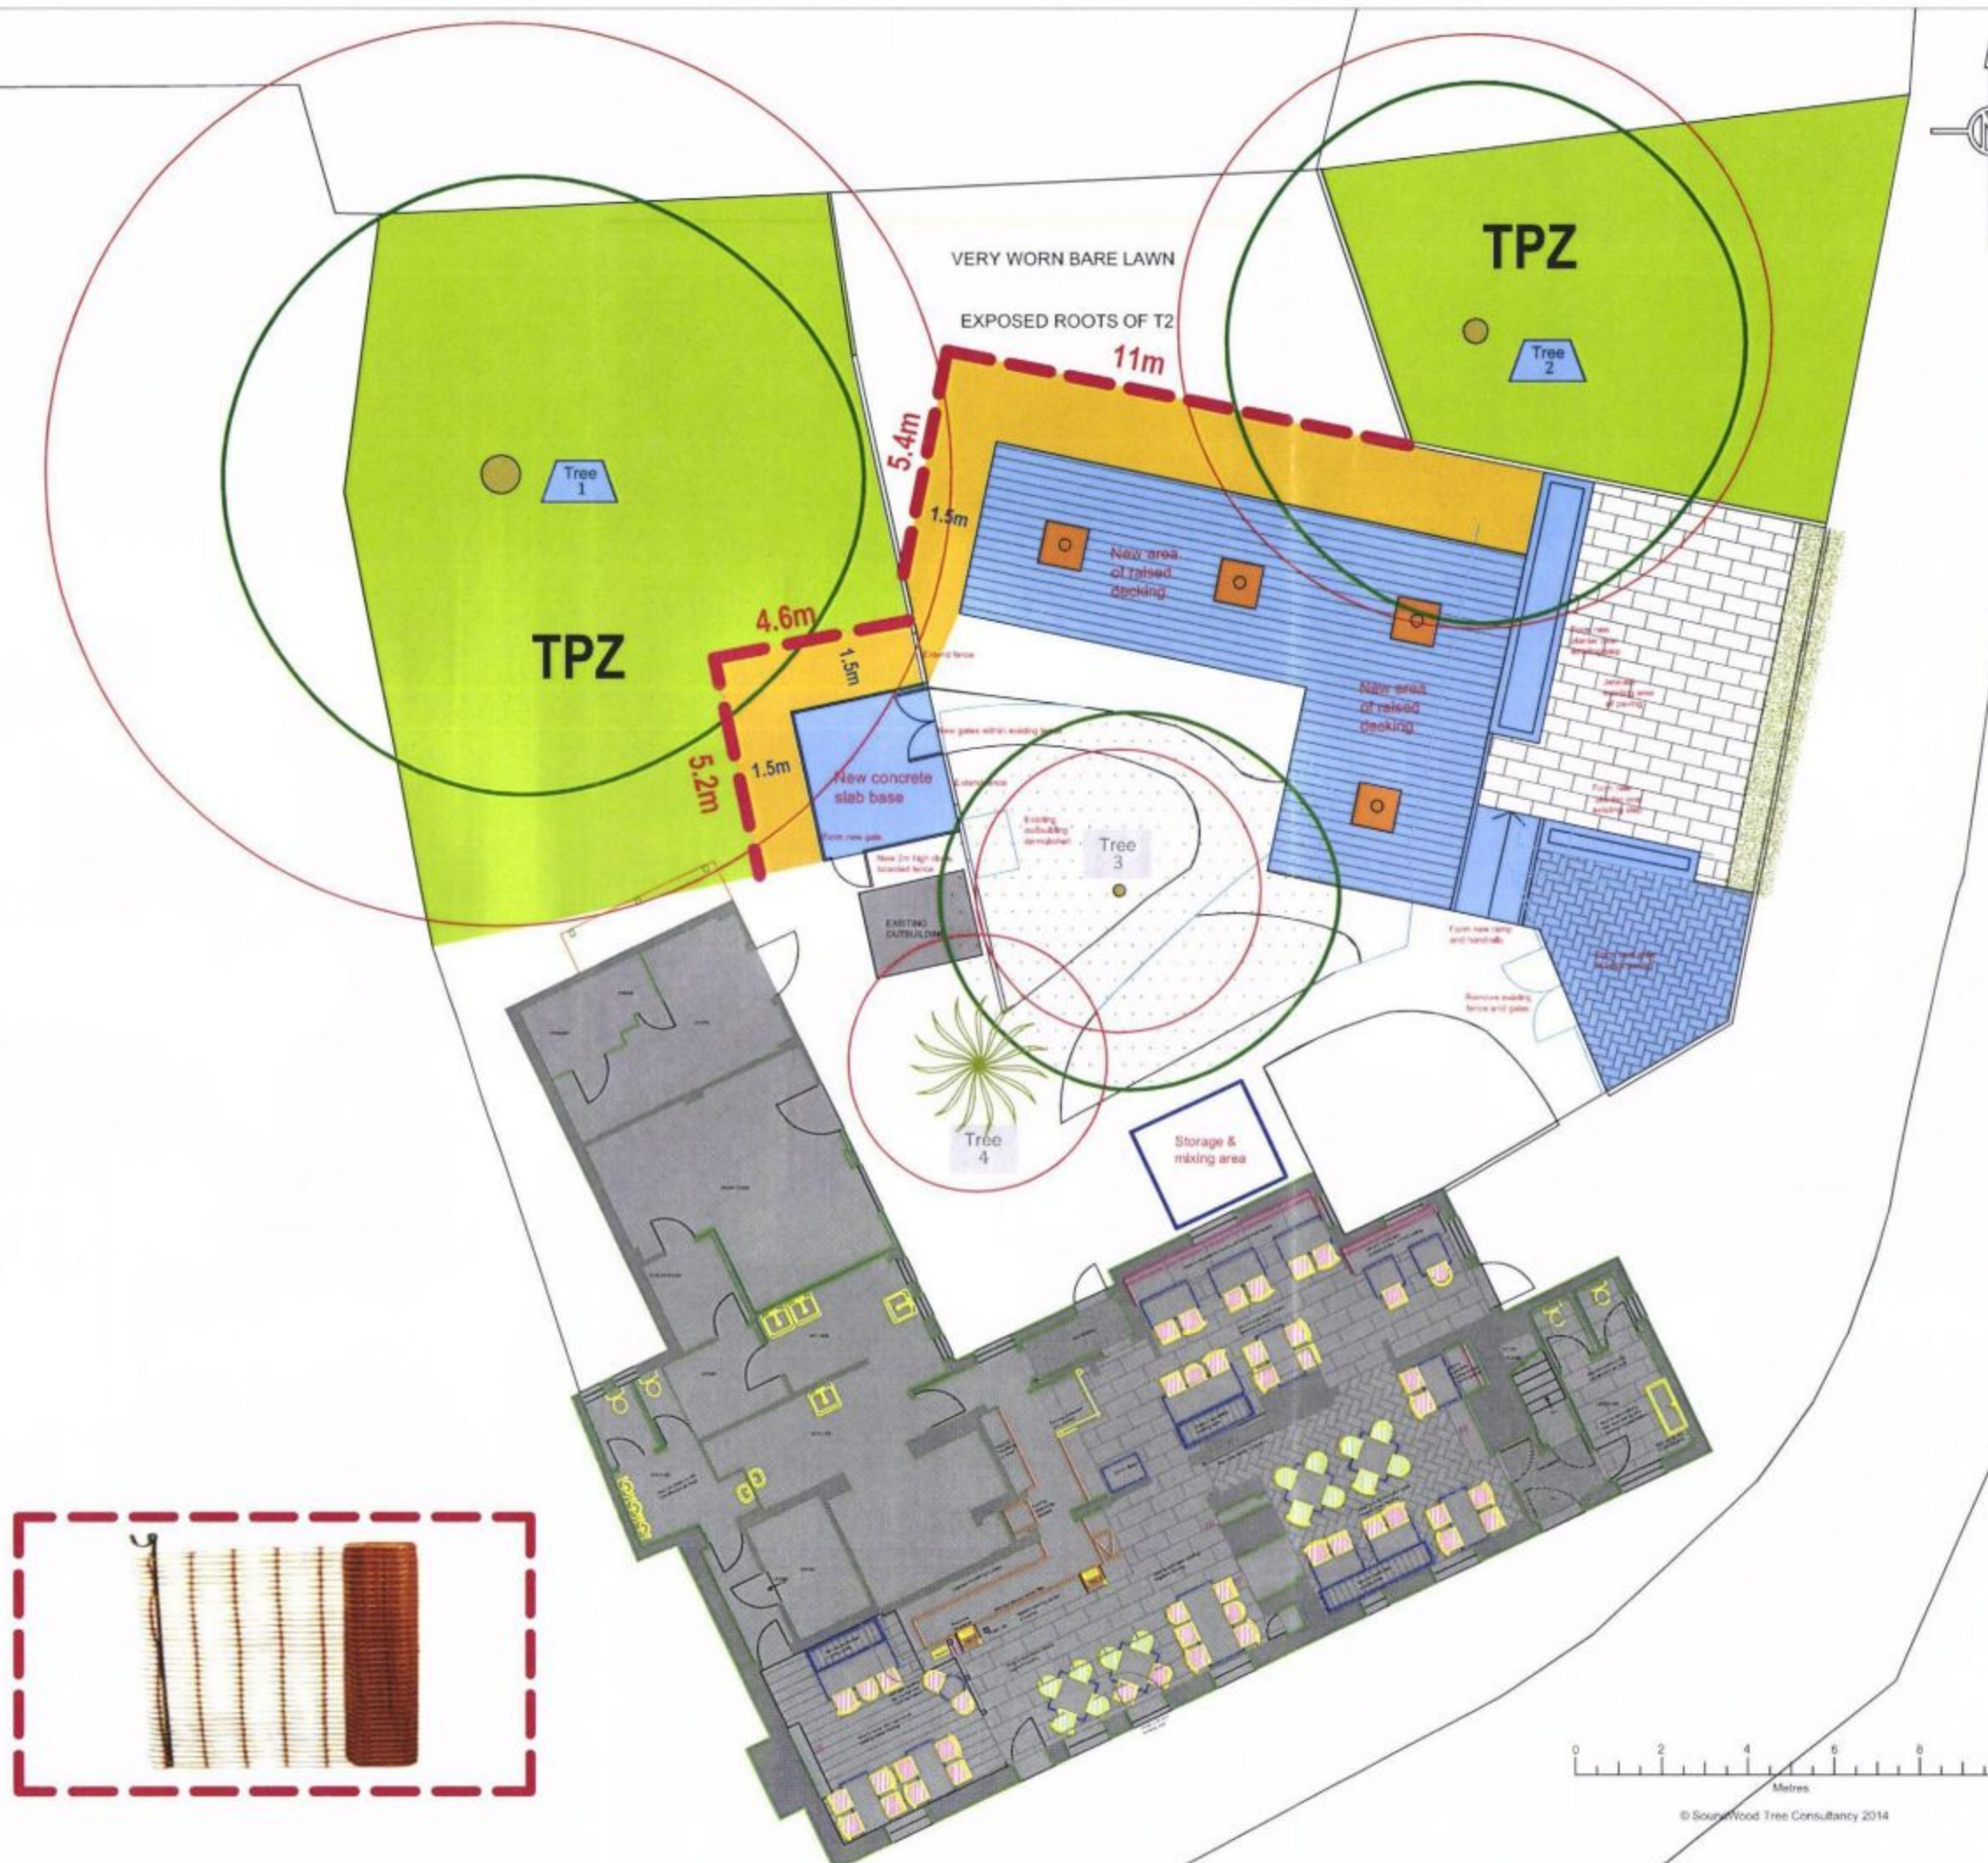
# TREE PROTECTION PROPOSED LAYOUT SW2

The footprint of proposed changes is shown shaded **ORANGE**. The 1m<sup>3</sup> concrete footing blocks for securing the new Jumbrellas are shown shaded **ORANGE**. In order for the retained trees to be accommodated within the context of the proposed changes with minimal impact the works **must** be undertaken as follows:

**Temporary ground protection.** The **GOLD** shading shows the two areas of high activity (42m<sup>2</sup>) where side-abutted scaffold planks are needed to protect exposed surface roots & soil structure.

1. The use of any plant or self-propelled machinery is prohibited.
2. Due to the presence of large surface roots from T2, there can be no changes in existing site levels.
3. All related excavations within KPAs **must** be undertaken using hand tools only in accordance with the guidance at page 3.
4. The new decking should be installed using no-dig methods, supported on pre-cast concrete Deck Blocks.
5. Any Geo-textile underlay must be Tree-Tex T300 available from [www.geosyn.co.uk](http://www.geosyn.co.uk). See SW3 for final layout.

The **LIGHT GREEN** shaded areas show the Tree Protection Zones [TPZ] into which all construction access is **strictly prohibited**. The following basic tree protection measures which are appropriate to the duration & scope of the works **must** be installed as a primary site task & approved by the project arboriculturalist/LPA tree officer **prior** to the commencement of any excavation or construction activities. Protective fencing, 26.2m barrier of ski-netting supported by road pins (inset) **must** be erected in the locations/dimensions depicted by the **DARK RED** thick broken lines.

**Storage & mixing.** A suggested location of the storage & mixing area for cementitious materials is shown by the **BLUE** rectangle, which in order to prevent run-off **must** be bunded in accordance with appendix 4. The above protection measures **must** be maintained & remain fit for their intended purpose throughout the **entire** duration of the works. They are only to be removed upon full completion of all external activities & with the written agreement of the LPA tree officer.

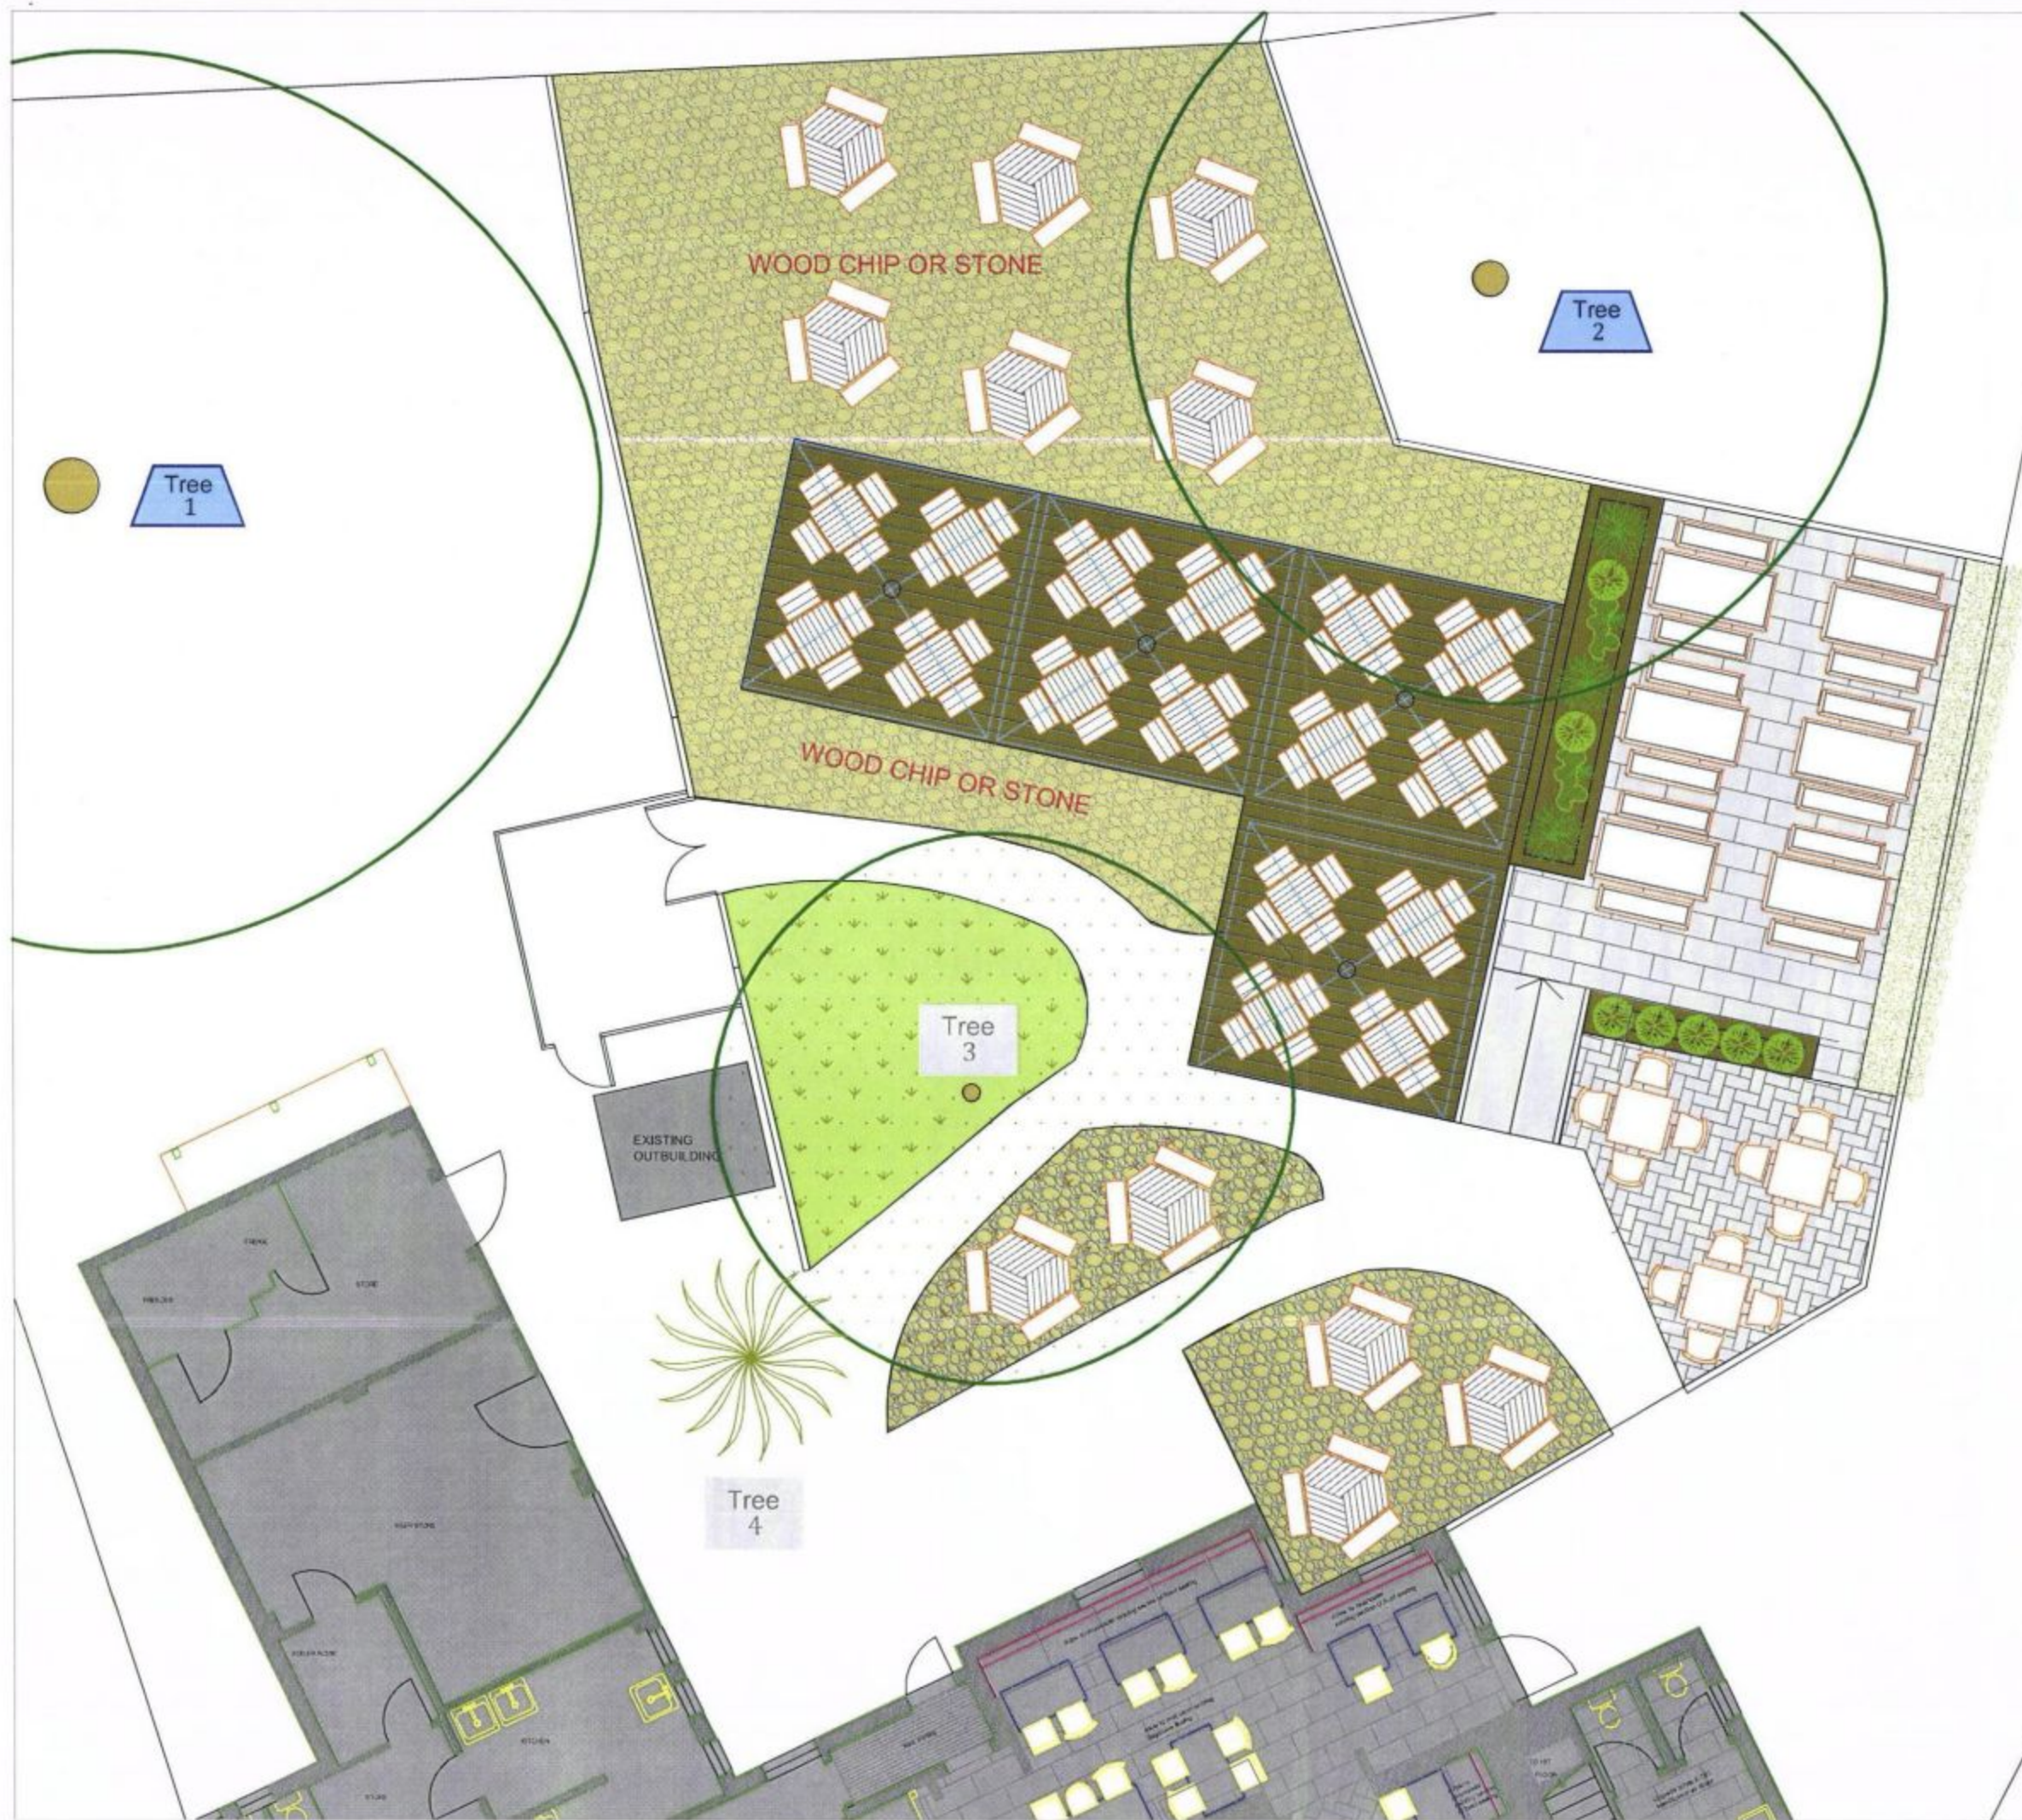
# FINAL LANDSCAPED LAYOUT SW3

This drawing shows the garden layout following completion of the works. As evidenced by the current condition of the lawns, grass is not a practical, durable or attractive surfacing option for the seating areas. Due to the presence of surface roots from T2, there can be no changes to existing site levels where these are found. However, a suitable no-dig solution will be to spread a minimum 50mm settled depth of either clean woodchip or a 20mm loose aggregate onto an underlay of fully porous and air-diffuse Tree-Tex T300 geo-textile available from [www.geosyn.co.uk](http://www.geosyn.co.uk)

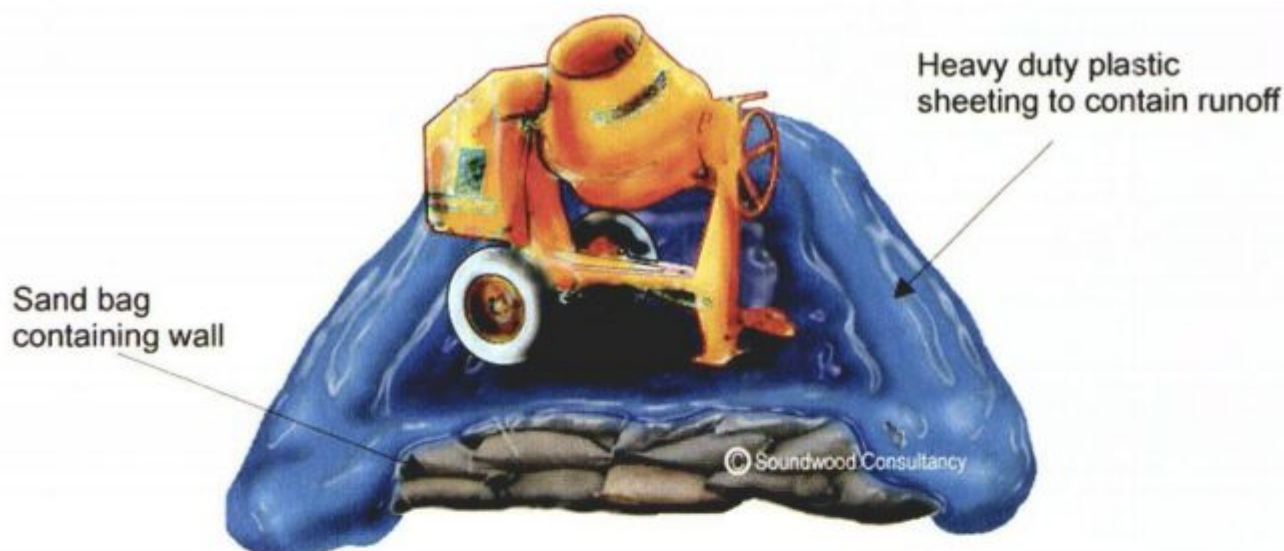
Where there is a high risk of soil contamination from mixing run-off draining into RPAs, heavy-duty plastic sheeting and sandbag walls **must** be used to form a bund to contain spillages - similar to the example drawing below.

Good site husbandry is extremely important and surplus cement **must** be removed at the end of each working day, and any such material dropped onto the ground **must** be immediately collected up and removed and the area thoroughly washed down with clean fresh water. A 25kg sack of cat litter should be kept available to quickly smother and contain accidental fuel or chemical spillages.
