Portsmouth Golf Club, Hampshire  
Aboricultural Report

E328-03

Parkwood Consultancy Services

April, 2012

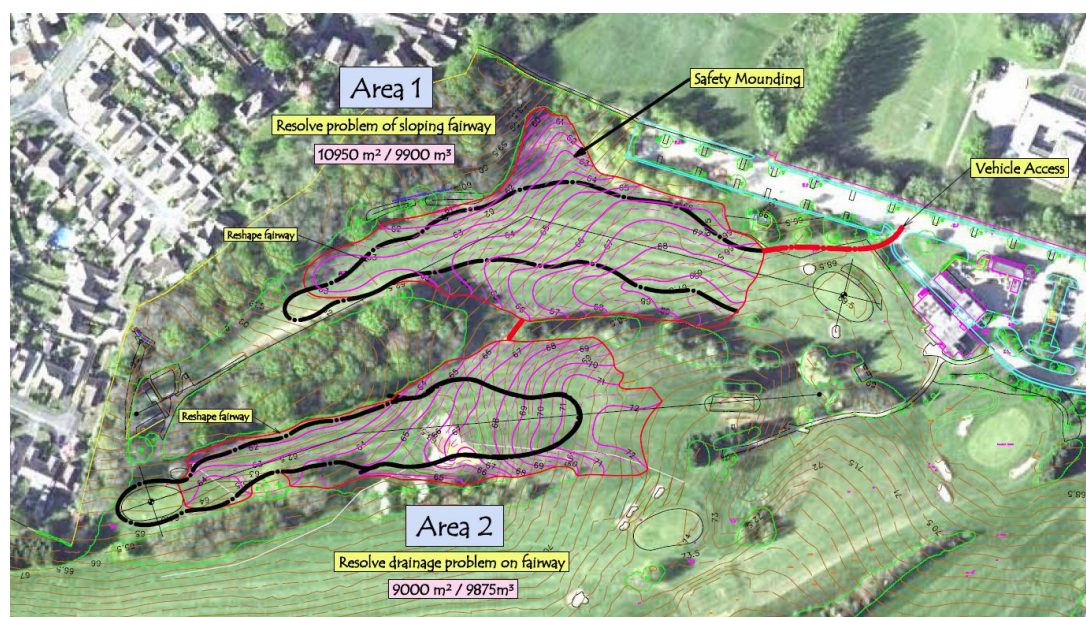
On the site drawing a number of individual English oak trees (*Quercus robur*) at the woodland edges have been identified with a lime green outline:

Under BS5837 Table 1 Cascade chart for tree quality assessment all of the individual trees would be afforded Category A and their Root Protection Areas (referred to hereafter as “RPA”) would be 12 times their stem diameters, which ranged from 590 to 800 mm, to give RPAs with a radius of 7.08m to 9.6m. However, under Natural England’s *Standing Advice for Ancient Woodlands* (referred to hereafter as “SAAW”) there is a requirement for:

**Provided that this buffer strip is implemented then there should be no adverse impact from the proposed development upon the ancient woodland surrounding Areas 1 and 2.**

Therefore, the BS5837 RPA will be overruled in favour of a minimum buffer of at least 15m in width between the edge of the woodland (taken to be the drip line) and the proposed development.
