**Arboricultural Impact Appraisal and Method Statement**  
194A Sea Front, Hayling Island

Date: 25 April 2014  
Ref: 14113-AIA-MW

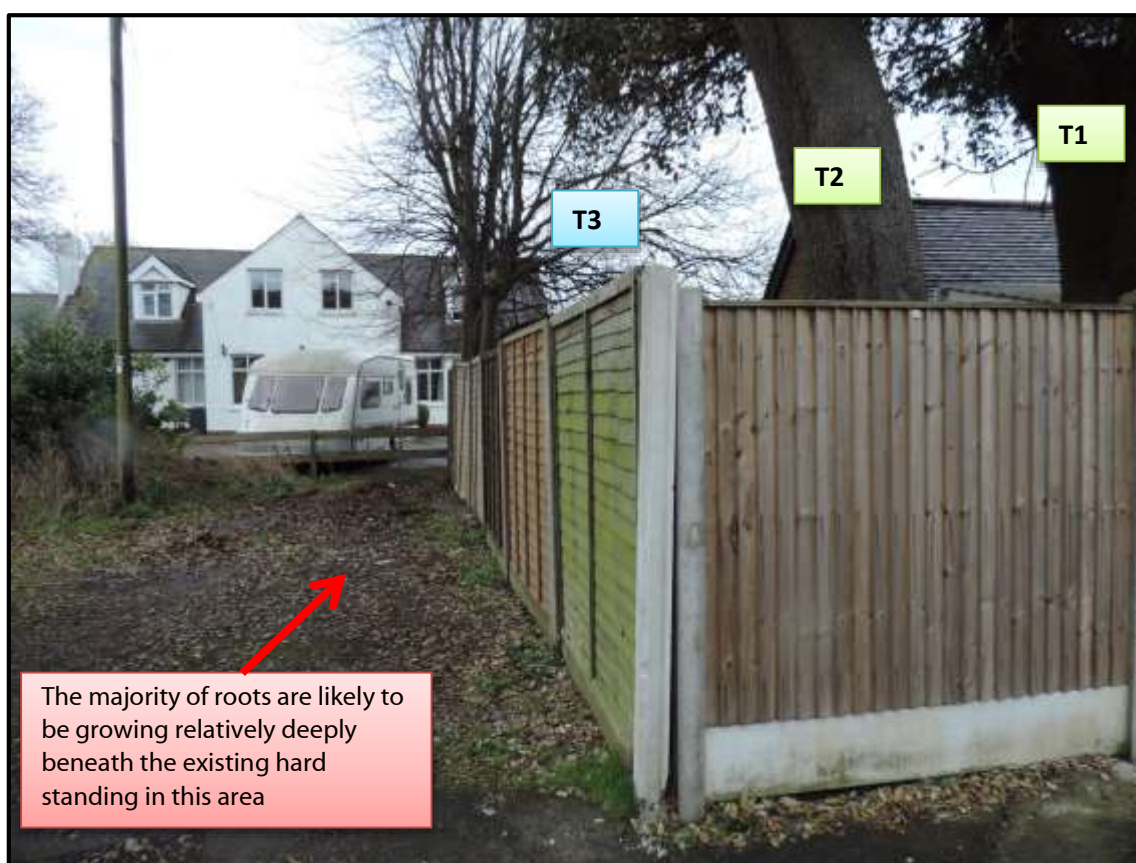
From the provided layout, three trees (T1, T2 and T3) are close enough to be affected by the proposed installation of the garage (Image 1). From my observations, T3 is growing beyond the existing boundary line which is close to the edge of the proposed garage wall (Image 2). However, I believe there is sufficient space to install the foundation without damaging the buttress roots if care is taken during the building works. Furthermore, the majority of smaller feeder and structural roots from these trees are likely to be growing deeply beneath the existing hard standing where the garage is to be located so there is unlikely to be a significant adverse impact on them. Additionally, as a precaution, the architect has designed the base of the floor using a concrete slab foundation to minimise excavation in the RPA. On this basis, if special precautions are applied during the installation of the foundation there is unlikely to be an adverse effect on the health or visual amenity value of the trees. Some of the lower secondary and tertiary branches of T3 extend very close to the proposed garage but either removing these branches or cutting them back would not adversely affect the tree's health or have a significant impact on visual amenity as its profile from public viewpoints would remain unchanged.

**Image 1:** Photo taken looking eastwards towards the area proposed for the new garage

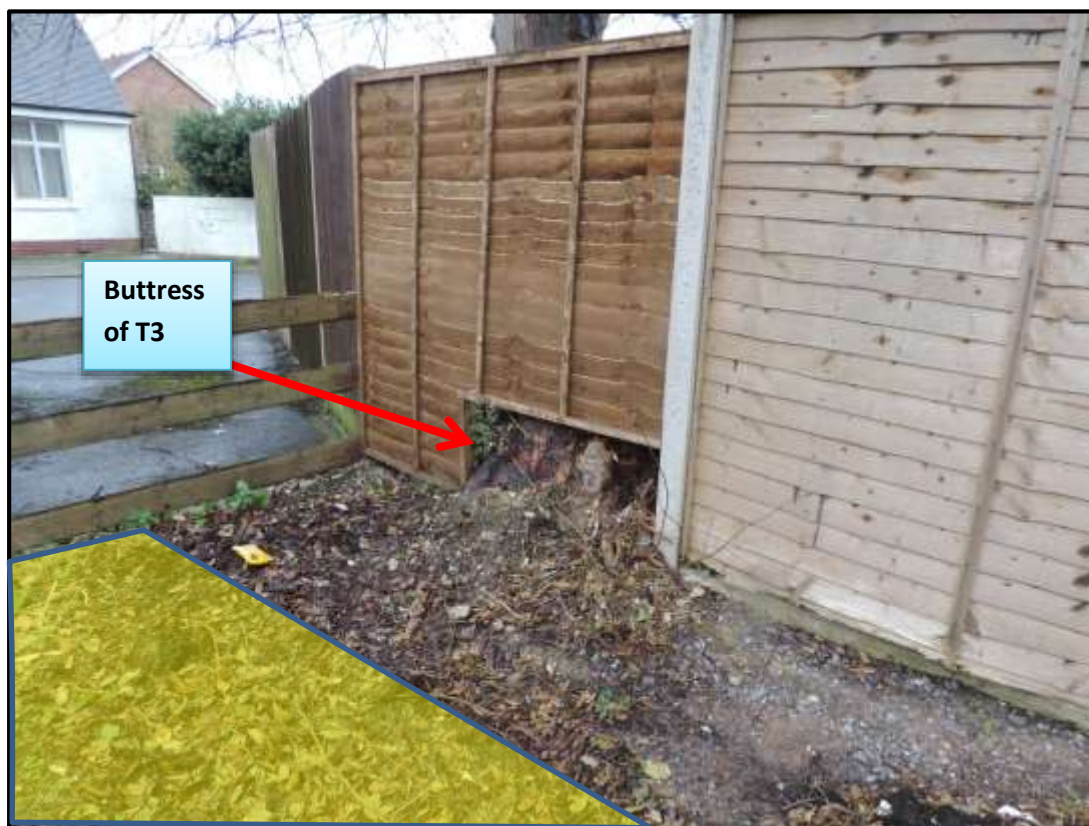
**Image 2:** The buttress of T3 grows beyond the existing boundary line but there is enough space to install the garage. The yellow filled area represents the approximate location of the concrete floor slab next to T3

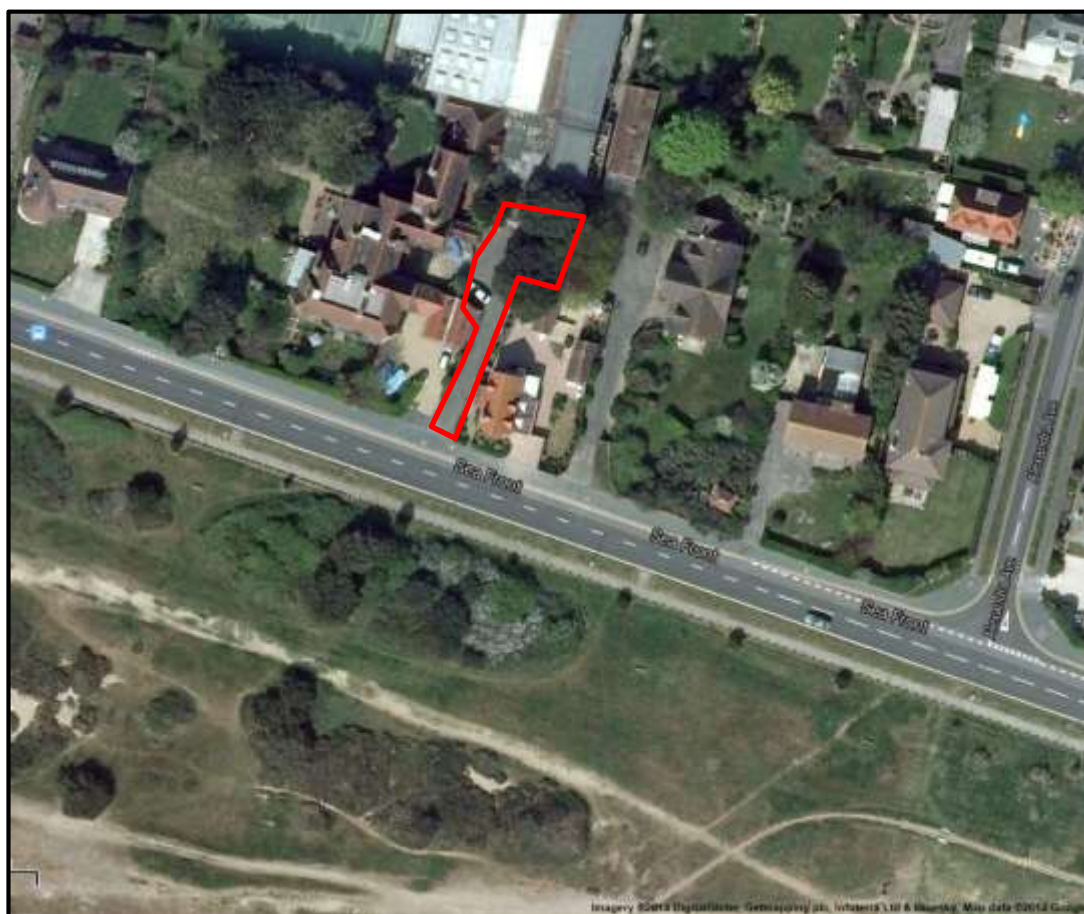
**Image 3:** The site access and area proposed for the new garage is approximately indicated by the red boundary
