**Proposed Development of  
Asda Home Shopping  
Purbrook Way, Havant**

**BS5837:2012  
Tree Survey and Implications Assessment**

**Prepared by EBS on behalf of SEP Ltd**

**Feb 2014**

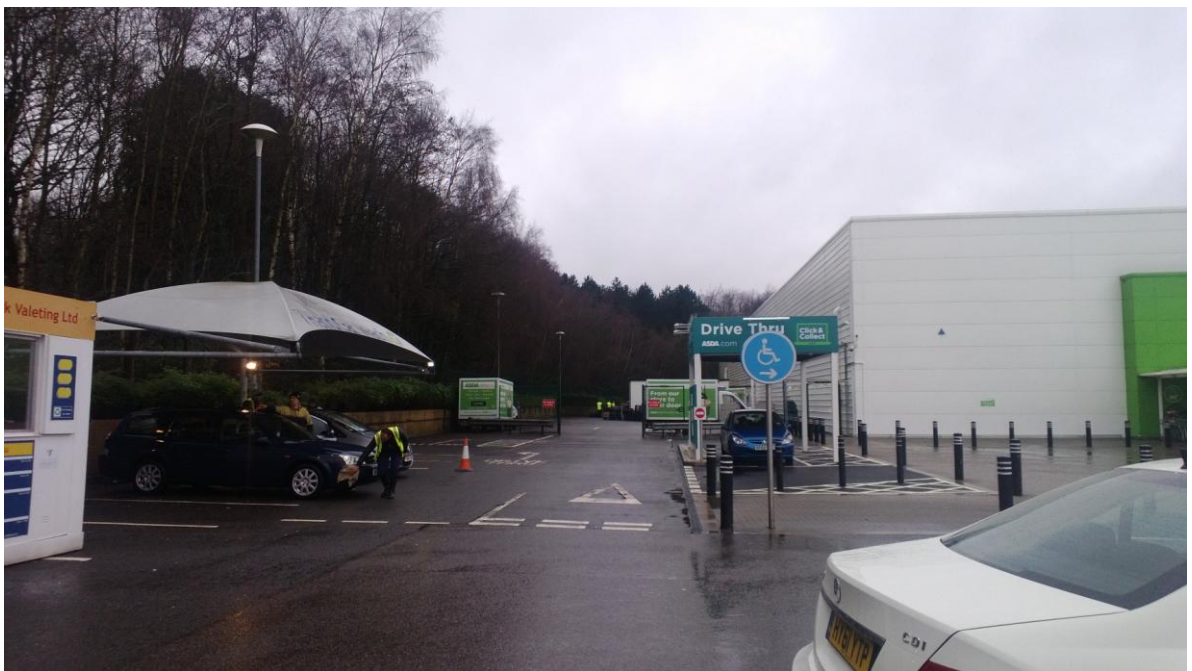
Photo 2. Showing screening of site
