Crayfern Homes

## ARBORICULTURAL STATEMENT

Site:  
Land off Scratchface Lane  
Bedhampton  
Hampshire

**Date:** July 2012

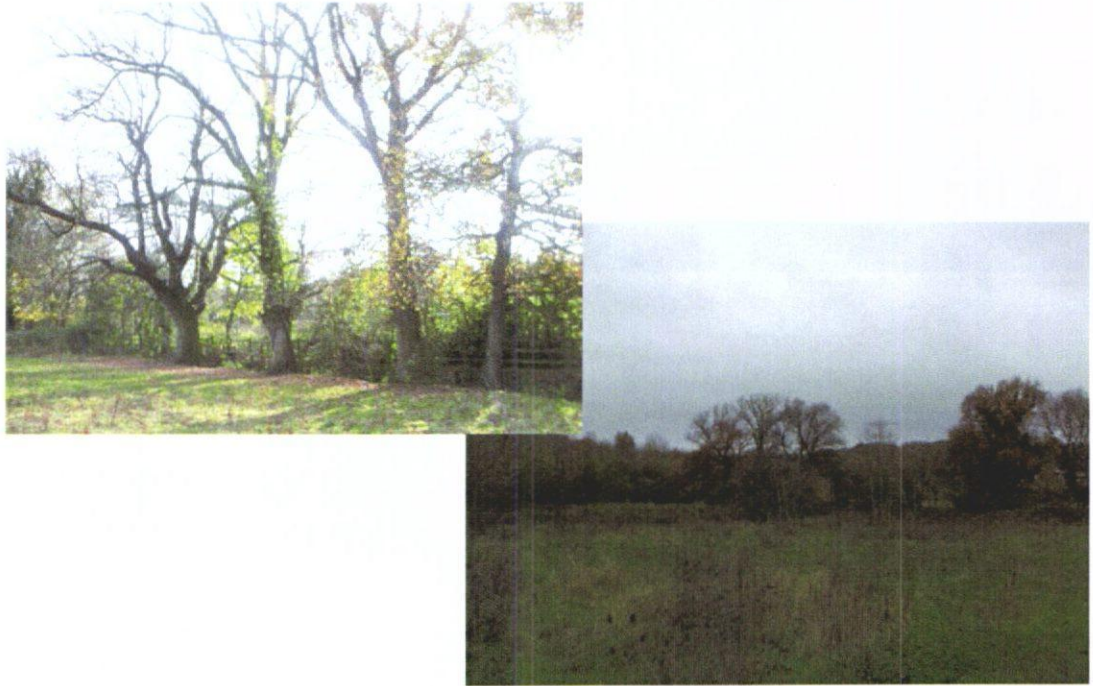
- 3.4 **Photograph 1:** Views of the TPO'd Oaks (Group 1 TPO No: 1934)

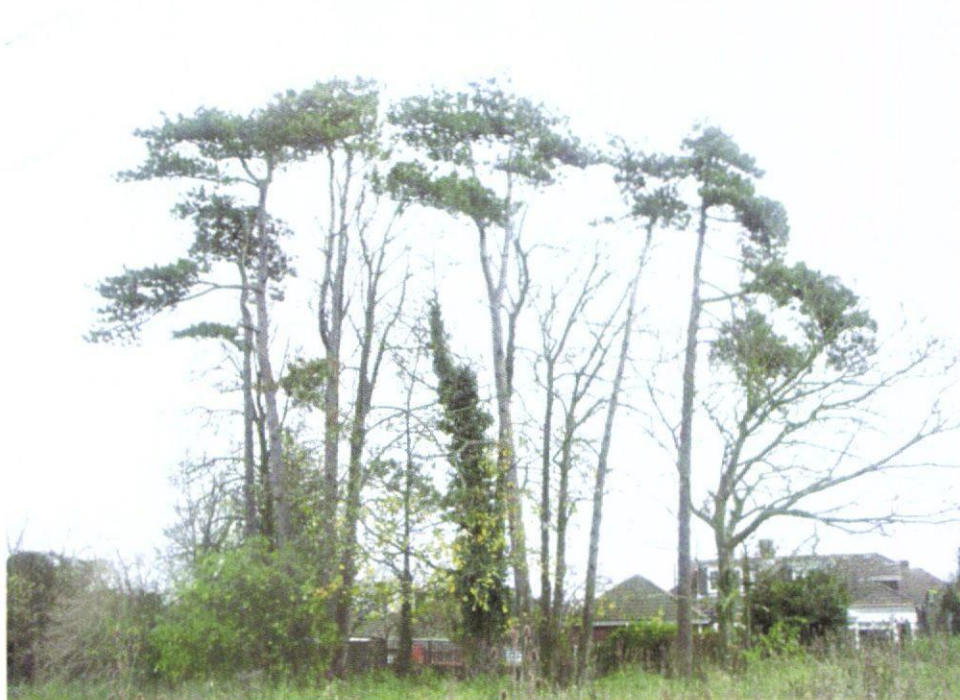
- 3.5 **Photograph 2:** A view of Trees 6-17 (Group 1, TPO No:1755)

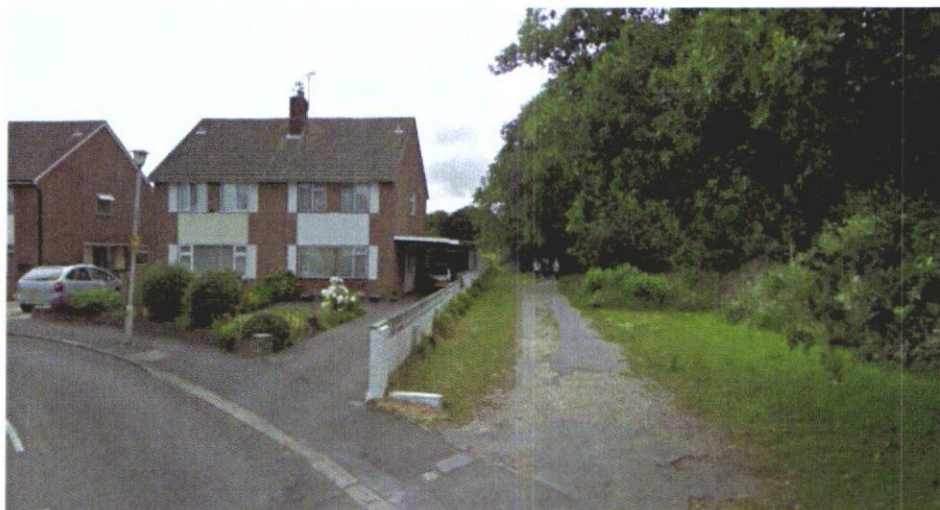
3.6 **Photograph 3:** A view from the East looking West along Scratchface Lane
