**FORBURY, 41 HAVANT ROAD, EMSWORTH, HAMPSHIRE PO10 7JD  
PROPOSED ADAPTATIONS TO STABLE BLOCK**

**HERITAGE STATEMENT**

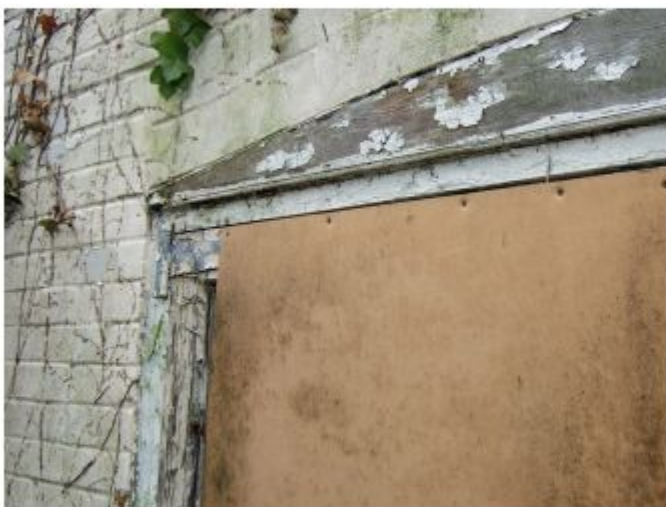
- 3 no. Arched doorways in painted brickwork to south elevation:  
almost flush at approx 20 mm. (see photo below)
  - 2 no. Arched windows in painted brickwork at eaves of south elevation:  
approx 30 mm. (see photo below)
  - 1 no. Window in brick reveals to rubble walling to east gable: approx 100 mm.
  - 1 no. Window in brick reveals to rubble walling to west gable: approx 100 mm.
- It is proposed to retain the latter two windows.

shallow reveal of existing  
arched doorway to south elevation

In summary there are shallow reveal depths at the south painted brickwork elevation and deeper reveals in the brick reveals to rubble masonry elsewhere. The approach taken for the replacement and new windows/doors is to continue the theme by providing deep reveals of approx 100 mm to the new openings (which will all have new brick surrounds) and to improve the theme at the south elevation by setting the frames somewhat further back than their present positions in order to provide a more definite shadow line to aid visual legibility of the archways. To aid this it is proposed to set the arch infill flush with the frames (instead of forward of them) to maximise definition at the curve of the arch.

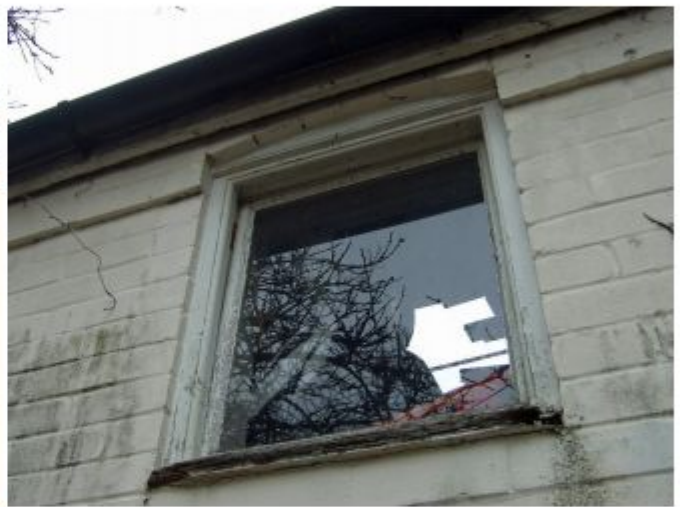
shallow reveal of existing  
arched window to south elevation

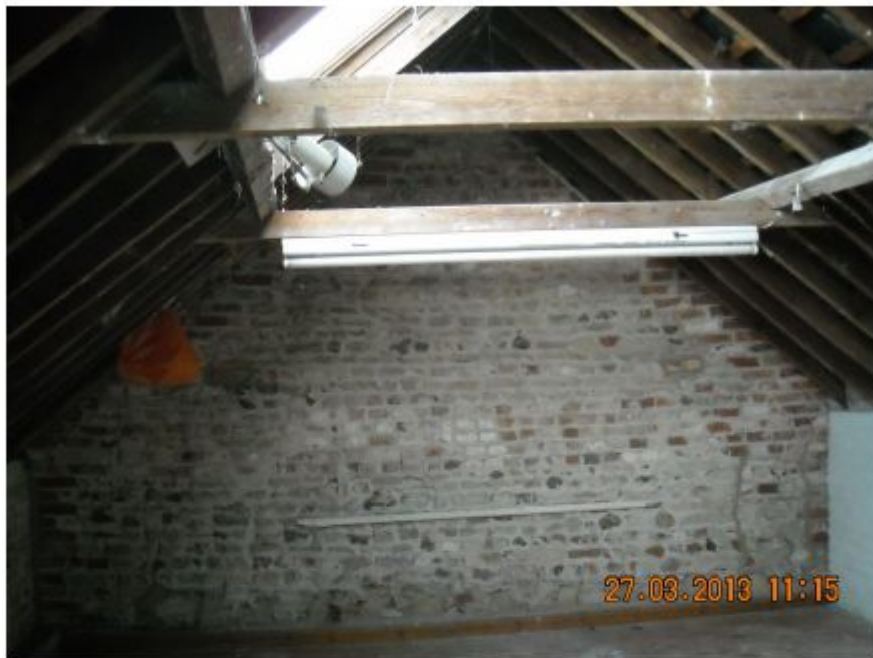
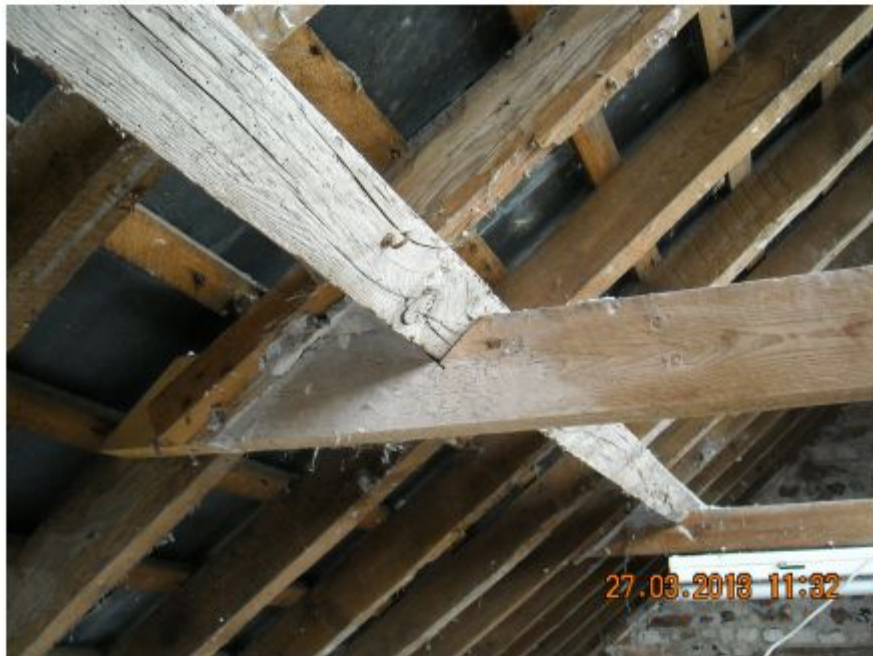
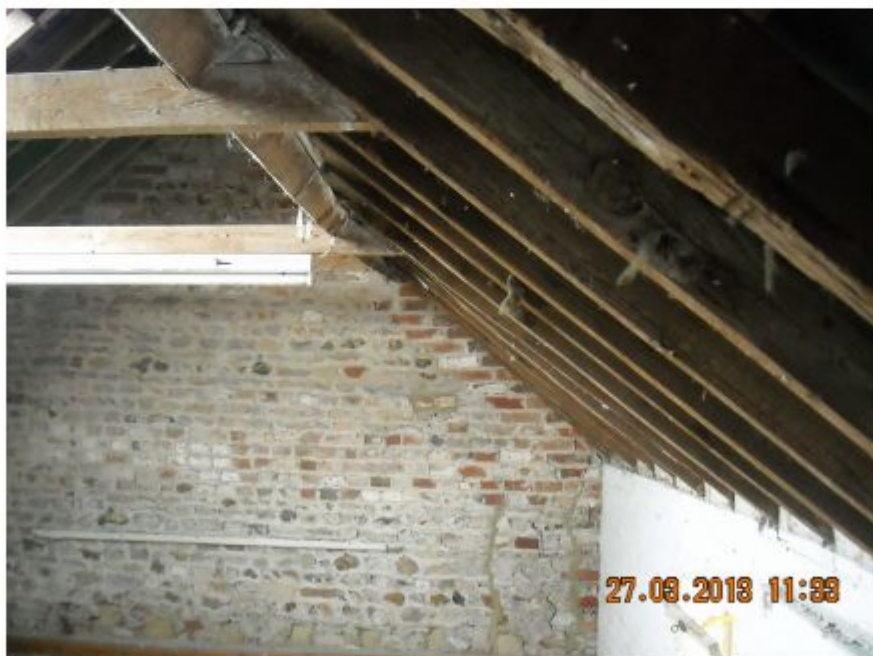
From a structural viewpoint, in its current condition, this roof is structurally inadequate and unstable, which has been clearly demonstrated by the excessive movements which have occurred.

From our brief measurements, the ridge has dropped by between 75-100mm, as have the purlins, the latter of which has caused the rafters to bow excessively.

The rafter feet at both eaves have spread, pushing out the supporting walls by between 75-100mm, causing them to bow along the length of the building.

As the vast majority of the existing roof structure is not original to the date the building was constructed, a third option would be to completely remove it and install new 150x50, C24, timber rafters at 400mm centres, spanning from eaves level up to the ridge.

At ridge level, these new rafters would be supported on a new steel ridge beam, spanning the length of the building between existing gable walls. At eaves level, they would be supported on the existing first floor front and rear walls, where no horizontal loads would be exerted, due to the presence of the new ridge beam.

For the reasons stated above, we would recommend the option of removing the existing roof structure and replacing it with a new, purpose designed roof structure, is adopted.
