**FORBURY, 41 HAVANT ROAD, EMSWORTH, HAMPSHIRE PO10 7JD  
PROPOSED ADAPTATIONS TO STABLE BLOCK**

**HERITAGE STATEMENT**

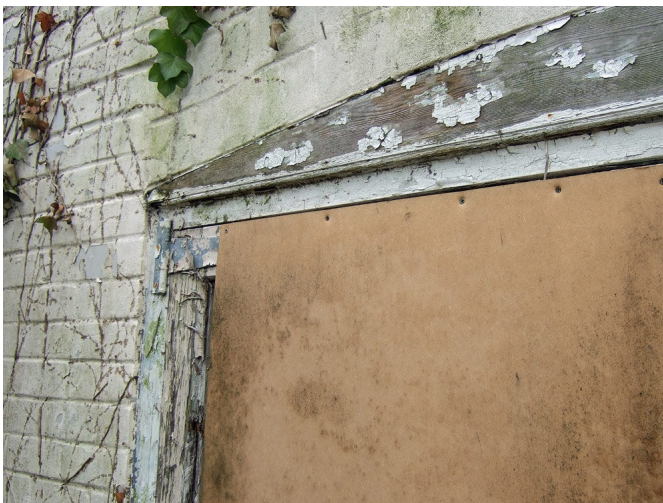
- 3 no. Arched doorways in painted brickwork to south elevation:  
almost flush at approx 20 mm. (see photo below)
  - 2 no. Arched windows in painted brickwork at eaves of south elevation:  
approx 30 mm. (see photo below)
  - 1 no. Window in brick reveals to rubble walling to east gable: approx 100 mm.
  - 1 no. Window in brick reveals to rubble walling to west gable: approx 100 mm.
- It is proposed to retain the latter two windows.

shallow reveal of existing  
arched doorway to south elevation

In summary there are shallow reveal depths at the south painted brickwork elevation and deeper reveals in the brick reveals to rubble masonry elsewhere. The approach taken for the replacement and new windows/doors is to continue the theme by providing deep reveals of approx 100 mm to the new openings (which will all have new brick surrounds) and to improve the theme at the south elevation by setting the frames somewhat further back than their present positions in order to provide a more definite shadow line to aid visual legibility of the archways. To aid this it is proposed to set the arch infill flush with the frames (instead of forward of them) to maximise definition at the curve of the arch.

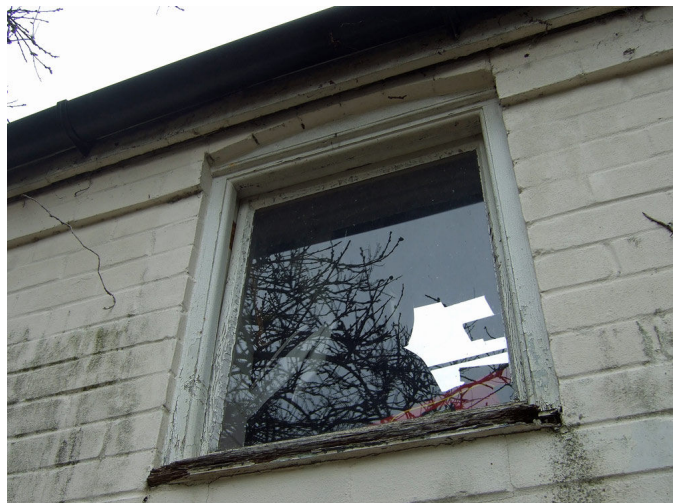
shallow reveal of existing  
arched window to south elevation

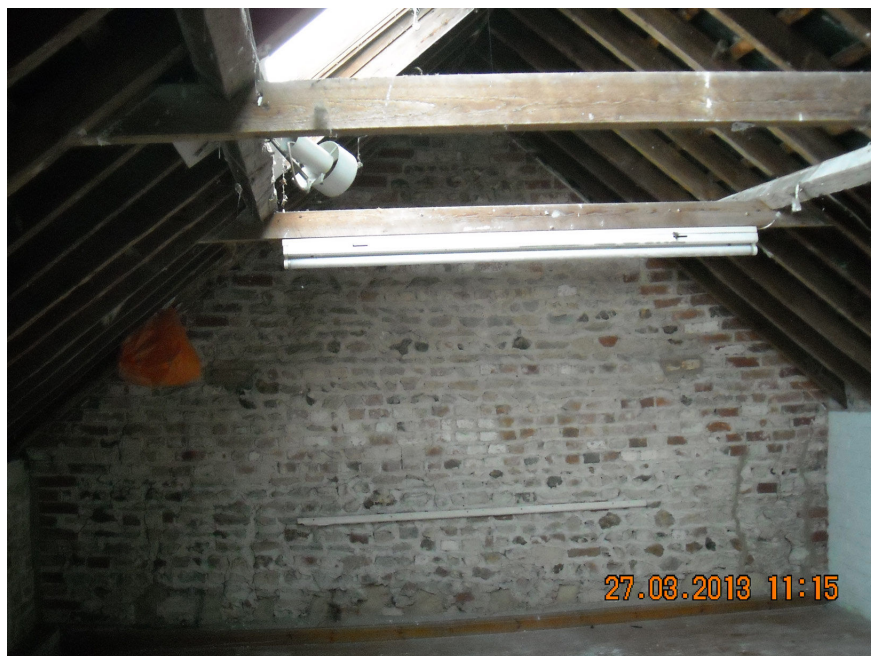
DSCN0251

From a structural viewpoint, in its current condition, this roof is structurally inadequate and unstable, which has been clearly demonstrated by the excessive movements which have occurred.

From our brief measurements, the ridge has dropped by between 75-100mm, as have the purlins, the latter of which has caused the rafters to bow excessively.

The rafter feet at both eaves have spread, pushing out the supporting walls by between 75-100mm, causing them to bow along the length of the building.

For the reasons stated above, we would recommend the option of removing the existing roof structure and replacing it with a new, purpose designed roof structure, is adopted.
