August 2010  
CBA7220

Crayfern Homes

## ARBORICULTURAL STATEMENT

Land off  
Scratchface Lane  
Bedhampton  
Hampshire

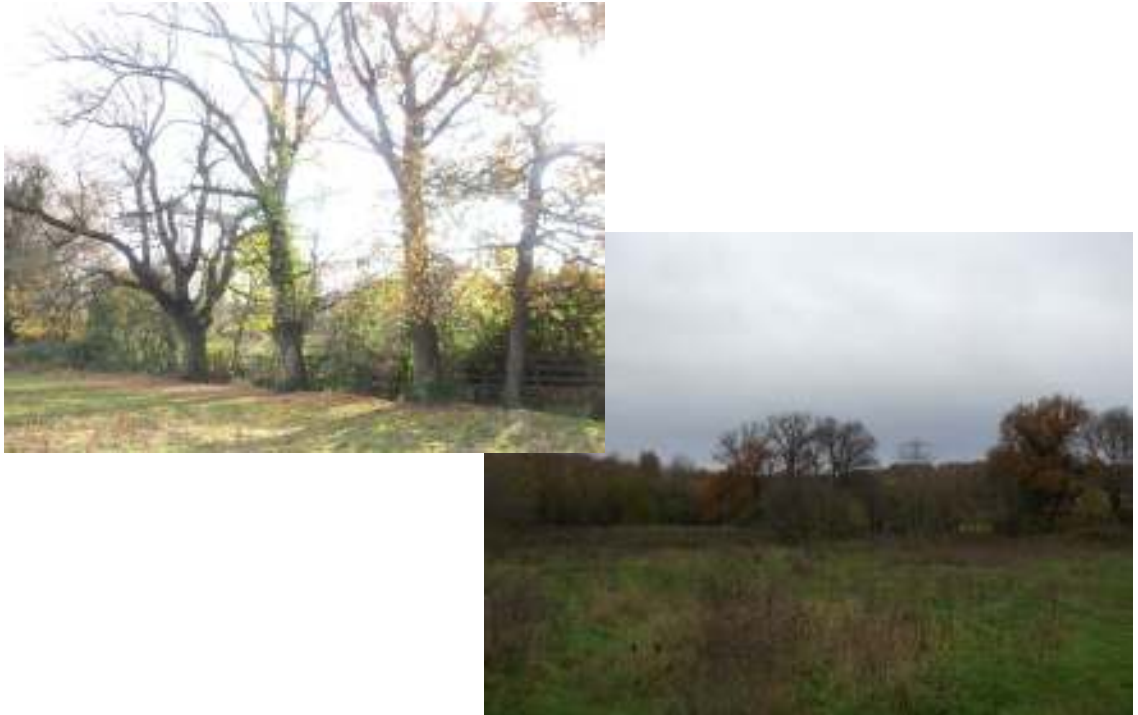
- 3.4 Photograph 1: A view of the TPO'd Oaks (Group 1 TPO No: 1934)

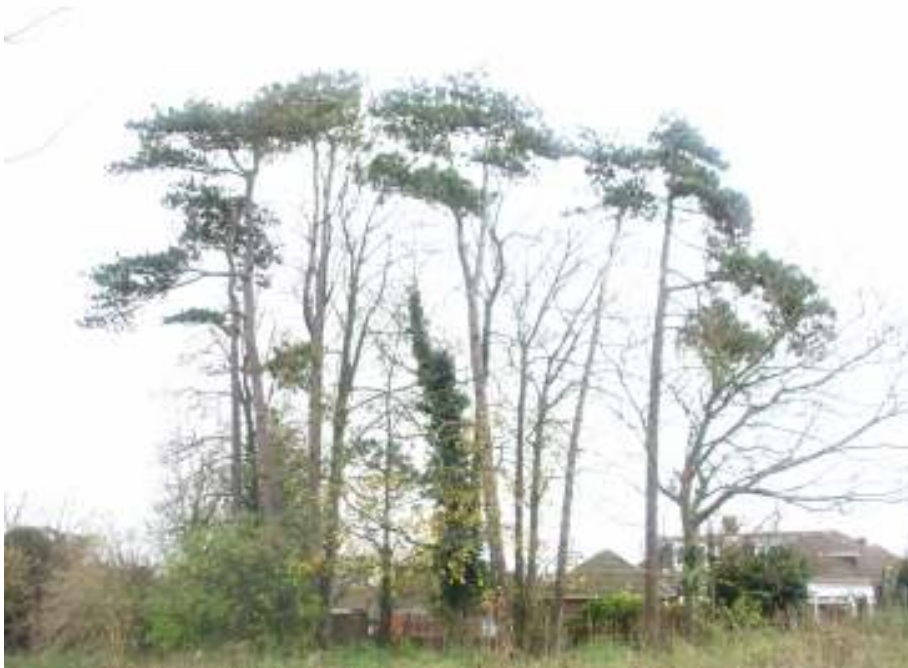
- 3.5 Photograph 2: A view of trees 6 – 17 (Group 1, TPO No:1755)

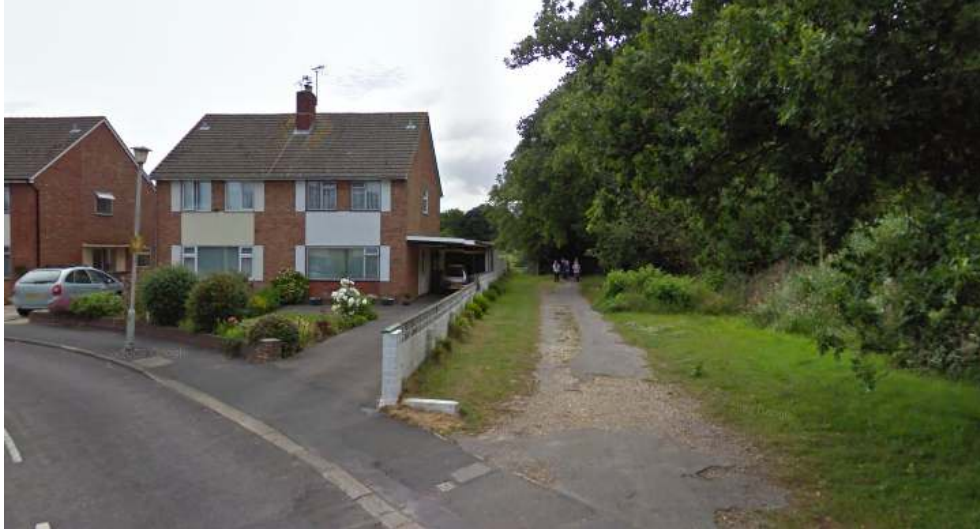
3.6 Photograph 3: A view from the East looking West along Scratchface Lane
