## **ARBORICULTURAL STATEMENT**

Site:  
Land off Scratchface Lane  
Bedhampton  
Hampshire

**Client:** Crayfern Homes

**Date:** July 2012

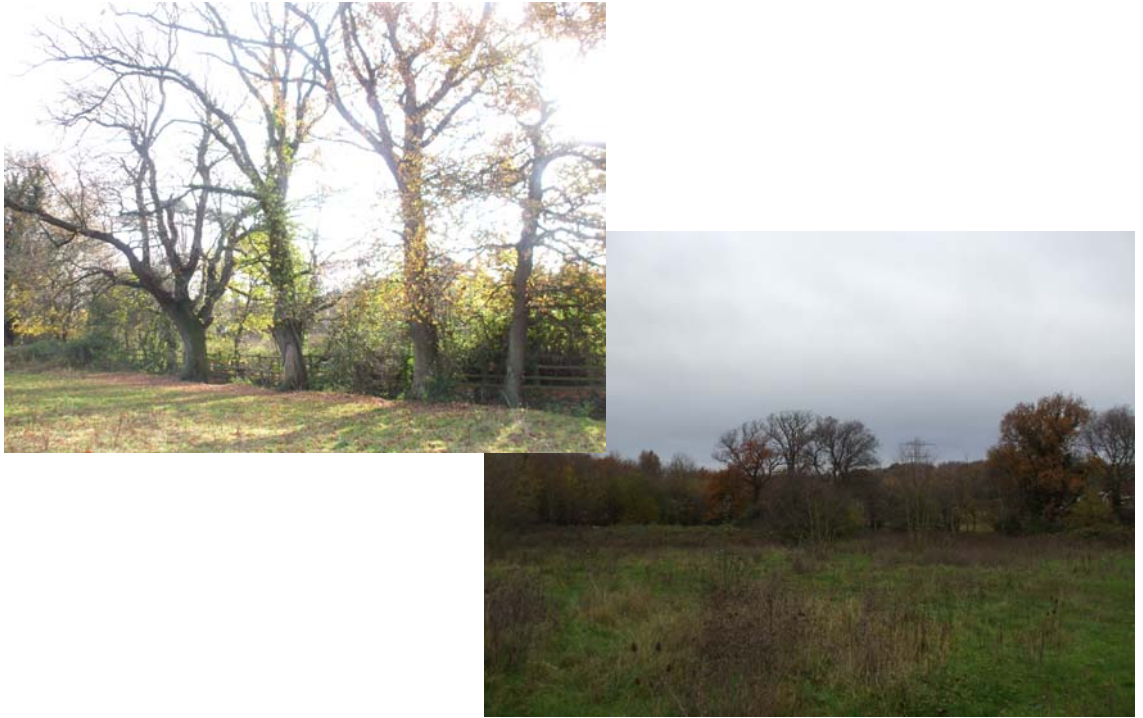
- 3.4 **Photograph 1:** Views of the TPO'd Oaks (Group 1 TPO No: 1934)

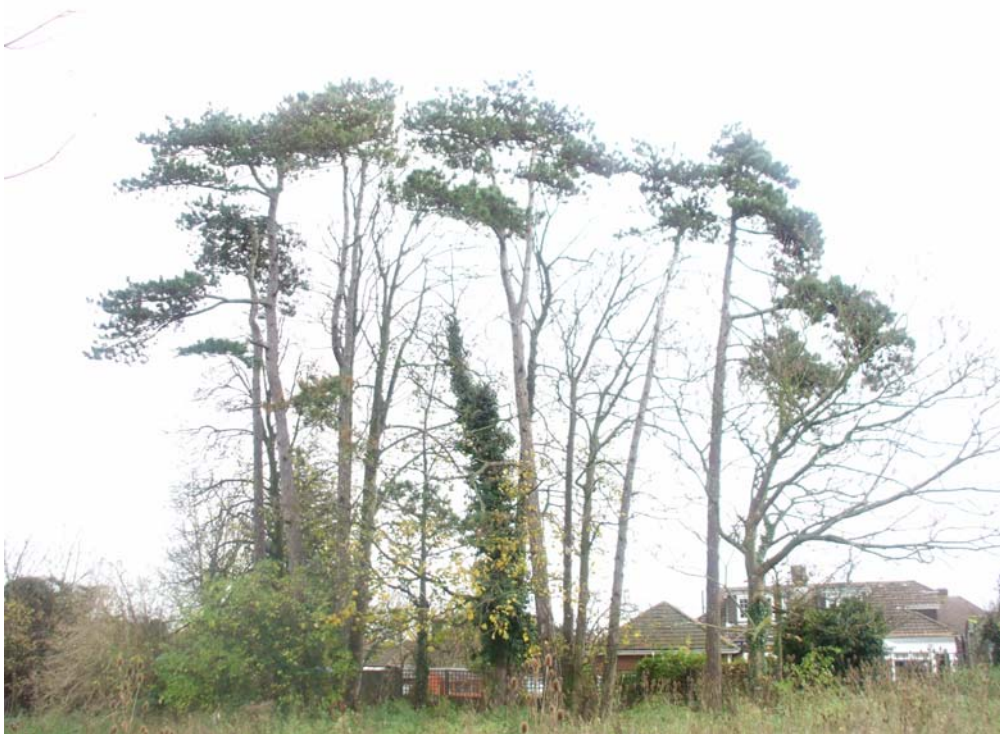
- 3.5 **Photograph 2:** A view of Trees 6-17 (Group 1, TPO No:1755)

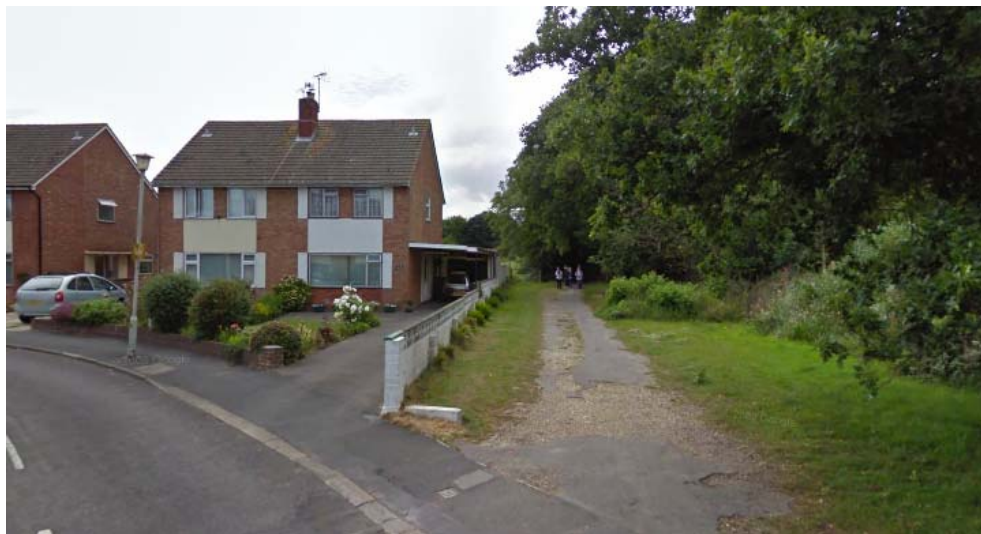
### 3.6 **Photograph 3:** A view from the East looking West along Scratchface Lane
