## **Arboricultural Method Statement**

### **Warblington Footbridge, Havant**

Client: Generator Group LLP

20 August 2012

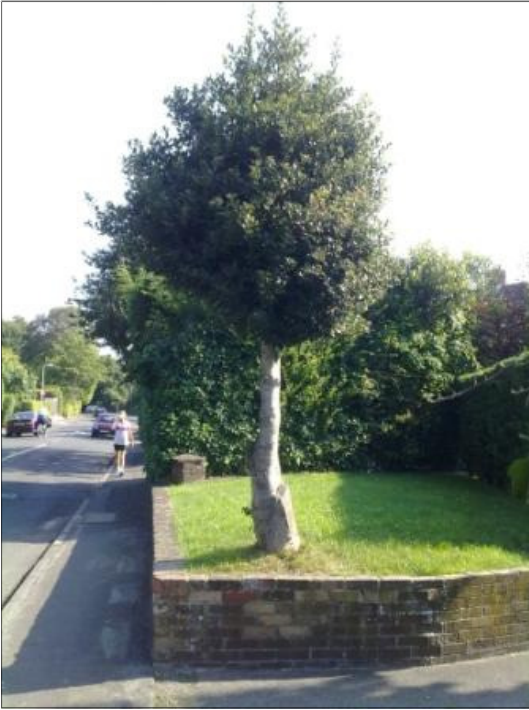
T1 holly

| Ref no | Species | Ht (m) | Stem diam (mm) | No. of stems | Crown spread (m) | | | | 1 <sup>st</sup> sig' branch ht' (m) | Direction of 1 <sup>st</sup> sig branch | Crown base ht' (m) | Life stage | General observations | Preliminary management recommendations | Rem' cont' (years) | Reten' Cat | |
|---|---|---|---|---|---|---|---|---|---|---|---|---|---|---|---|---|---|
| T1 | Holly<br><i>Ilex aquifolium</i> | 3.5 | 150 | 1 | 1 | 1 | 1 | 1 | 1.5 | 1.6 | East | 1.6 | Early<br>Mature | <ul style="list-style-type: none"><li>The tree was inaccessible in private land and therefore all assessments and measurements used were made from a distance.</li><li>The tree was an attractive roadside feature although somewhat diminutive in stature.</li></ul> (Cont'd) | <ul style="list-style-type: none"><li>No works currently identified.</li><li>RPA area = 10.2 square metres (radius = 1.8 metre)</li></ul> | 10-20 | C2 |

| Ref no | Species | Ht (m) | Stem diam (mm) | No. of stems | Crown spread (m) | | | | 1 <sup>st</sup> sig' branch ht' (m) | Direction of 1 <sup>st</sup> sig branch | Crown base ht' (m) | Life stage | General observations | Preliminary management recommendations | Rem' cont' (years) | Reten' Cat |
|---|---|---|---|---|---|---|---|---|---|---|---|---|---|---|---|---|
| T1 | Holly<br><i>Ilex aquifolium</i><br>(contd) | | | | N | E | S | W | | | | | (Contd)<br><ul style="list-style-type: none"> <li>The crown had been lifted repeatedly in the past creating a number of small diameter limb removal wounds and two very large limb removal wounds, the first on the south eastern side of the trunk at approximately 200 mm above ground level and the second on the north western side at approximately 600 mm above ground level.</li> <li>The wood exposed in these wounds was discoloured and there was a small amount of callous growth present around the periphery.</li> <li>Several epicormic shoots were emerging from the clear stem along with a number of basal suckers.</li> <li>The tree was located in a raised grass verge at the side of the road retained by a brick wall.</li> <li>The base of the trunk was approximately 200 mm from the top of this wall at its closest point.</li> <li>It was also considered likely that this damage would increase in the future hence the trees reduced grading.</li> </ul> (contd) | | | |

| Ref no | Species | Ht (m) | Stem diam (mm) | No. of stems | Crown spread (m) | | | | 1 <sup>st</sup> sig <sup>+</sup> branch ht' (m) | Direction of 1 <sup>st</sup> sig branch | Crown base ht' (m) | Life stage | General observations | Preliminary management recommendations | Rem <sup>+</sup> cont' (years) | Reten <sup>+</sup> Cat |
|---|---|---|---|---|---|---|---|---|---|---|---|---|---|---|---|---|
| T1 | Holly<br><i>Ilex aquifolium</i><br>(contd) | | | | N | E | S | W | | | | | (Contd)<br><ul style="list-style-type: none"> <li>The wall in this vicinity contained a small number of cracks and it was considered a possibility that the tree was exerting direct loads on this structure and thereby causing it damage.</li> </ul> | <ul style="list-style-type: none"> <li></li> </ul> | | |

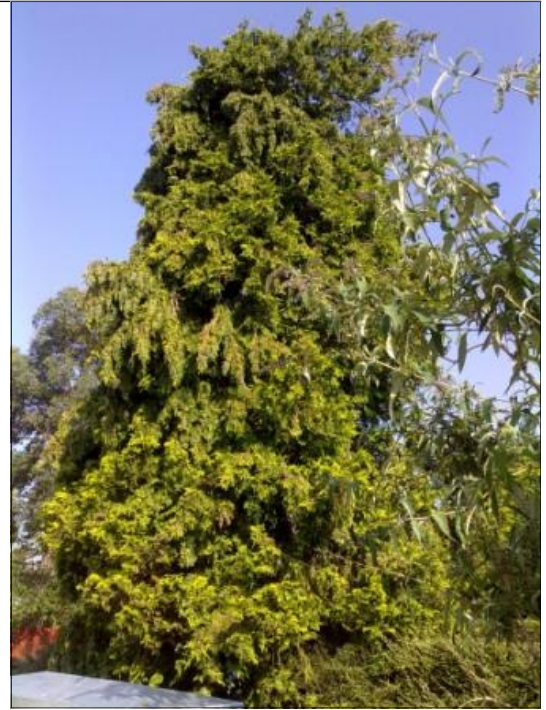
T2 Lawson cypress

- 3.1 T1 is a small holly tree growing in the front garden which has been regularly managed. T2 is a golden Lawson cypress in early maturity. It is 8m high and has a typical pyramidal crown, and from observing from the road, it does not appear to have been actively managed. There are no notable defects visible from the survey point of Southleigh Road, and this species does not usually suffer from naturally occurring structural faults. It has a small crown spread of a radius of 2m reaching down to ground level. This is a very commonly planted tree and provides some visual interest to Southleigh Road. No doubt it is appreciated by the owner as screening between the garden and Network Railway land. Golden Lawson cypress potentially can grow up to 18m tall in good growing conditions, but retains its pyramidal form.

| Ref no | Species | Ht (m) | Stem diam (mm) | No. of stems | Crown spread (m) | | | | 1 <sup>st</sup> sig <sup>+</sup> branch ht' (m) | Direction of 1 <sup>st</sup> sig branch | Crown base ht' (m) | Life stage | General observations | Preliminary management recommendations | Rem <sup>+</sup> cont' (years) | Reten <sup>+</sup> Cat |
|---|---|---|---|---|---|---|---|---|---|---|---|---|---|---|---|---|
| T2 | Lawson Cypress<br><i>Chamaecyparis lawsoniana</i> | 8 | 310 | 1 | 1.5 | 2 | 2 | 2 | 1.7 | West | 0.75 | Early<br>Mature | <ul style="list-style-type: none"> <li>The tree was inaccessible in private land and therefore all assessments and measurements used were made from a distance.</li> <li>The tree was an attractive boundary feature that contributed to boundary screening between the station and the neighbouring property.</li> <li>The tree had significant potential for future growth. However as it was located in a front garden close to a drive it was considered likely that this future growth would bring it into increasing conflict with the neighbouring property as the quantity of tree related debris dropped on the drive and on the parked cars increased with the size of the tree.</li> </ul> | <ul style="list-style-type: none"> <li>No works currently identified.</li> <li>RPA area = 43.5 square metres (radius = 3.7 metre)</li> </ul> | 20-40 | B2 |

| Tree no. | Species | Location | Proposed works | Reason |
|---|---|---|---|---|
| T2 | Golden Lawson cypress | In 43 Southleigh Road, Havant, very close to the southern boundary with Network Railway Line | On the southern side of the crown, cut back the minimum necessary live foliage at a height between 3—4.5m.<br><br>This work will need to be repeated annually | To achieve a reasonable clearance for construction and use of the sloping bridge<br><br>To maintain the distance |

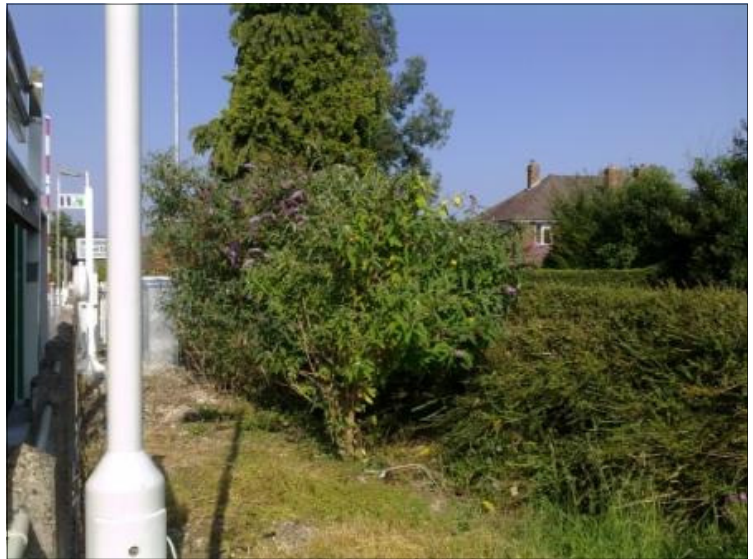
T2 Lawson cypress with S5

6.2 T1 is entirely unaffected. S2—S5 are unaffected. S1 will need to be removed. T2 will need to be slightly cut back mid crown on the southern side, within the green foliage. At this point, the bridge slopes up at about 3-4m in height and will be encased with 1.5m solid sides. This will leave a 'cut out' section at this height on the southern side of the tree. The absolute minimum will be cut back, and it seems likely that all cuts will be within live foliage. The tree's crown will need to be cut back annually in this zone, but can continue above it.
