Portsmouth Golf Club, Hampshire  
Aboricultural Report

E328-03

Parkwood Consultancy Services

April, 2012

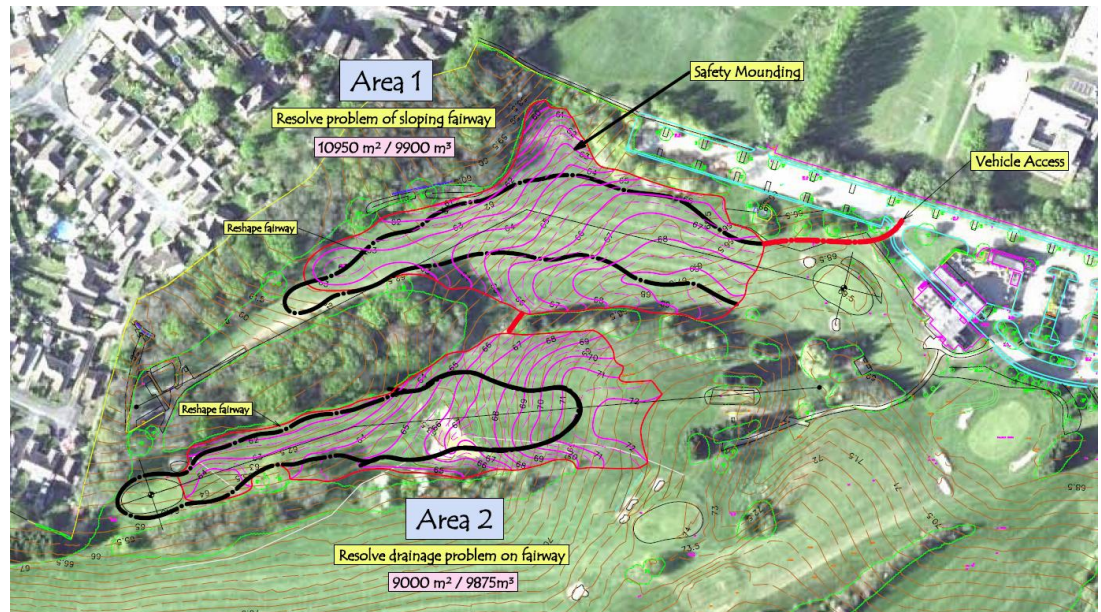
On the site drawing a number of individual English oak trees (*Quercus robur*) at the woodland edges have been identified with a lime green outline:

Under BS5837 Table 1 Cascade chart for tree quality assessment all of the individual trees would be afforded Category A and their Root Protection Areas (referred to hereafter as “RPA”) would be 12 times their stem diameters, which ranged from 590 to 800 mm, to give RPAs with a radius of 7.08m to 9.6m. However, under Natural England’s *Standing Advice for Ancient Woodlands* (referred to hereafter as “SAAW”) there is a requirement for:

Therefore, the BS5837 RPA will be overruled in favour of a minimum buffer of at least 15m in width between the edge of the woodland (taken to be the drip line) and the proposed development.

**Provided that this buffer strip is implemented then there should be no adverse impact from the proposed development upon the ancient woodland surrounding Areas 1 and 2.**

For Areas 1, 2 and 4 the implementation of a 15m buffer strip will help to reduce the risk of damage to the ancient woodland from the proposed development.

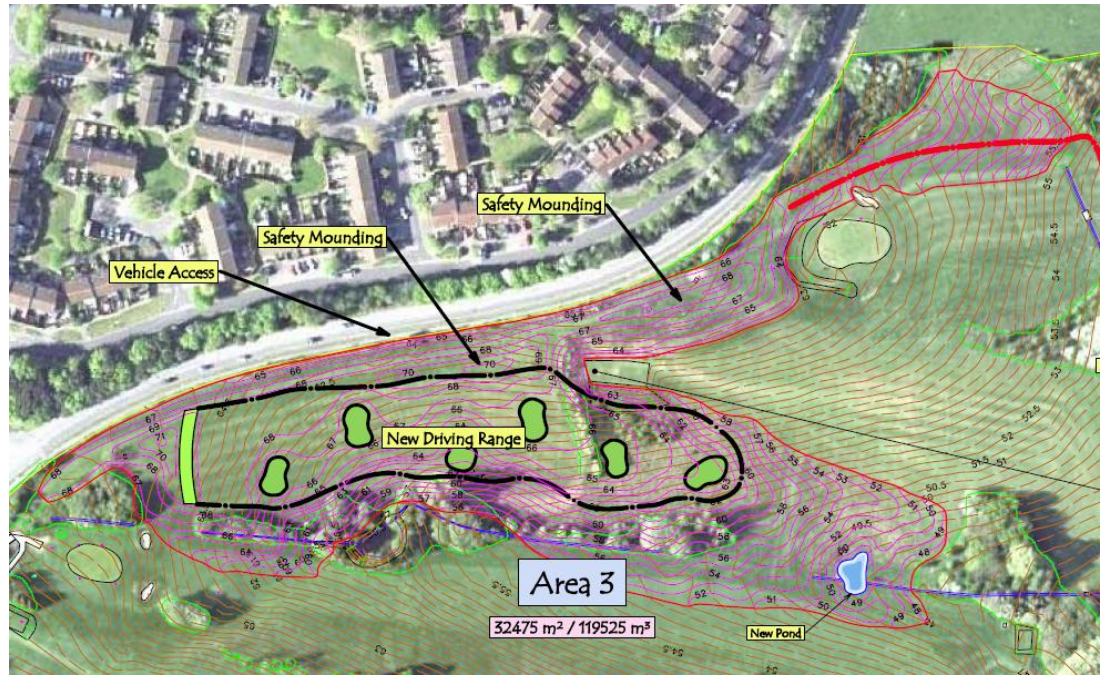
The proposals at Area 3 and 4 are extensive and they appear to have the potential to have a significant arboricultural impact on particular areas of the tree population, including some of the roadside vegetation alongside College Road and the scrub woodland along the northern bank of a drainage ditch bordering the 9<sup>th</sup> fairway.

However, the walkover survey noted that the affected areas contained and supported tree populations that may be considered to be of low value:

- the trees along the boundary to College Road were weak and stunted field maple (*Acer campestre*), hawthorn (*Crataegus monogyna*) or crab apple (*Malus sylvestris*) with the occasional ash (*Fraxinus excelsior*); to the east gorse and broom appear as the planting becomes more naturalised, or as the site becomes colonised by local plants,

- the shelter belt running north south through Area 3 (picked out in lime green on the site drawing) was of young common alder (*Alnus glutinosa*) and crack and white willows (*Salix fragilis* and *S. alba*), stem diameters were around 100 mm,

- the boundary scrub woodland along the northern bank of the drainage ditch to the north of the 9<sup>th</sup> fairway comprised common broadleaved pioneer species of crack and white willows (*Salix fragilis* and *S. alba*), aspen (*Populus tremula*) and white poplar (*Populus alba*) with hawthorn (*Crataegus monogyna*) and blackthorn (*Prunus spinosa*) of no great age.

Therefore I would suggest that appropriate remediation for this element of the development proposal would be the implementation of a considered planting scheme that has been designed, as a minimum, to replace the range of arboricultural values lost during the development, (for example the contribution that the tree cover made toward climate change and to public amenity) and to increase the arboricultural interest of this part of the Course, by the inclusion of locally native large species trees and their associated understorey plants and herb layer.

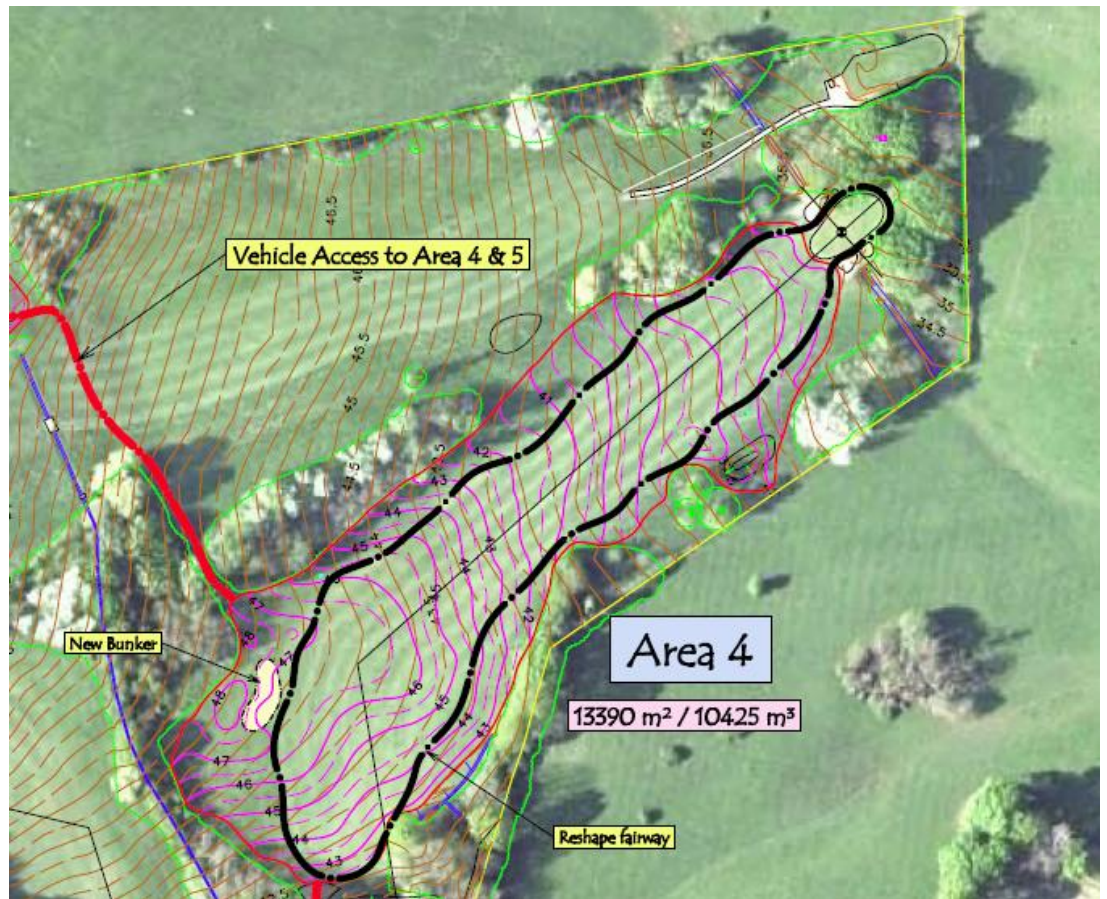
In Area 4 some individual tree outlines are marked out in lime green on the site drawing adjacent to the 6<sup>th</sup> fairway, see also 3.3 above:

Whilst their status as Category A trees under BS5837 would have given their rooting area some protection (an RPA radius twelve times the tree's diameter) it would appear from the site drawing that the development proposals have recognised the principle to maintain a minimum of 15m clearance from these trees, perhaps affording them a value that they do not deserve but none the less providing space for new planting, should this be considered a suitable location by the landscape architect.

The group of mature oaks forming the backdrop to the 6<sup>th</sup> green should not be affected by the development proposal as shown on the site drawing.

**The short term impacts of the proposed development are negative, areas of existing tree cover will be lost.**

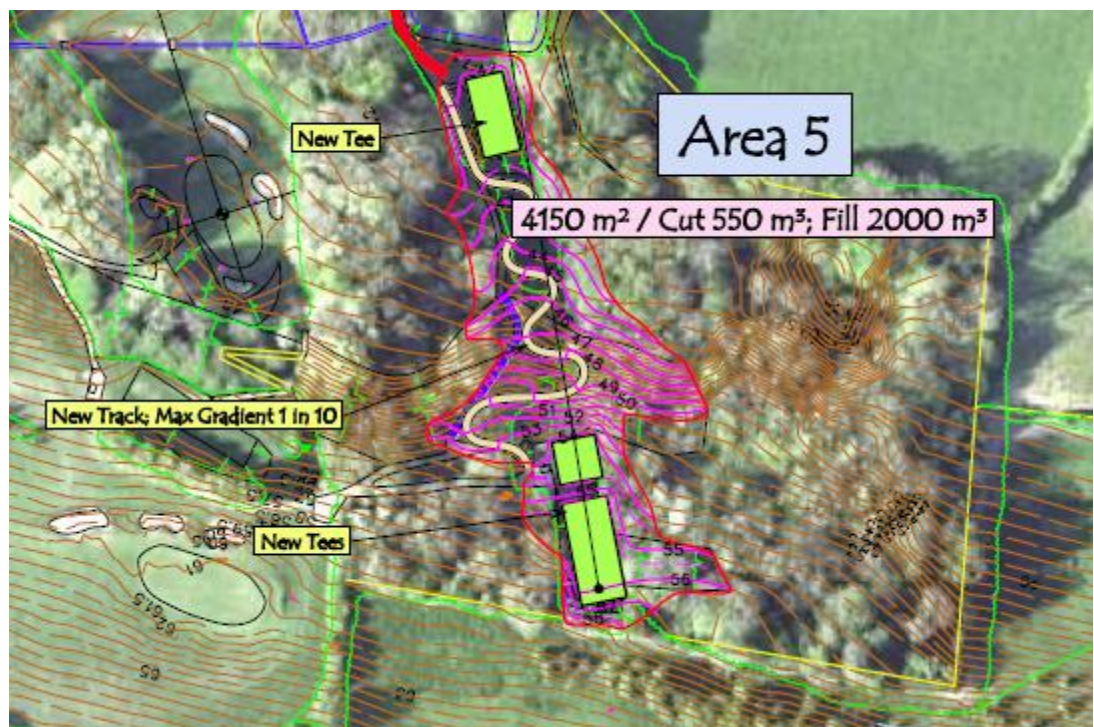
This area is secluded and not overlooked from outside the course and so its public amenity is very limited. Moreover, there was limited arboricultural or silvicultural value in the scrub woodland next to the green and fairway: the area was dominated by elder (*Sambucus nigra*), hawthorn (*Crataegus monogyna*) and other scrub species, the largest standing trees close to the green were poor quality ash (*Fraxinus excelsior*).

The development proposals in this area impact upon 4,150m<sup>2</sup> in the environs to the existing 6<sup>th</sup> tee, out of an area of woodlands estimated to be some 17,500m<sup>2</sup> in total, so less than 25% by area of the woodland is affected by the development proposal.

**The short term impacts of the proposed development are negative, areas of existing tree cover will be lost.**

The recommended primary source of mitigation, outside the scope of this instruction, will be the implementation of a considered planting scheme that has been designed, at the very minimum, to replace the range of arboricultural values and benefits lost during the development, (for example the contribution that the tree cover made toward climate change and to public amenity) and to increase the arboricultural interest of the Course, by the inclusion of locally native large species trees and their associated understorey plants and herb layer.

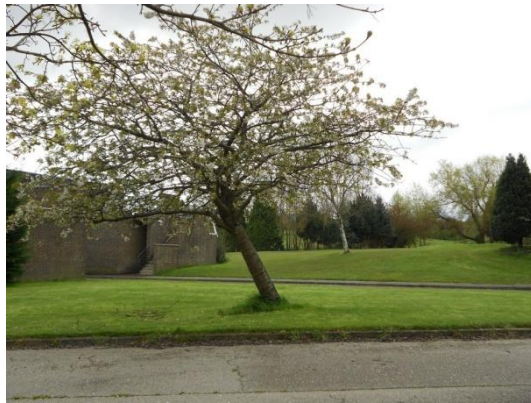
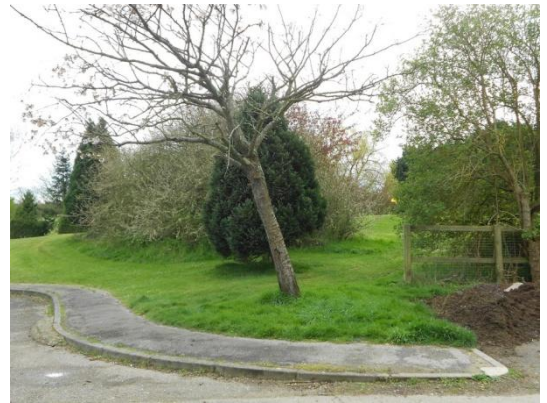
The start of the proposed access route as shown on the site drawing will mean the loss of three poor quality trees, the two leaning flowering cherry (*Prunus* spp.) and a low growing variety of Lawson Cypress (*Chamaecyparis lawsoniana*) illustrated below:

**The short term impacts of the proposed development are negative, as three existing trees will be lost, albeit two are of poor form and condition.**

**New planting will have a positive impact by adding to the range of values and benefits that the tree stock currently provides.**

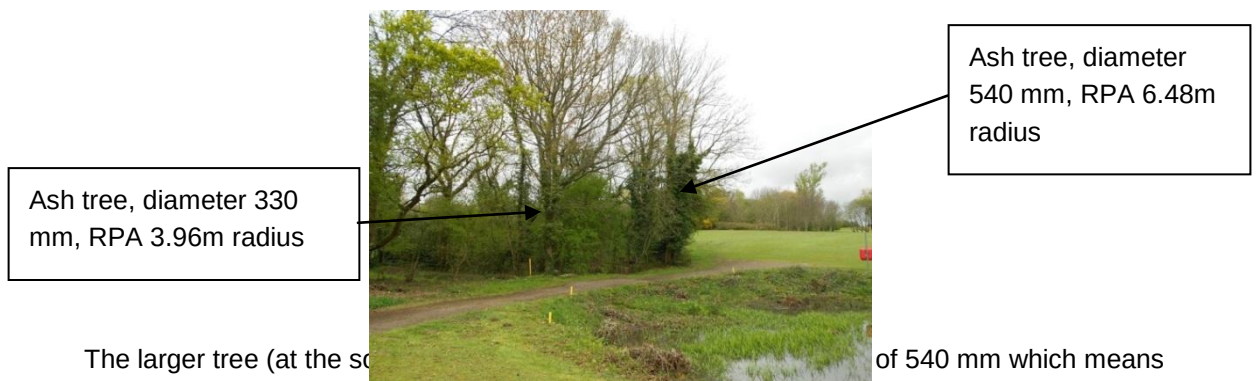
There are two mature ash trees (*Fraxinus excelsior*) close to the line of the only realistic line for the vehicle access from Area 4 to Area 5.

The larger tree (at the south end of the path) has a diameter of 540 mm which means that the minimum radius of the RPA will be 6.48 m, the smaller tree's diameter is 330 mm and so the RPA for that tree is 3.96 m (that tree is sited immediately north of the drainage ditch feeding the pond).

In each case care should be taken to protect the RPA, ideally no vehicle traffic will be allowed within the RPA but if that cannot be achieved then measures will need to be put in place to spread the load of any vehicular traffic crossing the RPA. The load may be spread by the installation of a temporary sub-base for the access track formed from a suitable granular fill material (such as no-fines gravel, washed aggregate, or cobbles) which does not inhibit vertical gaseous diffusion, contained within a cellular confinement system laid at ground level.

For the access route from Area 4 to 5, provided that the traffic can be kept outside the RPA then a simple traffic management plan will help to reduce the risk of damage to the tree populations from the proposed development. However, if the RPA has to be crossed by vehicles then measures to spread the load of any traffic within the RPA will be required to be put in place.
