## Arboricultural Impact Appraisal and Method Statement

*St Michaels Convent, Waterlooville*

Date: 12 July 2012  
Ref: 11373-AIA3-PB

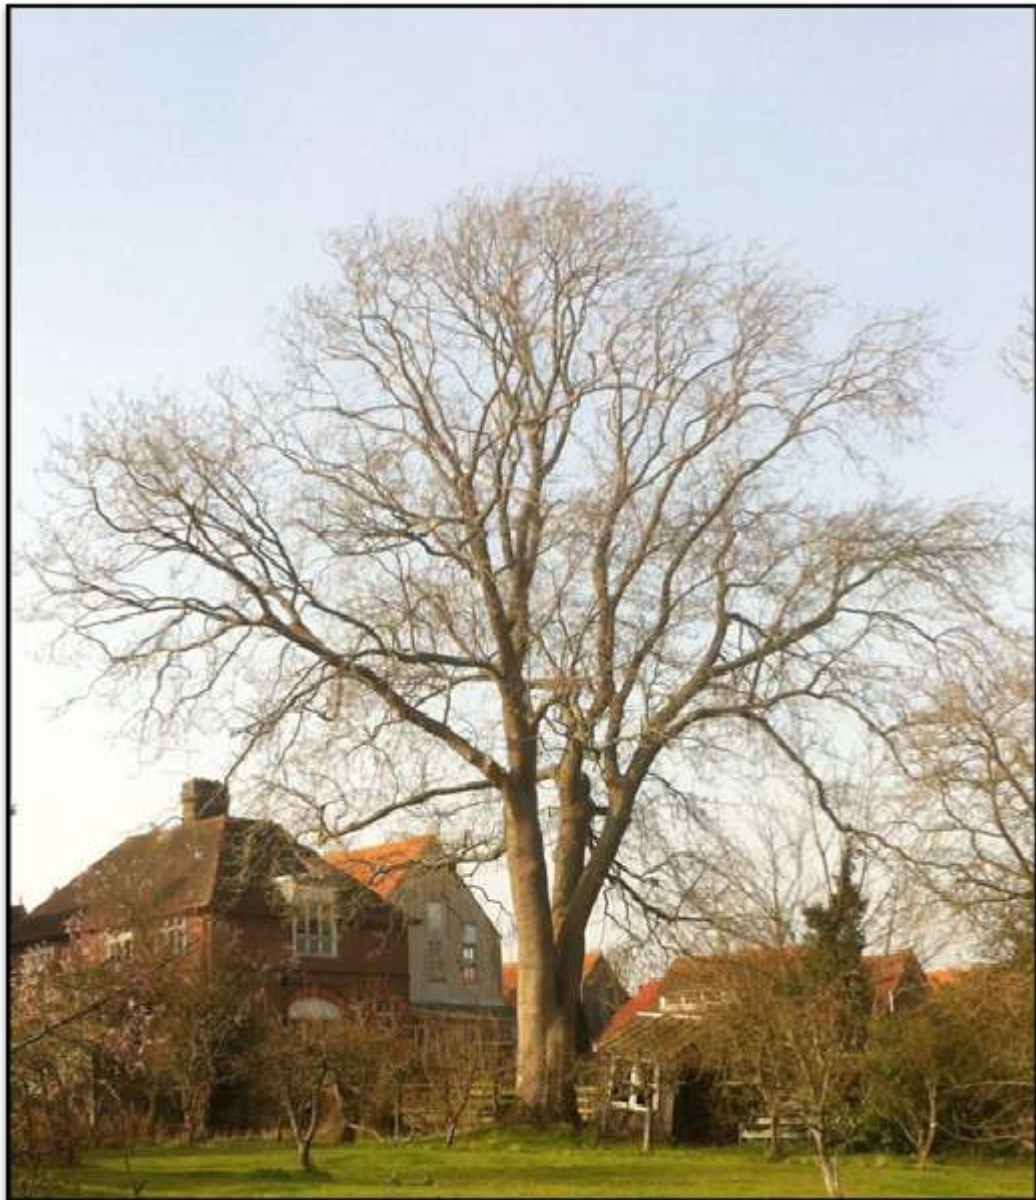
- **Tree 41:** This category B tree is not an outstanding individual due to its advanced maturity, twin stemmed nature and the presence of a wood decaying fungal pathogen within its lower stem area. This pathogenic presence is likely to significantly decrease the time over which this tree can be sustainably retained. As such it is concluded that the current constraint posed by the tree should not influence the planned redevelopment, however, suitable mitigation via the landscape plan should be put in place to compensate for the loss of what is currently a large and prominent tree. At the time of my visit photos were taken of this tree and a selection follow:

**Photo 1:** Distance view of tree 41 highlighting its twin stemmed nature with a further major stem division at approximately 6m

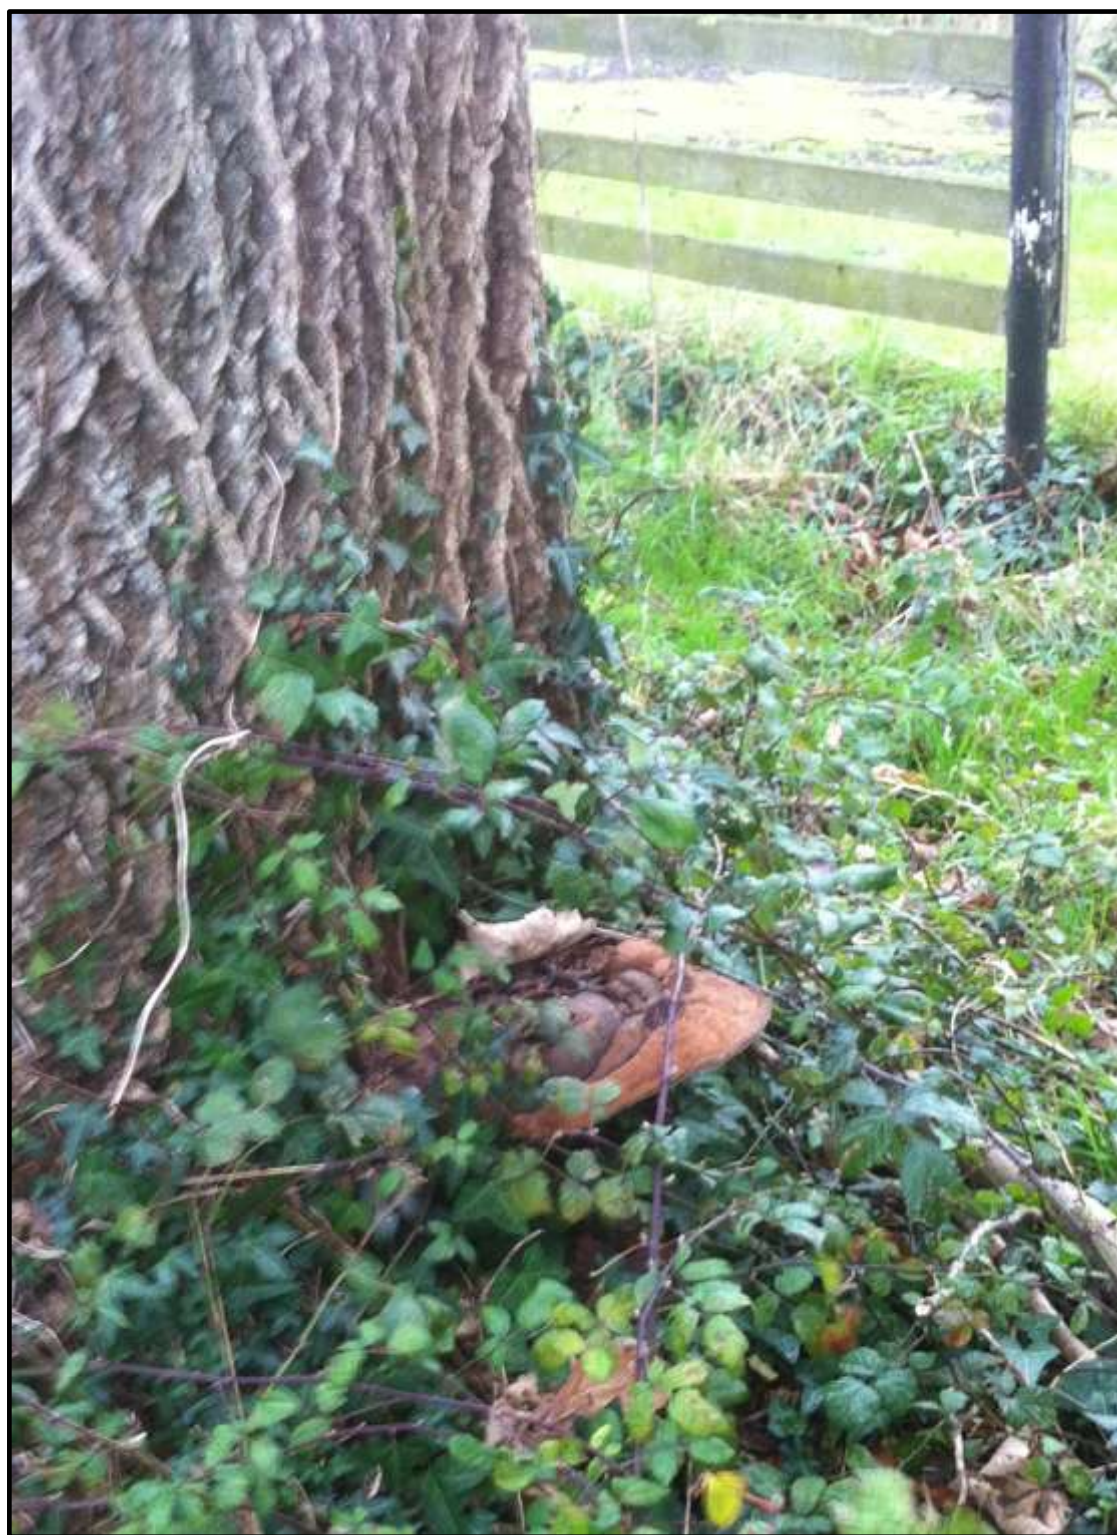
**Photo 2:** Close up detail of bracket fungus (*Ganoderma* sp) observed at the base of tree 41 (southern side).

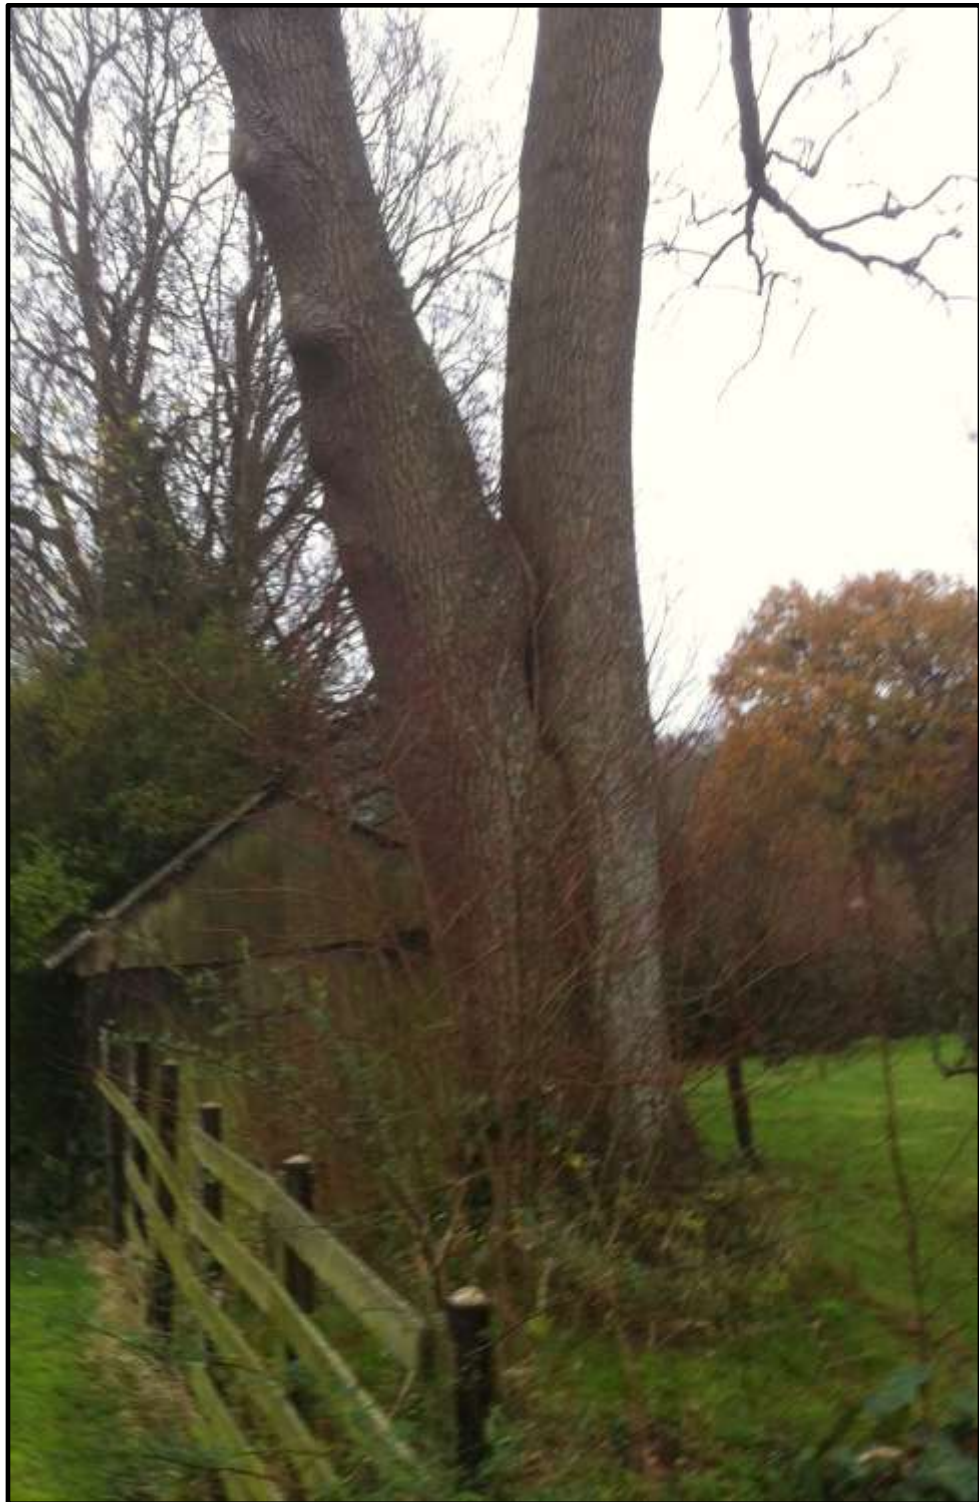
**Photo 3:** View of tree 41 from northern aspect, highlighting twin stemmed nature
