Both my wife and I received letters dated 16<sup>th</sup> March 2023 from the Planning Service giving your name as case officer in relation to our next door neighbour's Planning Proposal: Listed Building Consent for partial demolition and reconstruction of existing boundary wall to listed dwelling (Ref: APP/23/0173).

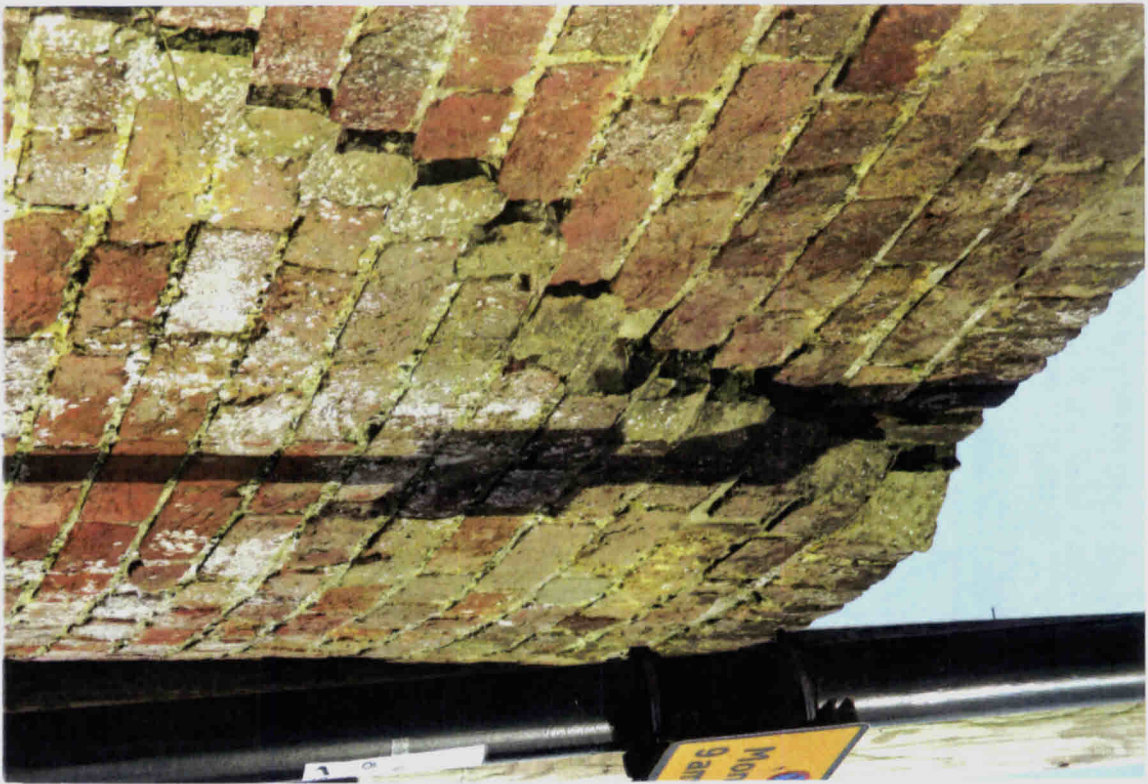
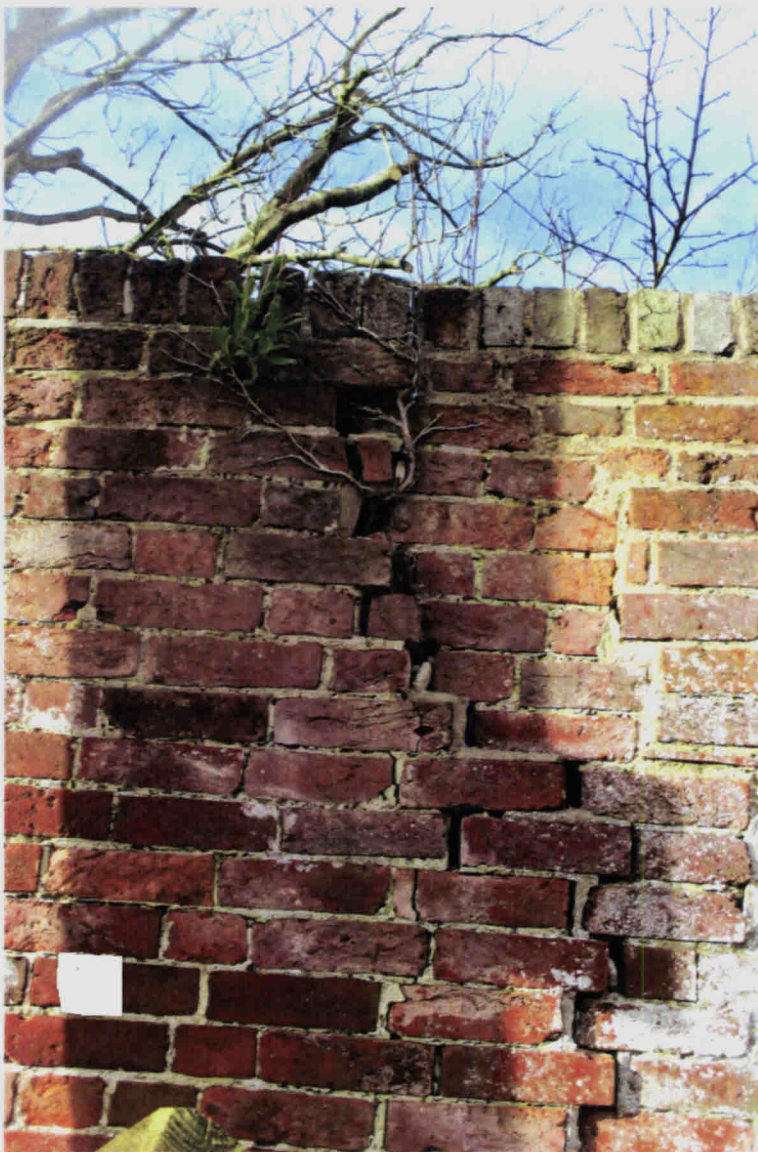
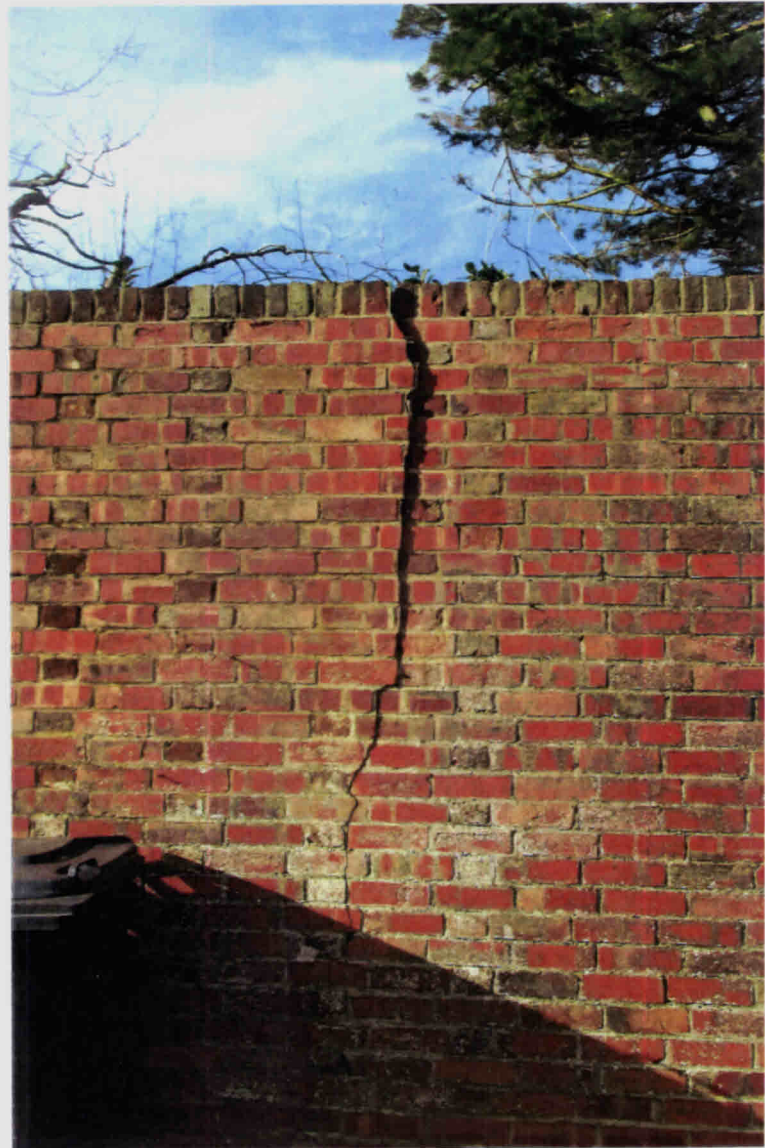
This advice dates back to the period just prior to our purchase of [REDACTED] after we had the property inspected on 8<sup>th</sup> January 2021. An RICS surveyor's report was produced dated 14<sup>th</sup> January 2021 which stated that 'There is a long driveway leading to the property which has a brick boundary wall. This wall leads all the way round to the side of the property and there are several significant vertical cracks to this wall which will require further investigation and remedial works in due course'. Photographs of these cracks were taken by

- 1) The cracks in the wall between the large Cypress tree (Macrocarpa spp) and the telegraph pole at the King Street Road end of the [REDACTED] driveway have widened substantially

Photographs taken April 2021 - cracks have increased since then.

4) We propose that on safety grounds the planning permission currently applied for should be extended to allow adequate foundations to be installed. The sections of the wall, referred to above in point 3), should be similarly reconstructed. This would create a safe boundary wall along the drive and also around the front garden of [REDACTED]. The Cypress tree (probably Cupressus macrocarpa) is likely to increasingly threaten the safety of a reconstructed wall and we feel that it should be removed. The trunk is very close to the wall and its roots must be substantially undermining it. I [REDACTED] was employed for over 30 years in the Plant Sciences Division of the School of Biosciences at the University of Nottingham and while not claiming to be an expert on this species, I can see from the Wikipedia entry, that trees of Cupressus macrocarpa have 'been recorded at over 40m (130ft) tall and 3m (9.8ft) in trunk diameter.' An alien tree, originating from California and Oregon, which is already well on the way towards potentially attaining these dimensions, should not be recklessly allowed to continue to grow next to a 10ft high wall which has been deemed by a Structural Engineer to '**pose a risk to the general public**'.
