Barn B, Lords Wood Barn, Petworth, West Sussex, GU28 9BS

**Ref: P4814 78 Havant Road, Emsworth – Potential Roost Feature (Tree Climbing) Inspection**

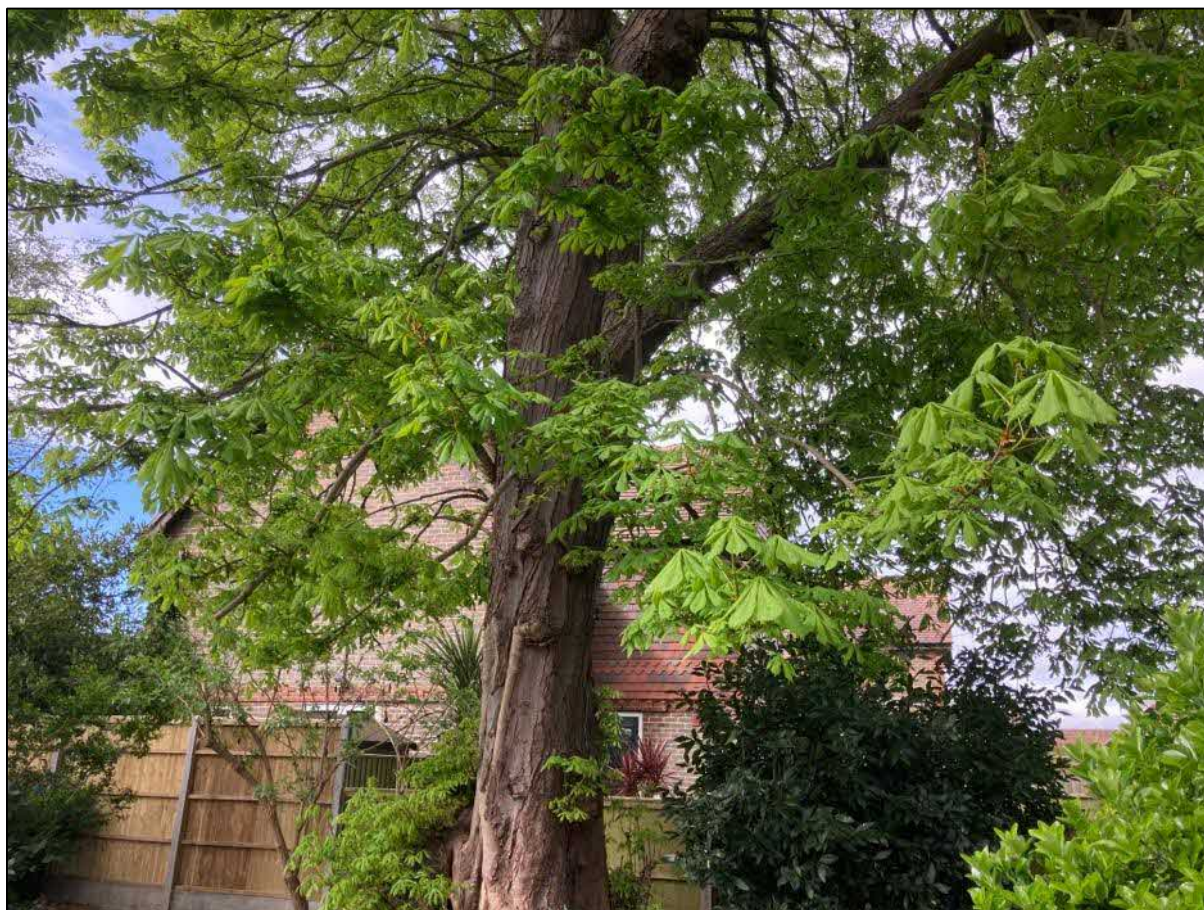
**Figure 1.** The chestnut tree, located at the western boundary of 78 Havant Road, which was the subject of the PRF inspection survey.

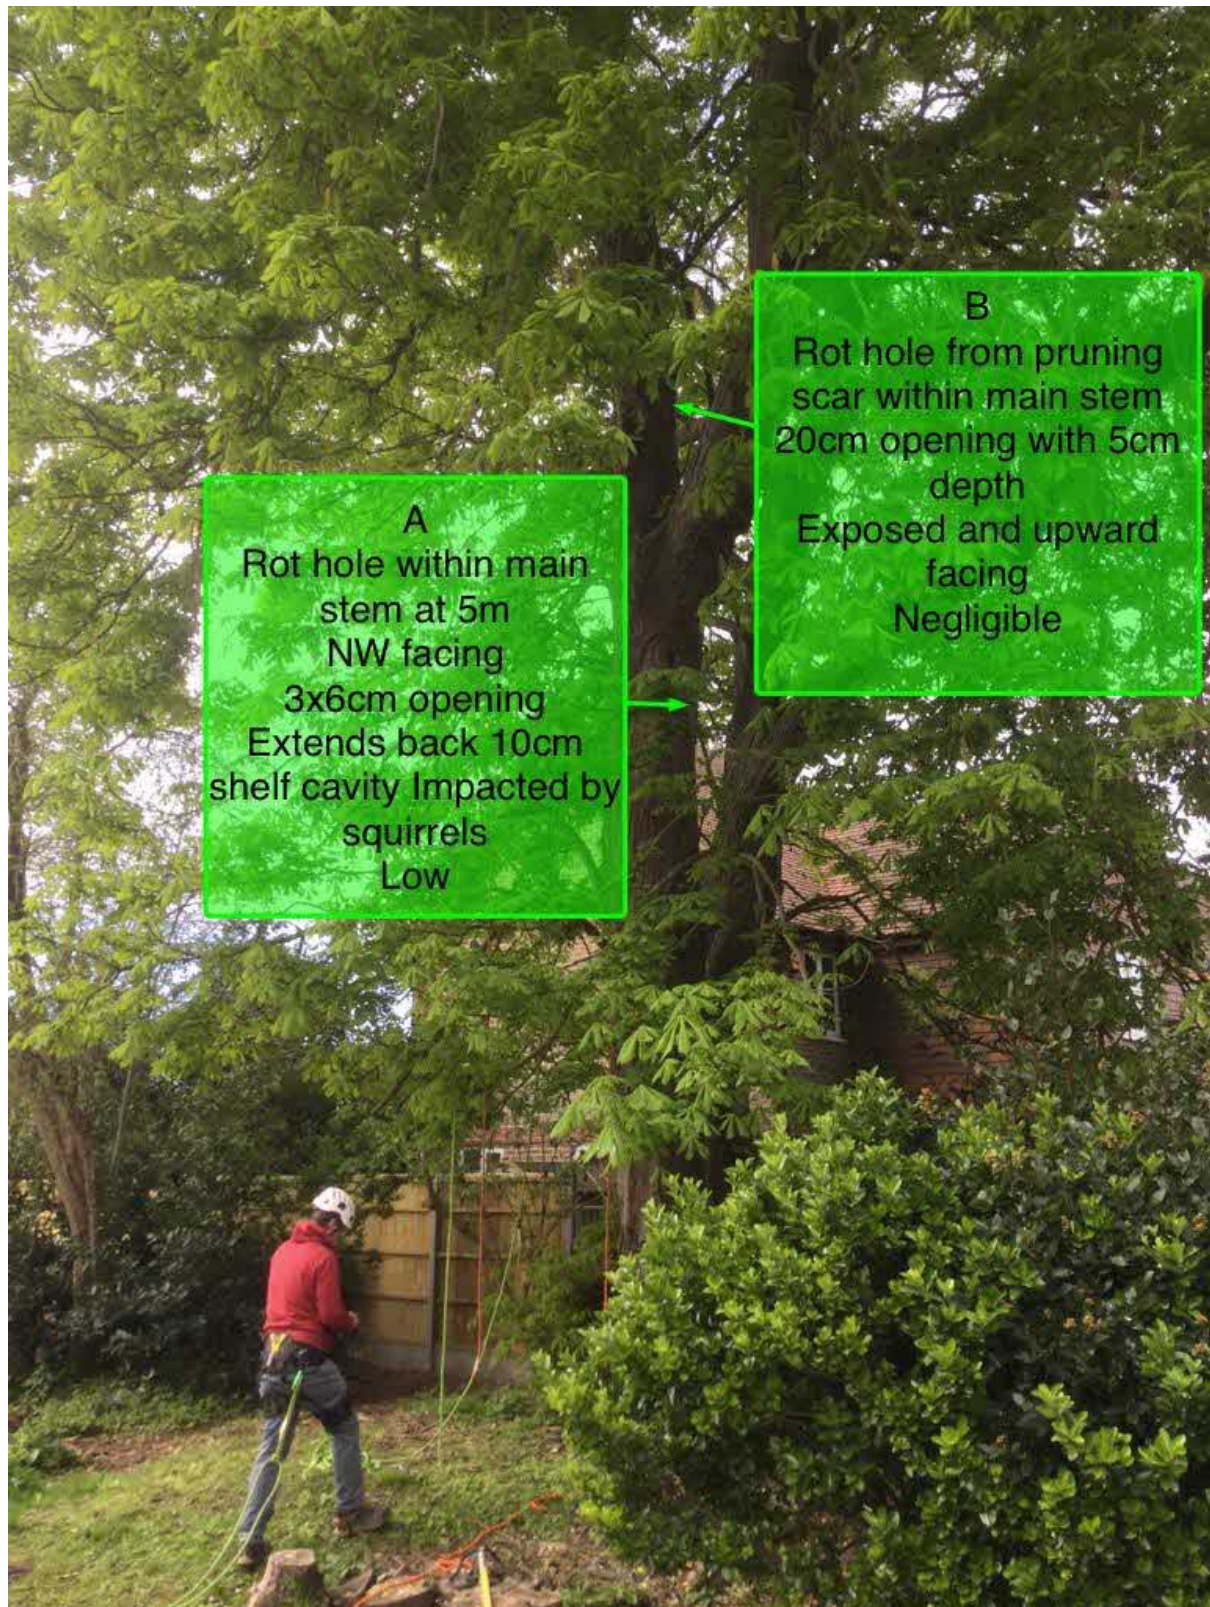
All suitable features on the chestnut tree were inspected for evidence of bats and were fully assessed in terms of their suitability to support roosting bats (see Figure 2 and 3). No direct evidence of bats or features suitable for roosting bats were identified.

**Figure 2.** The locations and descriptions of the PRFs identified on/within the tree.

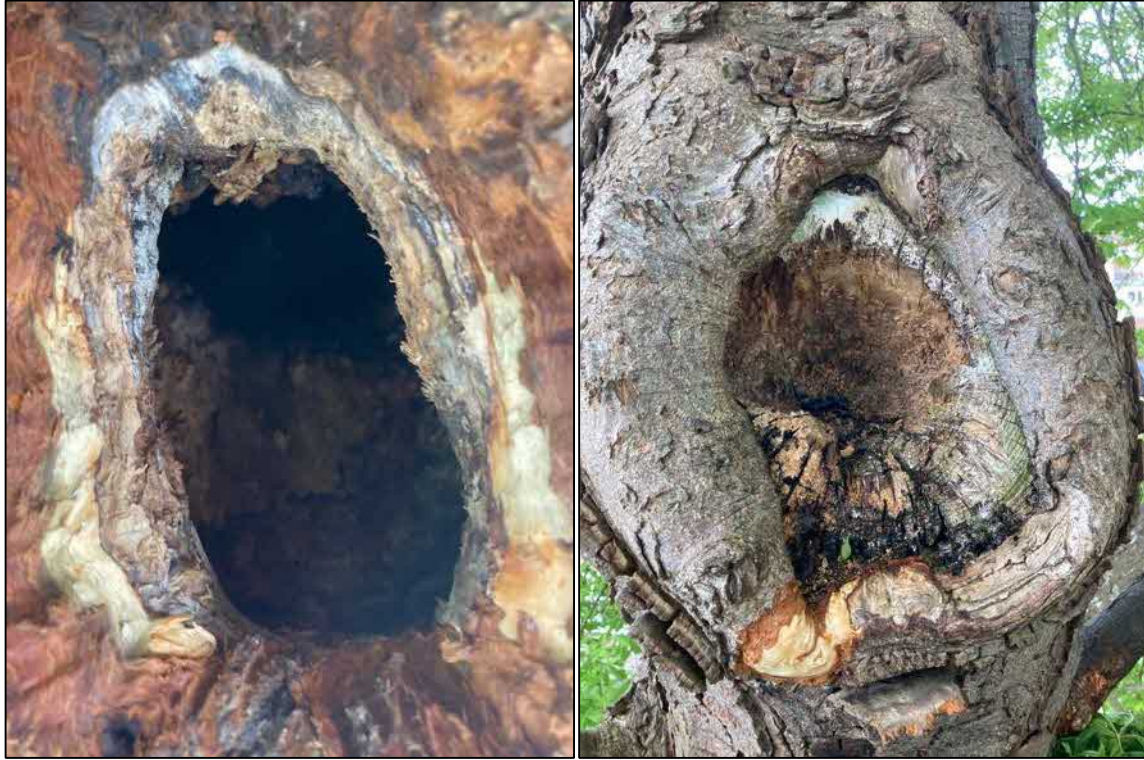
A rot hole exists within the north-western aspect of the stem, approximately 5m above ground level. The entrance hole measures approximately 3cm x 6cm and leads into a shelf cavity which extends into the stem approximately 10cm. The cavity is cone shaped with a sloping roof and does not extend upwards or downwards into the stem. The entrance hole shows signs of squirrel damage to the bark and a dray was observed on a limb 1m above the PRF. The tree was categorised as having 'low' potential to support roosting bats in accordance with best practice<sup>2</sup>; whilst the feature is considered largely unsuitable for roosting bats (especially given the presence of competitors i.e. squirrels), the feature is potentially large enough to shelter an individual bat on occasion.

A pruning wound exists on the stem's eastern aspect approximately 7m above ground level. The wound has healed completely and does not create any sheltered crevices or cavities for roosting bats. The PRF was assessed as having 'negligible' bat roosting potential.

The overall potential of the tree was assessed according to its most suitable PRF, therefore the chestnut is considered to have 'low' bat roosting potential. No further surveys of the tree are recommended. As a precautionary measure, the tree should be climbed by a suitably qualified ecologist immediately prior to its felling, so the ecologists can confirm the absence of bats from within the rot hole. In the unlikely event that a bat roost is identified, the works would need to be delayed until a mitigation licence has been secured from Natural England.

**Figure 3a (left) & 3b (right).** Left – a rot hole within the stem assessed as having 'low' bat roosting potential. Right – a pruning wound on the stem assessed as having 'negligible' roosting potential.
