# BS 5837:2012 Arboricultural Survey

Stanton's Yard, Havant

Issued: October 2018

Delta-Simons Project No. 18-0609.02

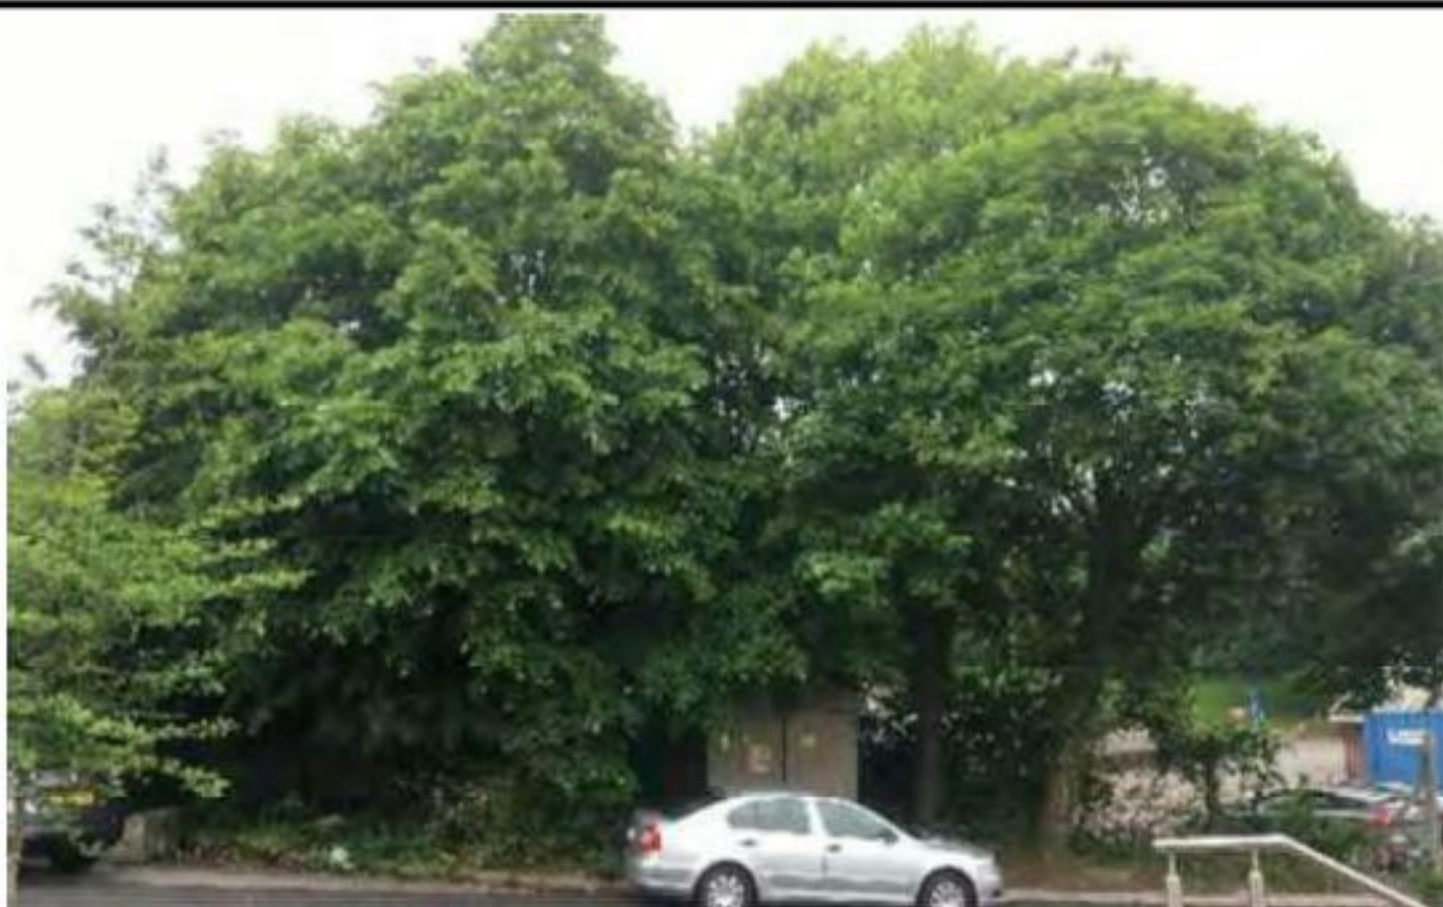
Photograph 1 – TG1

| Tree Number | Tree Species | | Measurements | | | | Crown (m) | | | | Tree Condition | | | | | Management | | | | |
|---|---|---|---|---|---|---|---|---|---|---|---|---|---|---|---|---|---|---|---|---|
| TG1 | Common lime<br>Norway maple | <i>Tilia europaea</i><br><i>Acer platanoides</i> | SM | 10<br>Av | 1 | 400<br>Av | 4 | 4 | 6 | 5 | 3 | No visual signs of damage | Single stems.<br>Vertical | Spreading.<br>Mutually shared canopy | | G | >40 | B | 4.80 | |

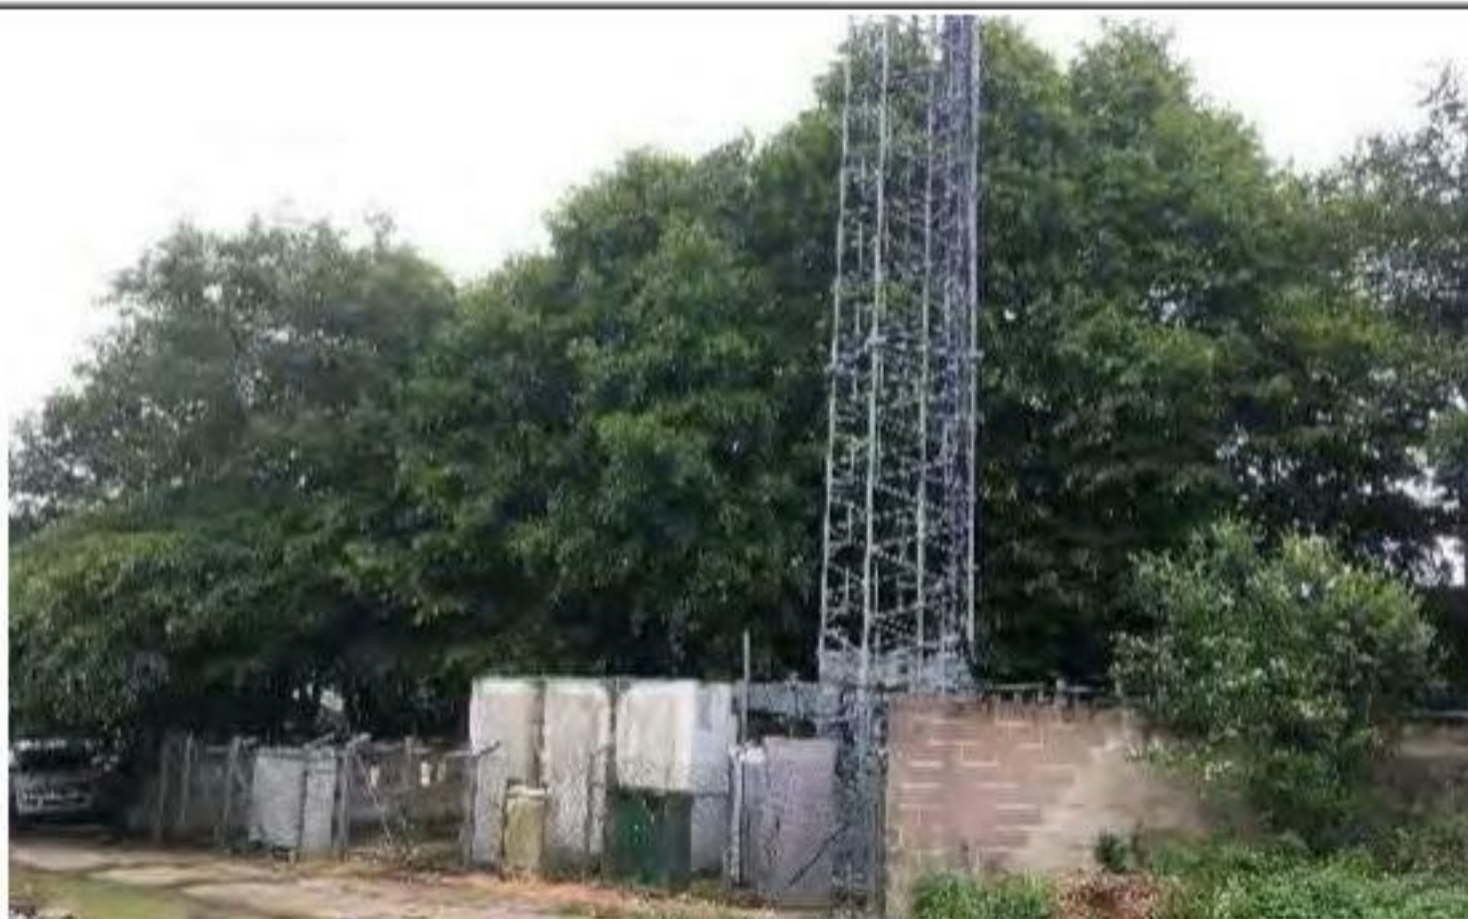
Photograph 2 – TG2

| Tree Number | Tree Species | | Measurements | | | | Crown (m) | | | | Tree Condition | | | | | Management | | | | |
|---|---|---|---|---|---|---|---|---|---|---|---|---|---|---|---|---|---|---|---|---|
| TG2 | Common lime<br>Pedunculate oak | <i>Tilia europaea</i><br><i>Quercus robur</i> | SM | 12<br>Av | 1 | 330<br>Av | 0 | 6 | 4 | 3 | 4 | No visual signs of damage | Single stems.<br>Vertical | Mutually shared canopy. Species suppressed in understorey | | G | >40 | B | 3.90 | |

It appears no management has taken place to the trees present on-Site. TG2, TG3, TG7, TG8 and TG9 would benefit from selective thinning of the understorey trees, which should extend the viability and general health of the remaining trees. To ensure that the root areas and canopy extremities of the individual trees and the tree groups that may be retained are not damaged, a Constraints Plan has been prepared to show the locations where protective fencing should be erected for any trees selected for retention (see Figure 4). Any tree surgery required is best carried out towards the conclusion of the development so that, if necessary, any known root damage can be corrected by the appropriate crown thinning to restore root /shoot balance.

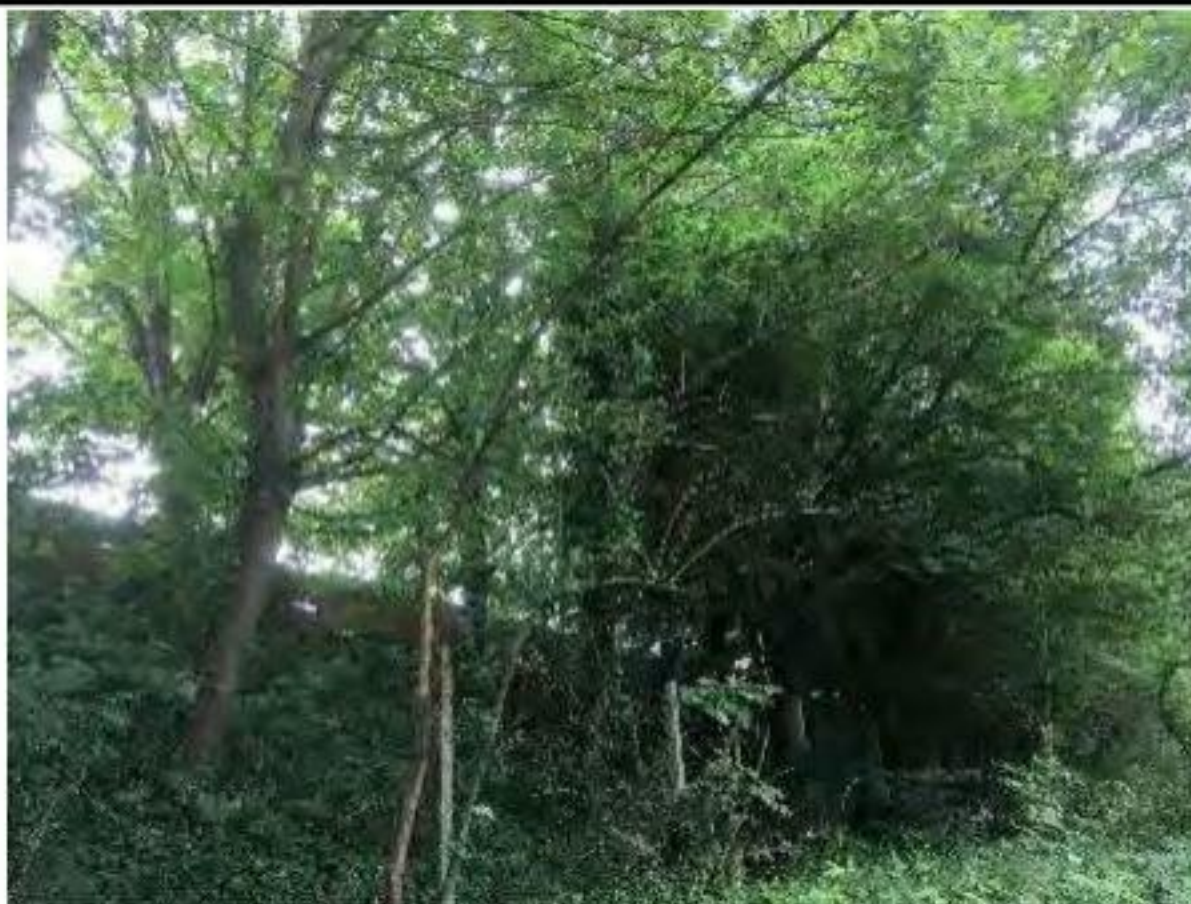
Photograph 3 – TG3

| Tree Number | Tree Species | | Measurements | | | | Crown (m) | | | | Tree Condition | | | | | Management | | | | |
|---|---|---|---|---|---|---|---|---|---|---|---|---|---|---|---|---|---|---|---|---|
| TG3 | Sycamore<br>Field maple<br>Norway maple<br>Silver birch<br>Hazel | <i>Acer pseudoplatanus</i><br><i>Acer campestre</i><br><i>Acer platanoides</i><br><i>Betula pendula</i><br><i>Corylus avellana</i> | SM<br>Y | 12<br>Av | 1 | 380<br>Av | 1 | 6 | 6 | 3 | 3 | No visual signs of damage | Single stems.<br>Vertical | Mutually shared canopy | Group provides good screening from supermarket to the north | F | >20 | B | 4.50 | |

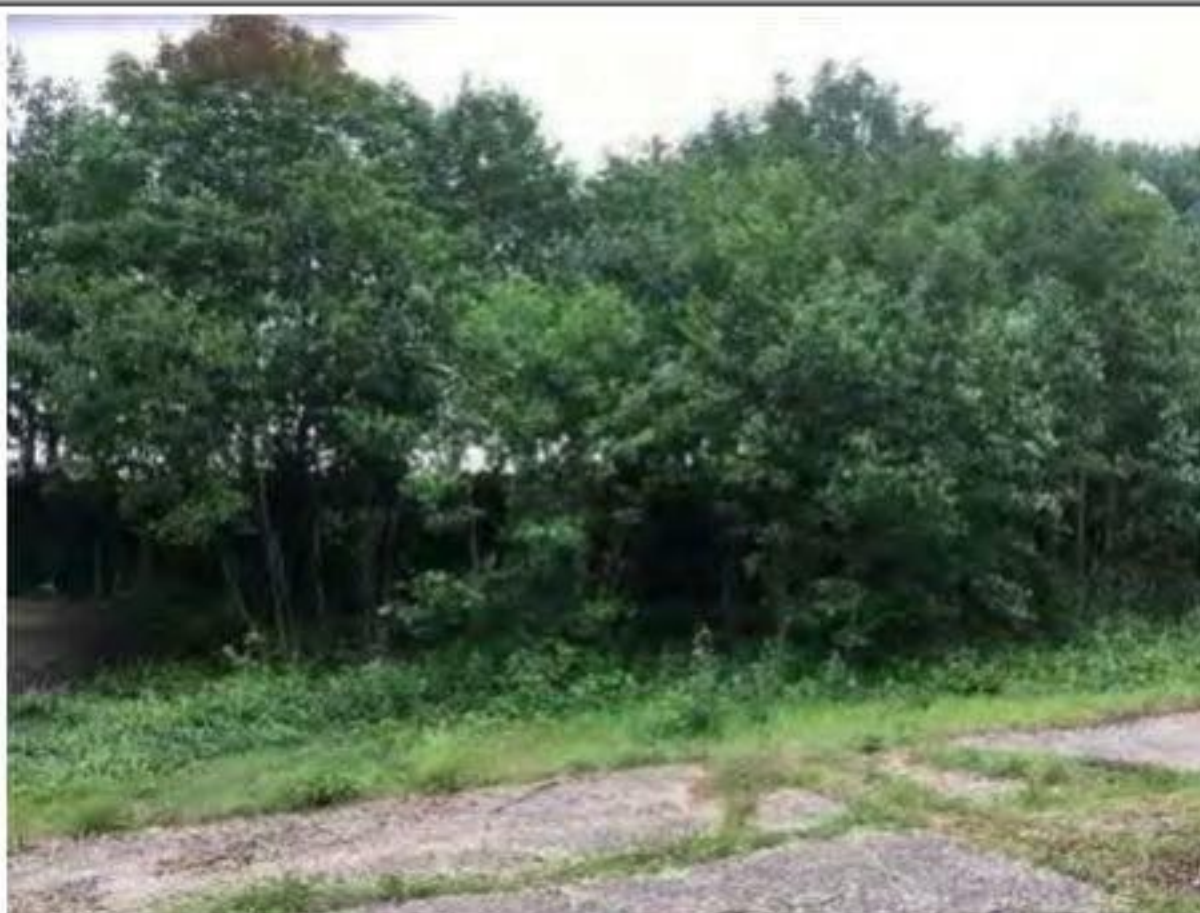
Photograph 4 – TG4

| Tree Number | Tree Species | | Measurements | | | | Crown (m) | | | | Tree Condition | | | | | Management | | | | |
|---|---|---|---|---|---|---|---|---|---|---|---|---|---|---|---|---|---|---|---|---|
| TG4 | Alder<br>Ash | <i>Alnus glutinosa</i><br><i>Fraxinus excelsior</i> | Y | 8<br>Av | 1 | 130<br>Av | 1 | 1 | 1 | 1 | 1 | No visual signs of damage | Single stems.<br>Vertical | Balanced | Group of self-set trees under 150 mm diameter at breast height | F | >20 | C | 1.50 | |

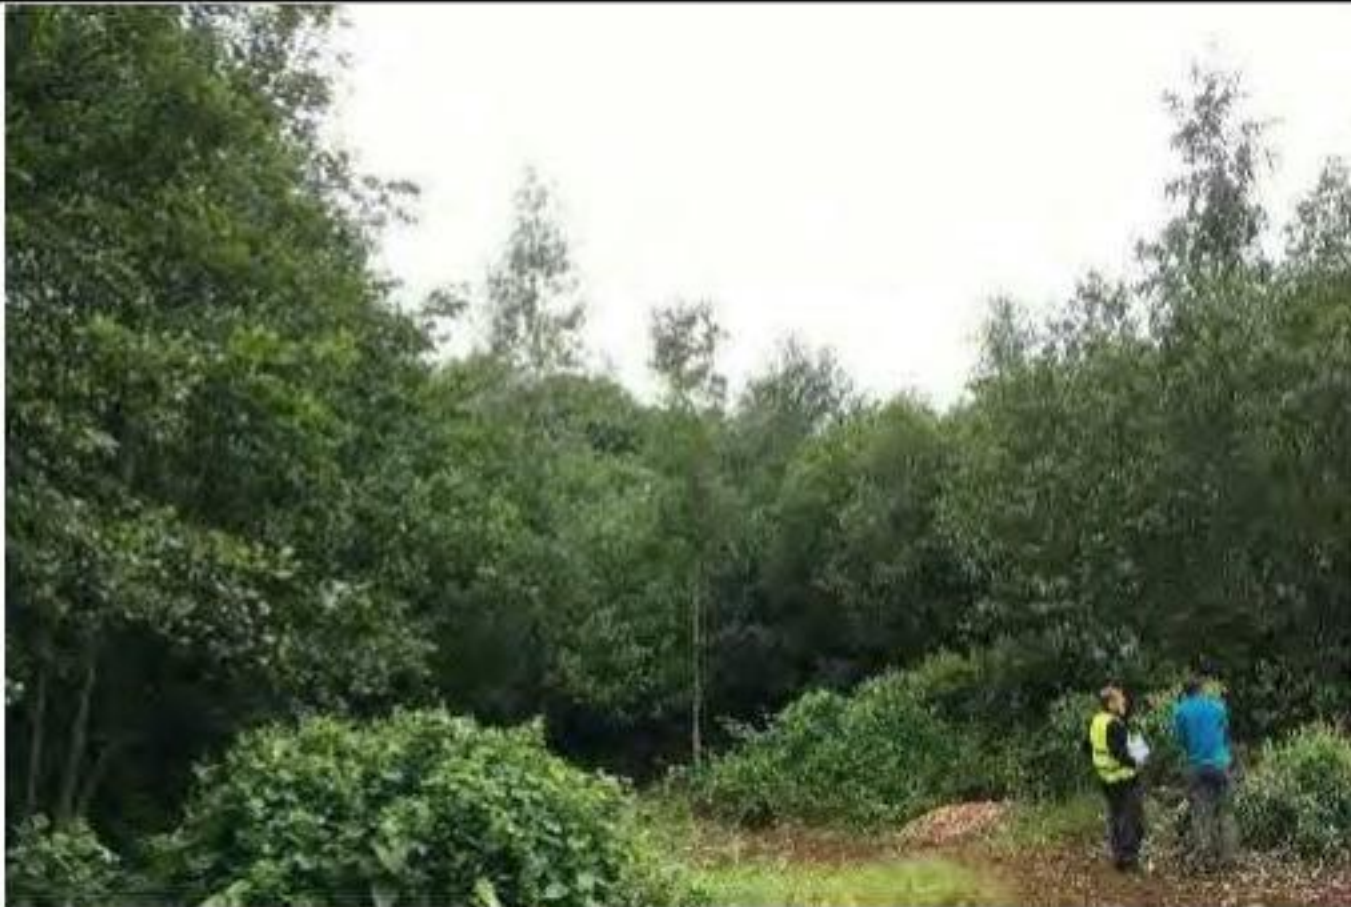
Photograph 5 – TG5

TG5 and TG6, located within the western extent of the Site, are mixed groups of young and semi-mature deciduous trees which are of low landscape value and offer only temporary screening benefit. A percentage of the trees within the group are suppressed, mostly self-set with an understorey of hazel and cherry. A percentage of the willow are in poor condition

| Tree Number | Tree Species | | Measurements | | | | Crown (m) | | | | Tree Condition | | | | | Management | | | | |
|---|---|---|---|---|---|---|---|---|---|---|---|---|---|---|---|---|---|---|---|---|
| TG5 | Goat willow<br>Aspen<br>Cherry<br>Hazel<br>Ash<br>Silver birch<br>Hornbeam<br>Alder<br>Horse chestnut | <i>Salix caprea</i><br><i>Populus tremula</i><br><i>Prunus</i> sp.<br><i>Corylus avellana</i><br><i>Fraxinus excelsior</i><br><i>Betula pendula</i><br><i>Carpinus betulus</i><br><i>Alnus glutinosa</i><br><i>Aesculus hippocastanum</i> | SM<br>Y | 14<br>Av | 1 | 400<br>Av | 1 | 4 | 4 | 4 | 4 | No visual signs of damage | Single stems, Vertical and leaning | Mutually shared canopy | Trees within group mutually suppressed. Mostly self-set with understorey of hazel and cherry. Percentage of willow in poor condition | F | >20 | C | 4.80 | |

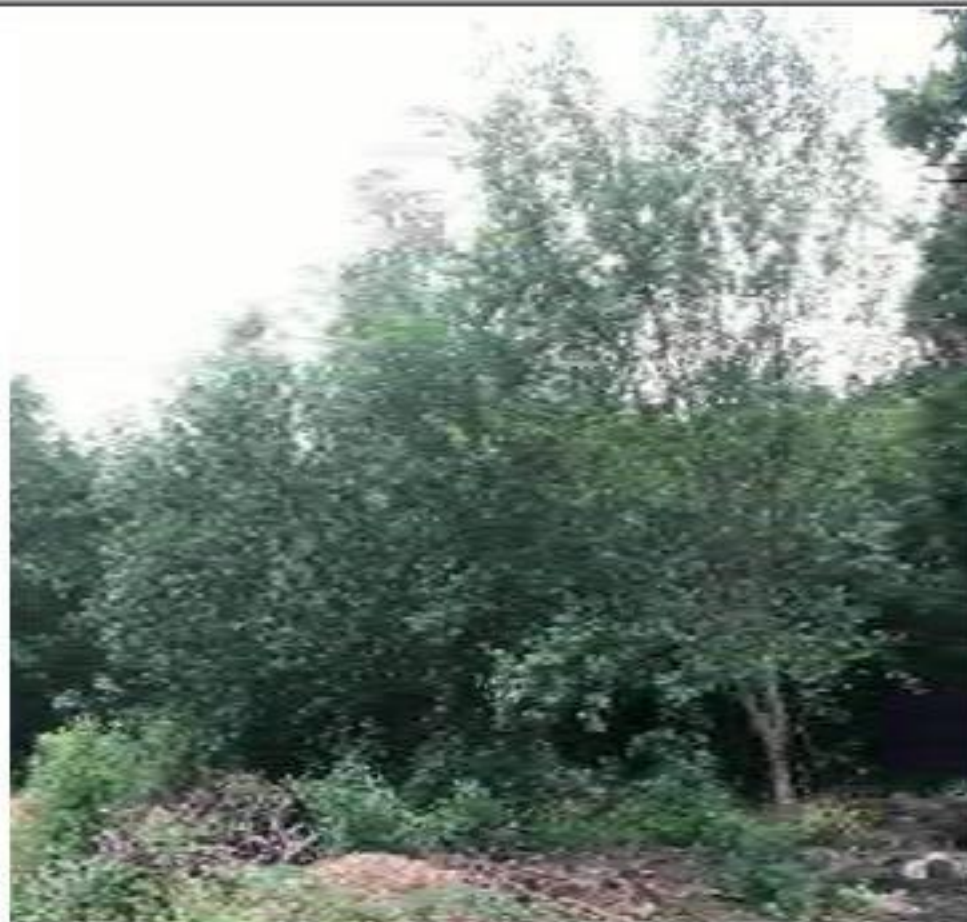
Photograph 6 – TG6

| Tree Number | Tree Species | | Measurements | | | | Crown (m) | | | | Tree Condition | | | | | Management | | | | |
|---|---|---|---|---|---|---|---|---|---|---|---|---|---|---|---|---|---|---|---|---|
| TG6 | Goat willow | <i>Salix caprea</i> | Y | 6<br>Av | MS | 230<br>Av | 0 | 3 | 3 | 3 | 2 | No visual signs of damage | Multi-stemmed.<br>Vertical | Balanced | Self-set trees within hardstanding | F | >20 | C | 2.70 | |

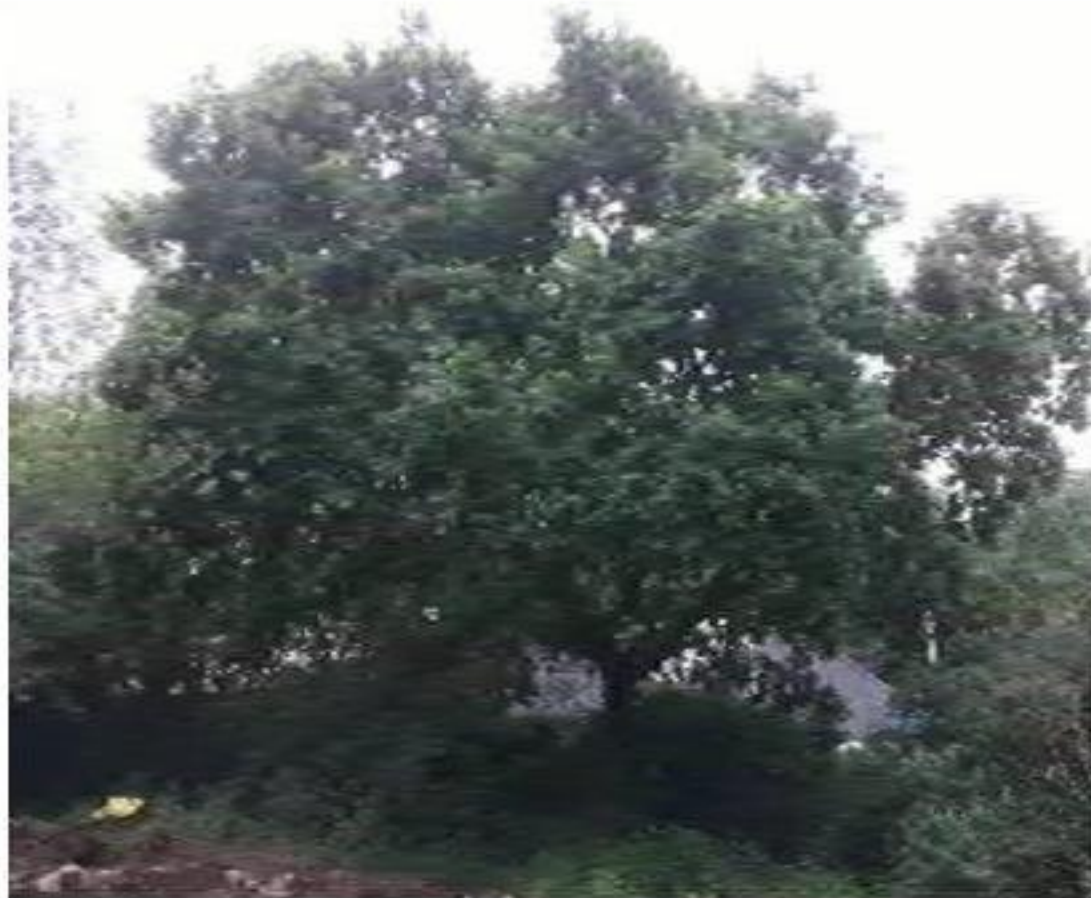
Photograph 7 – TG7

| Tree Number | Tree Species | | Measurements | | | | Crown (m) | | | | Tree Condition | | | | | Management | | | | |
|---|---|---|---|---|---|---|---|---|---|---|---|---|---|---|---|---|---|---|---|---|
| TG7 | Pedunculate oak<br>Goat willow | <i>Quercus robur</i><br><i>Salix caprea</i> | SM | 12<br>Av | 1 | 460 | 3 | 6 | 5 | 6 | 4 | No visual signs of damage | Single stem.<br>Vertical | Spreading | Understorey of willow and elder | G | >40 | B | 5.40 | |

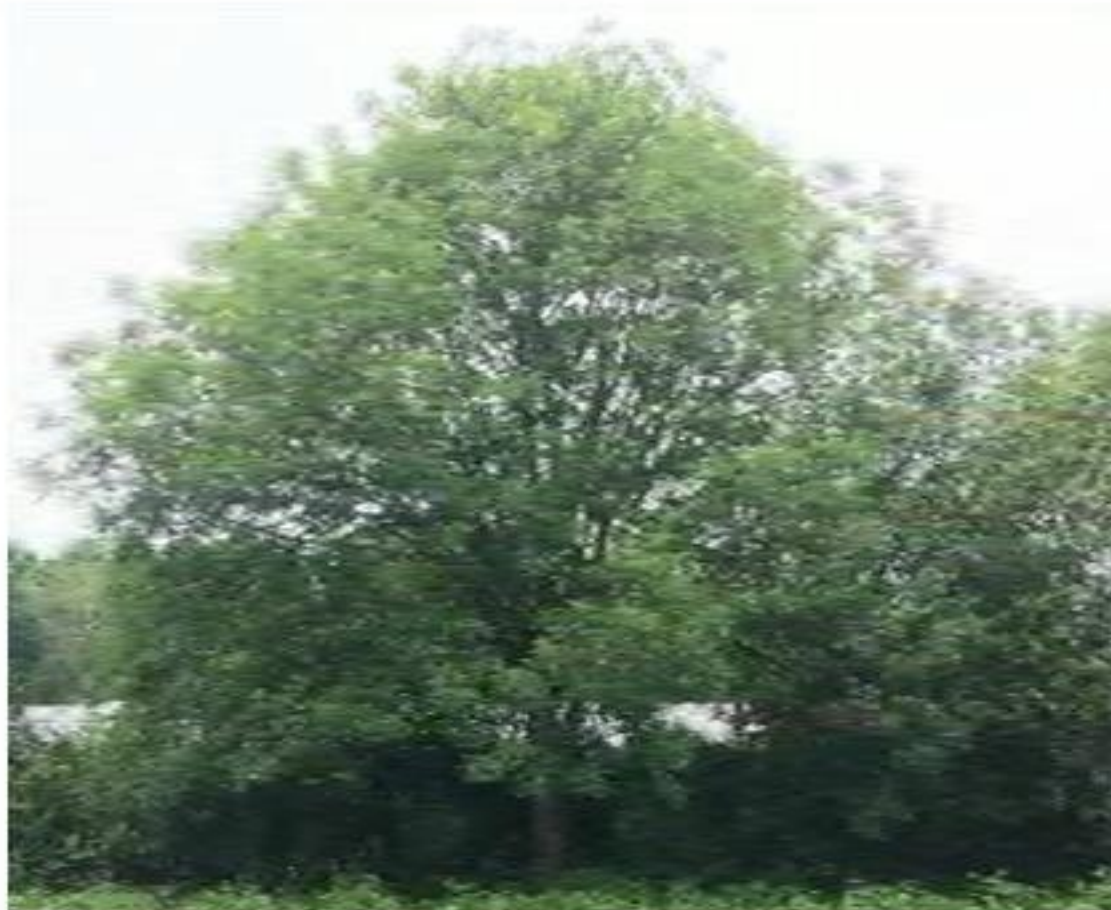
Photograph 8 – TG8

| Tree Number | Tree Species | | Measurements | | | | Crown (m) | | | | Tree Condition | | | | | Management | | | | |
|---|---|---|---|---|---|---|---|---|---|---|---|---|---|---|---|---|---|---|---|---|
| TG8 | Ash<br>Goat willow | <i>Fraxinus excelsior</i><br><i>Salix caprea</i> | SM | 13<br>Av | 1 | 480 | 2 | 5 | 5 | 5 | 5 | No visual signs of damage | Single stem.<br>Vertical | Spreading | Understorey of willow and elder | G | >40 | B | 5.70 | |

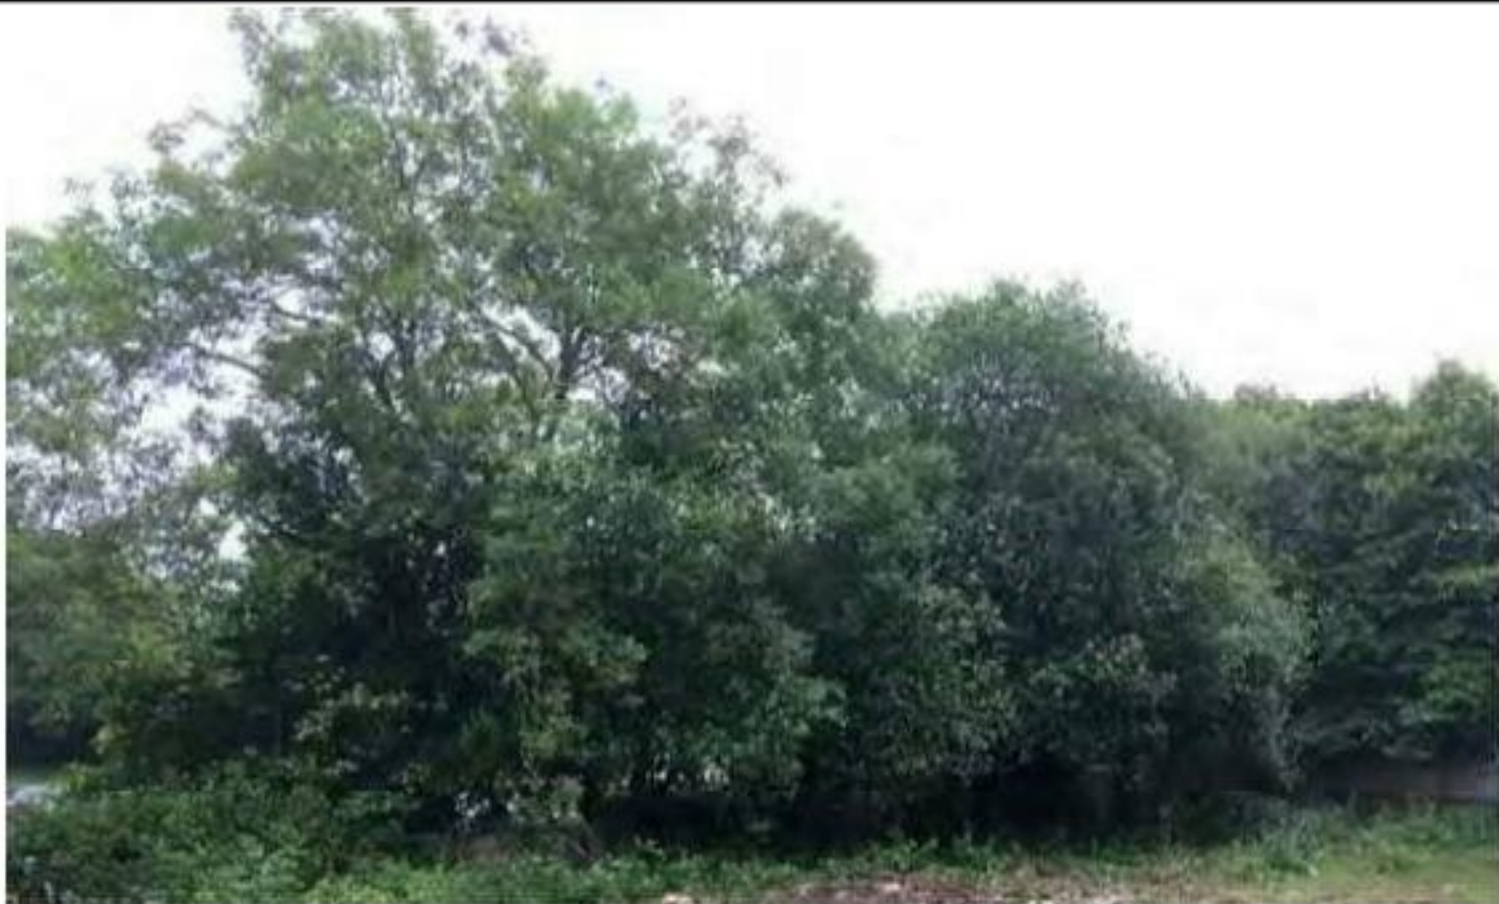
Photograph 9 – TG9

| TG9 | Goat willow<br>Sycamore<br>Common lime<br>Ash | Salix caprea<br>Acer<br>pseudoplatanus<br>Tilia europaea<br>Fraxinus<br>excelsior | SM<br>Y | 11<br>Av | 1 | 320<br>Av | 0 | 3 | 4 | 3 | 4 | No visual<br>signs of<br>damage | Single stems.<br>Vertical | Spreading | F | <20 | B | 3.90 | |
