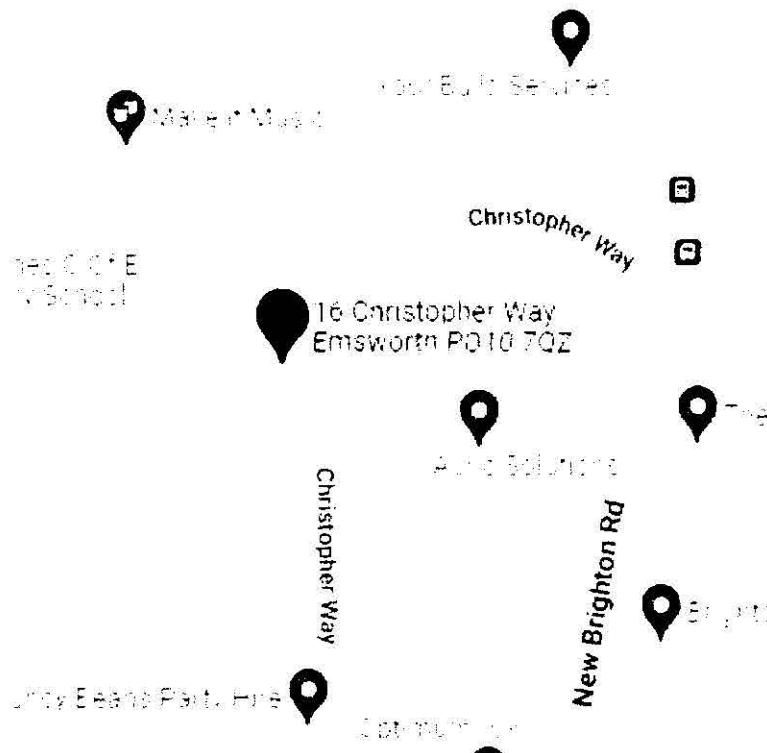
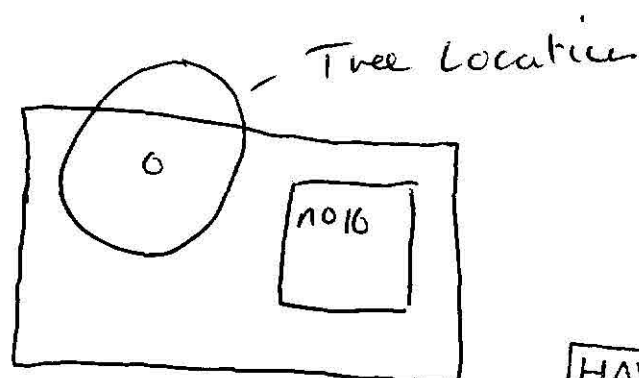
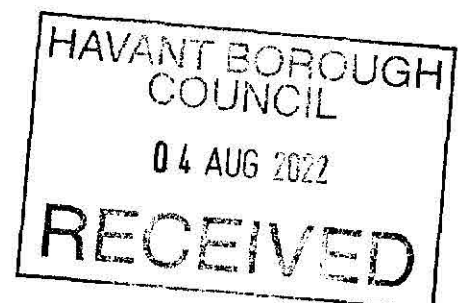
The tree in question is a mature eucalyptus in good health, however has had little maintenance carried out over the years. The tree at the base has pushed the wall over and is causing root issues along the pavement the owners of the tree very much like the tree but would like to carry out some maintenance to keep the size sensible the proposed works would be a height reduction of 1.5 metres and a lateral canopy spread reduction of 1.5 metres all work will be carried out in accordance with British standards

The current height of the tree is 18 metres so it would be reduced to 16.5 metres and the current lateral spread of the tree is 15 metres so this would be reduced to 13.5.
