**Project:** 23\_5837\_06\_12  
**Site:** Seacourt Tennis Club, 20 Victoria Avenue, Hayling Island, PO11 9AJ  
**Client:** Jonathan McDermott

| Document Title: | Tree Survey & Arboricultural Impact Assessment |
| Project Title: | Seacourt Tennis Club, 20 Victoria Avenue, Hayling Island, PO11 9AJ |

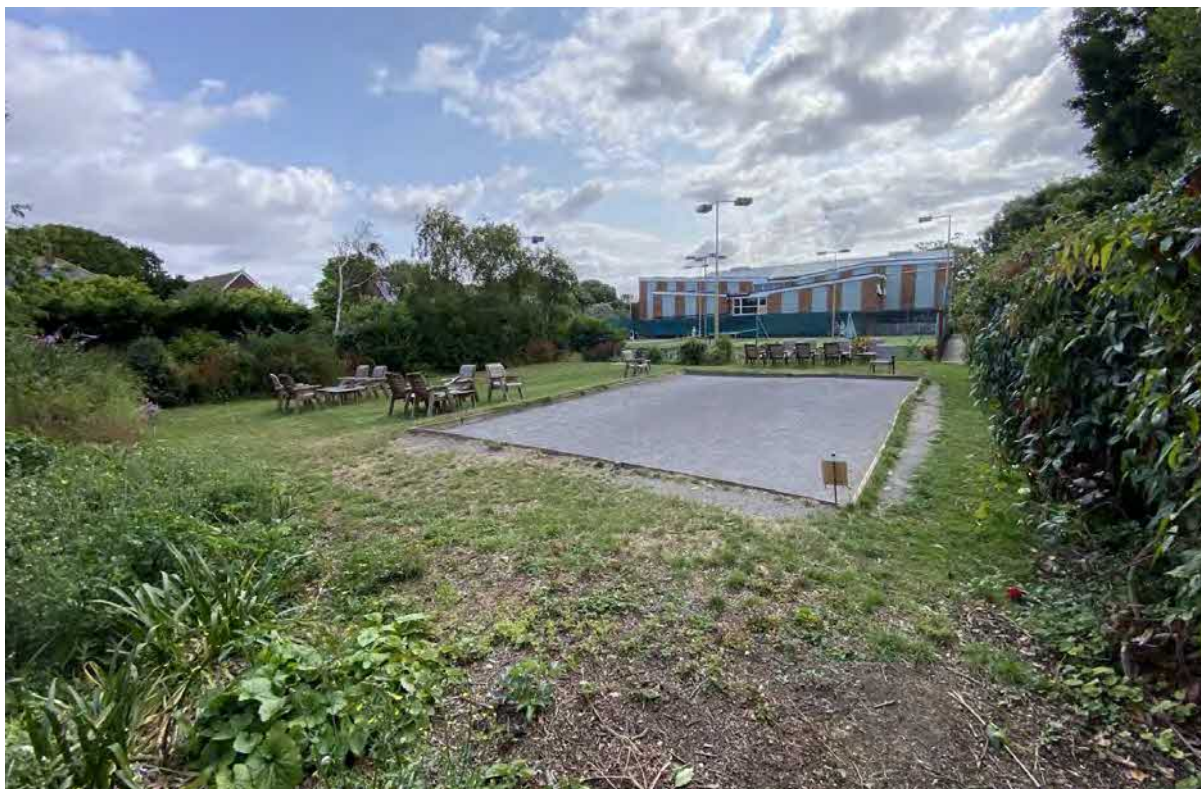
*Photographic plate showing proposed new court area to the west of the existing courts.*

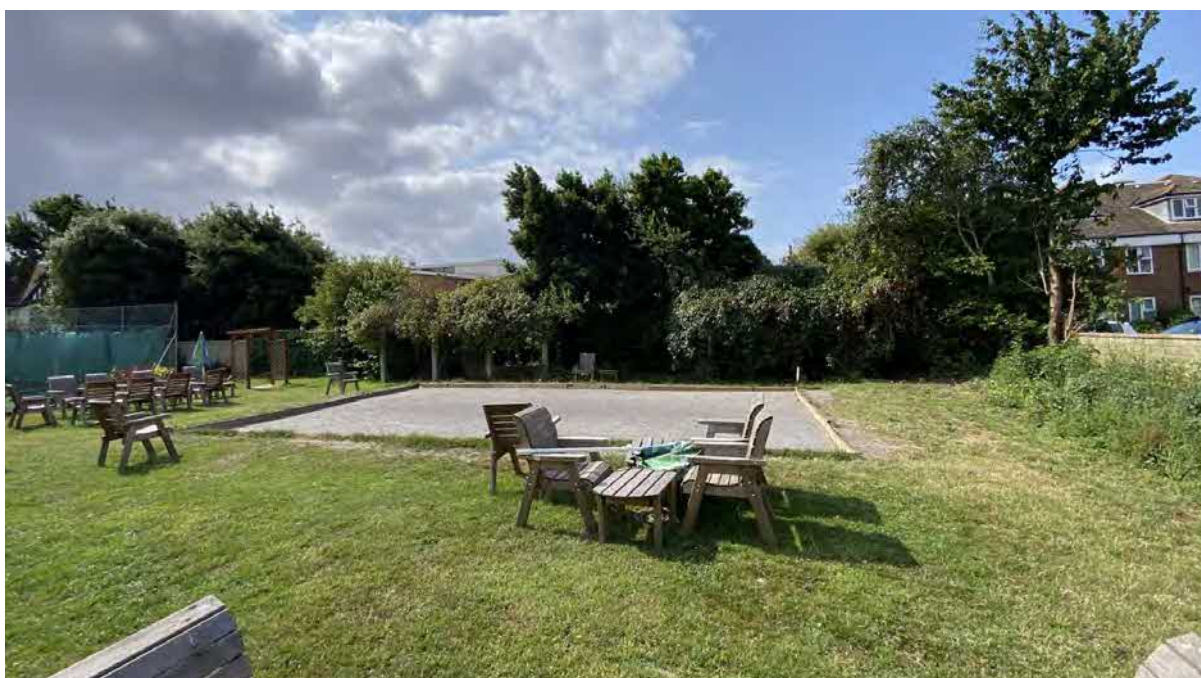
*Photographic plate showing existing petanque court as well as linear feature of trees adjacent to the southern boundary T1(left) to T8 (right)*

| Tree Number | Species | Age Class | DBH | Height (crown height) | N | E | S | W | Condition | Life Expectancy | Physical Description | Comments | Managment Recommendations | RPA offset from stem. | Category Rating |
|---|---|---|---|---|---|---|---|---|---|---|---|---|---|---|---|
| T8 | <i>Prunus avium</i> (Wild Cherry) | M | 245 | 8.5(1) | 2.5 | 2.5 | 1.5 | 2.5 | Poor | <10 | Poor shape & form. Declining. Tree located within hard surface area. Major bark wounding on stem. Mechanical Damage. | / | / | 2.94 | U |
| T9 | <i>Prunus avium</i> (Wild Cherry) | EM | 165 | 8(1) | 2 | 2 | 1 | 2 | Poor | <10 | Poor shape & form. Declining. Tree located within hard surface area. Leaning North. Major bark wounding on stem. Mechanical Damage. | / | / | 1.98 | U |

| Tree | Cause For Removal |
|---|---|
| T8 | Category U tree in poor condition |
| T9 | Category U tree in poor condition |

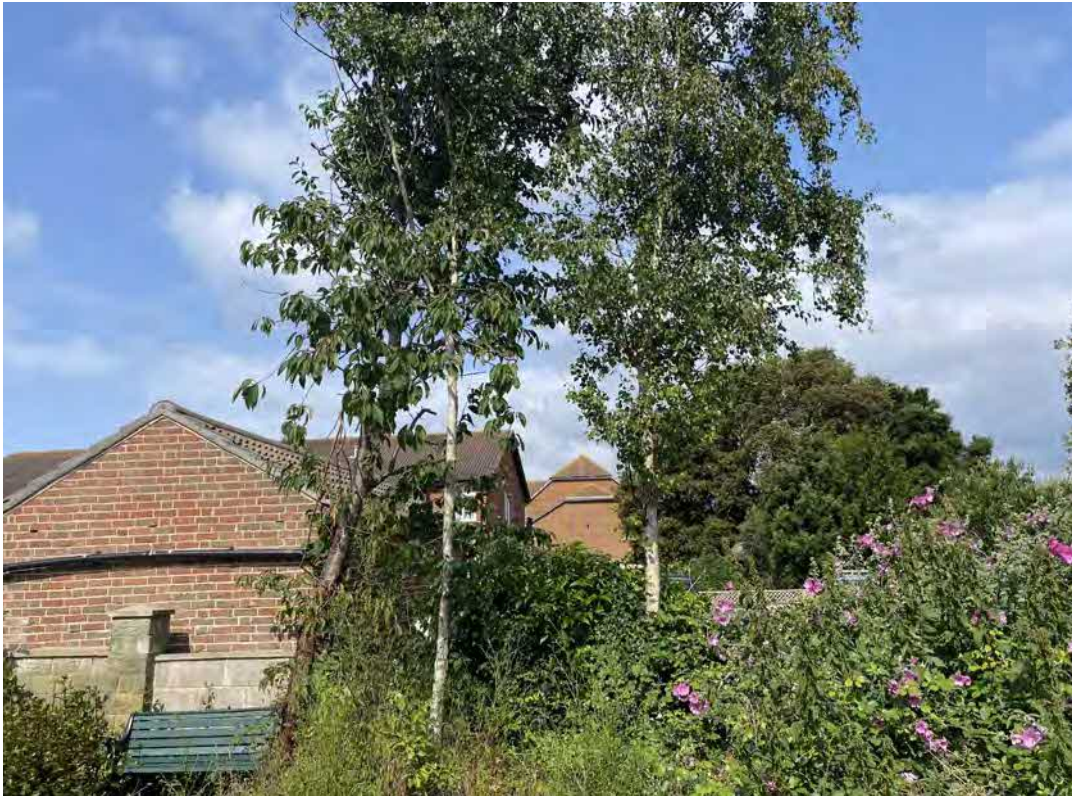
*Photographic plate showing general condition of T9-T11*

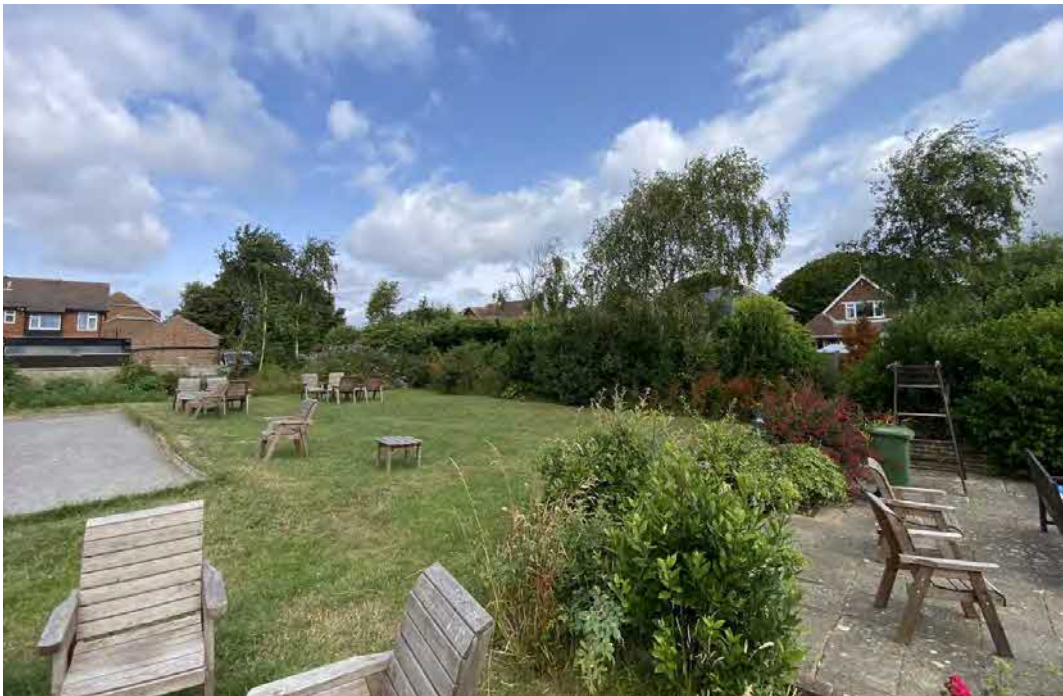
*Photographic plate showing Northern boundary.*
