Southmoor Asset  
Improvement Options  
Appraisal and Business Case

Outline Arboricultural Impact Assessment Report

Environment Agency

September 2017

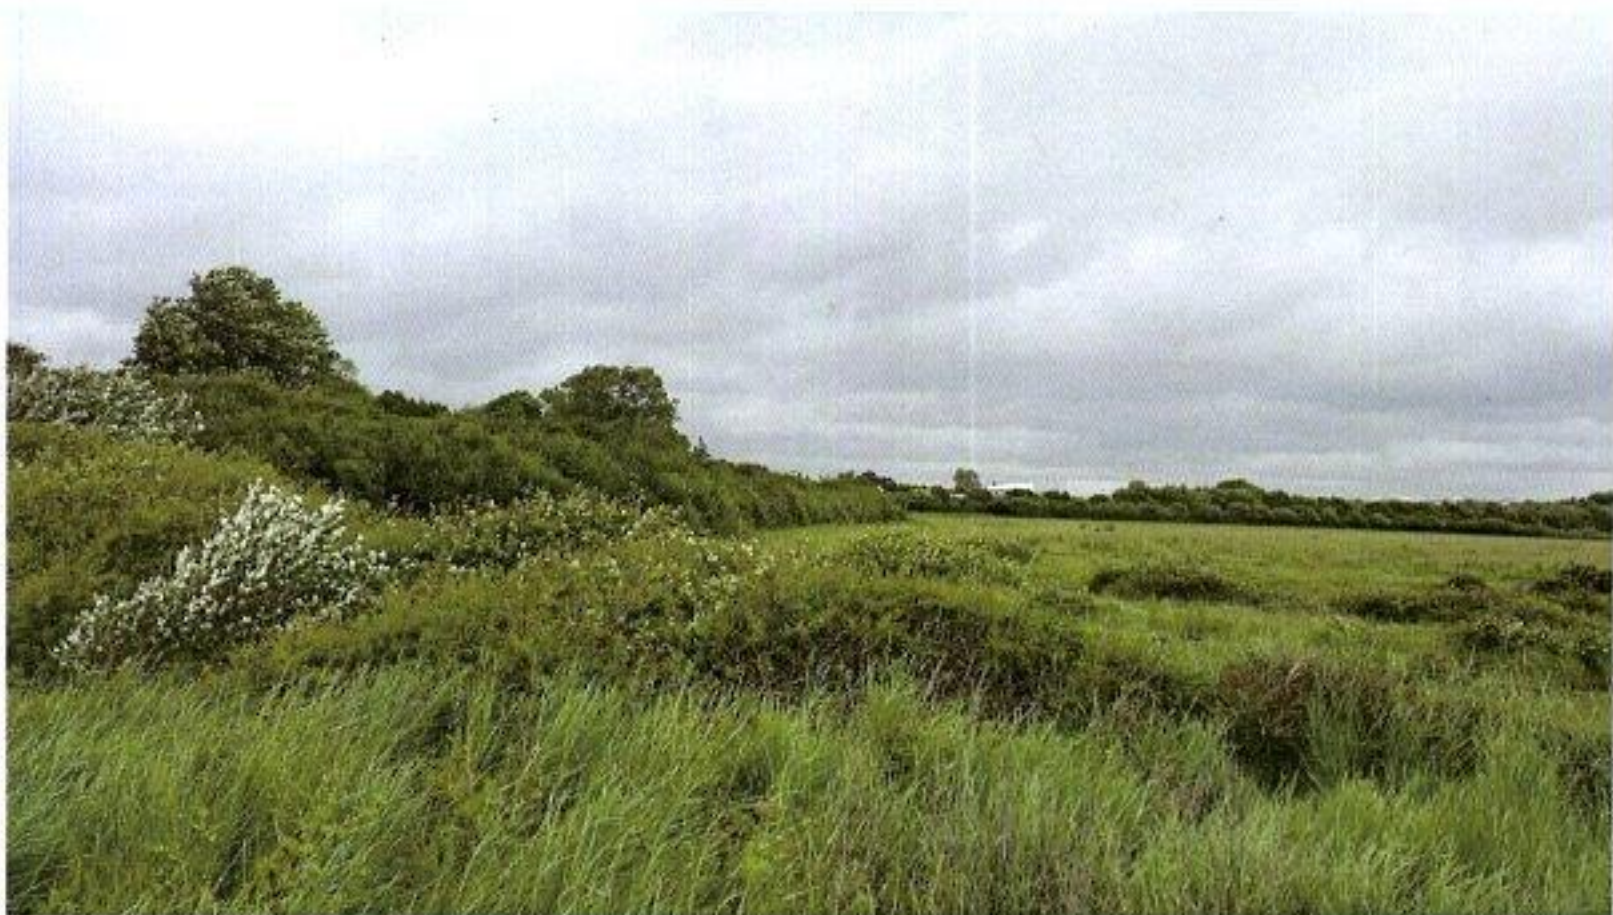
Image 1 View of H1 from south

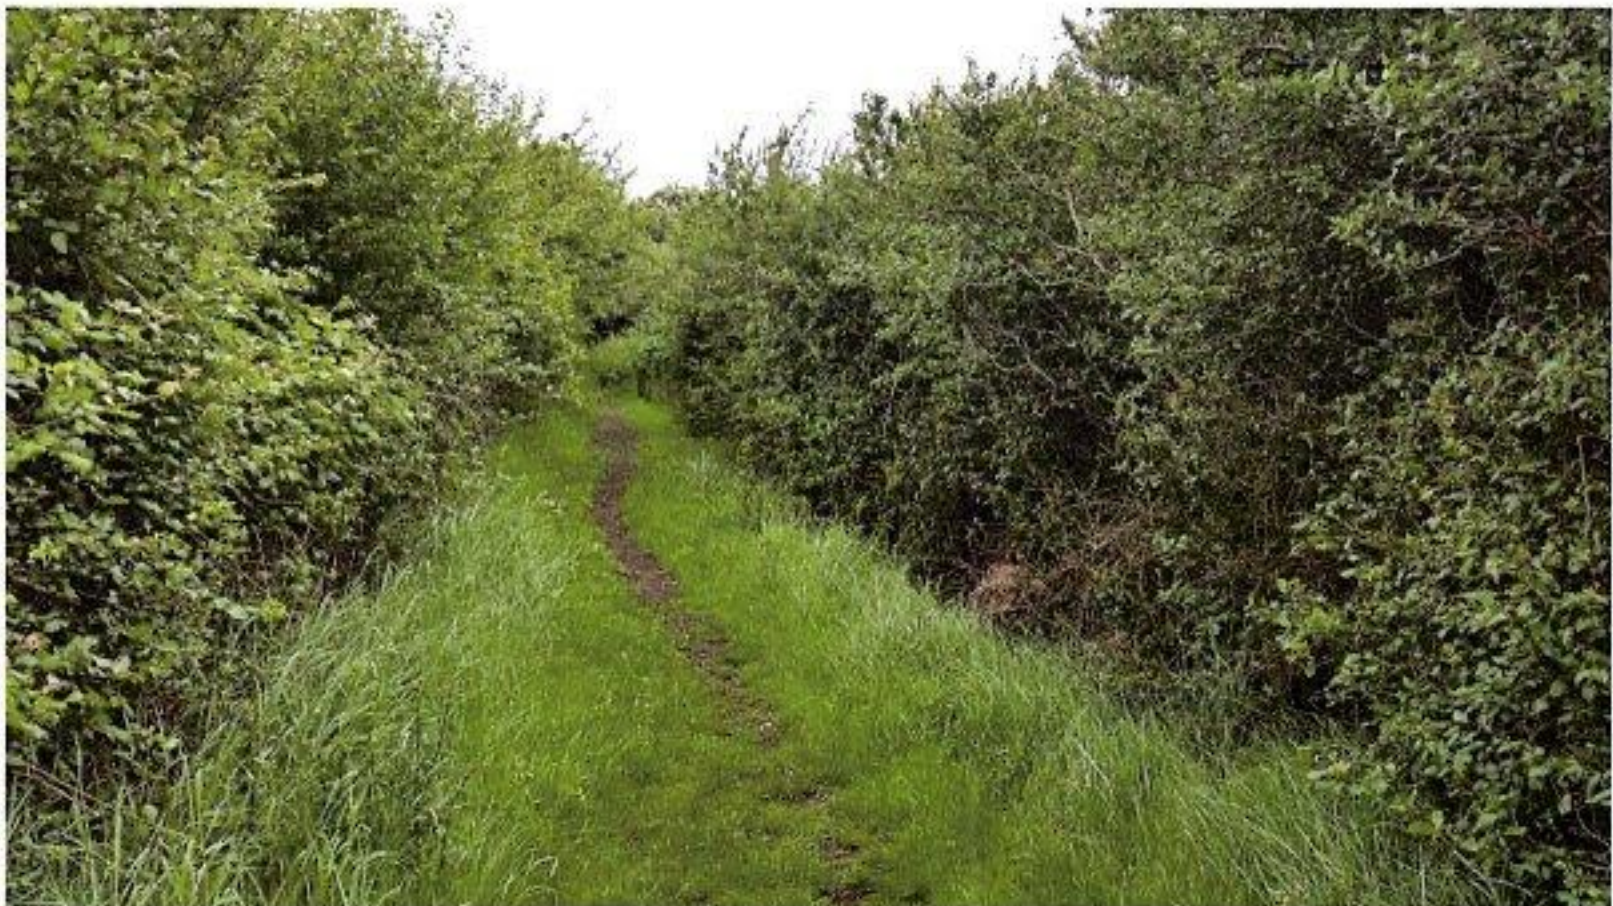
Image 2 Public footpath along length of G2b and G8

The existing footpath which runs north to south through groups G2B and G8 is to be widened and surfaced/resurfaced to account for the likely increased pedestrian traffic as it becomes part of the diverted route of the Coast Path.

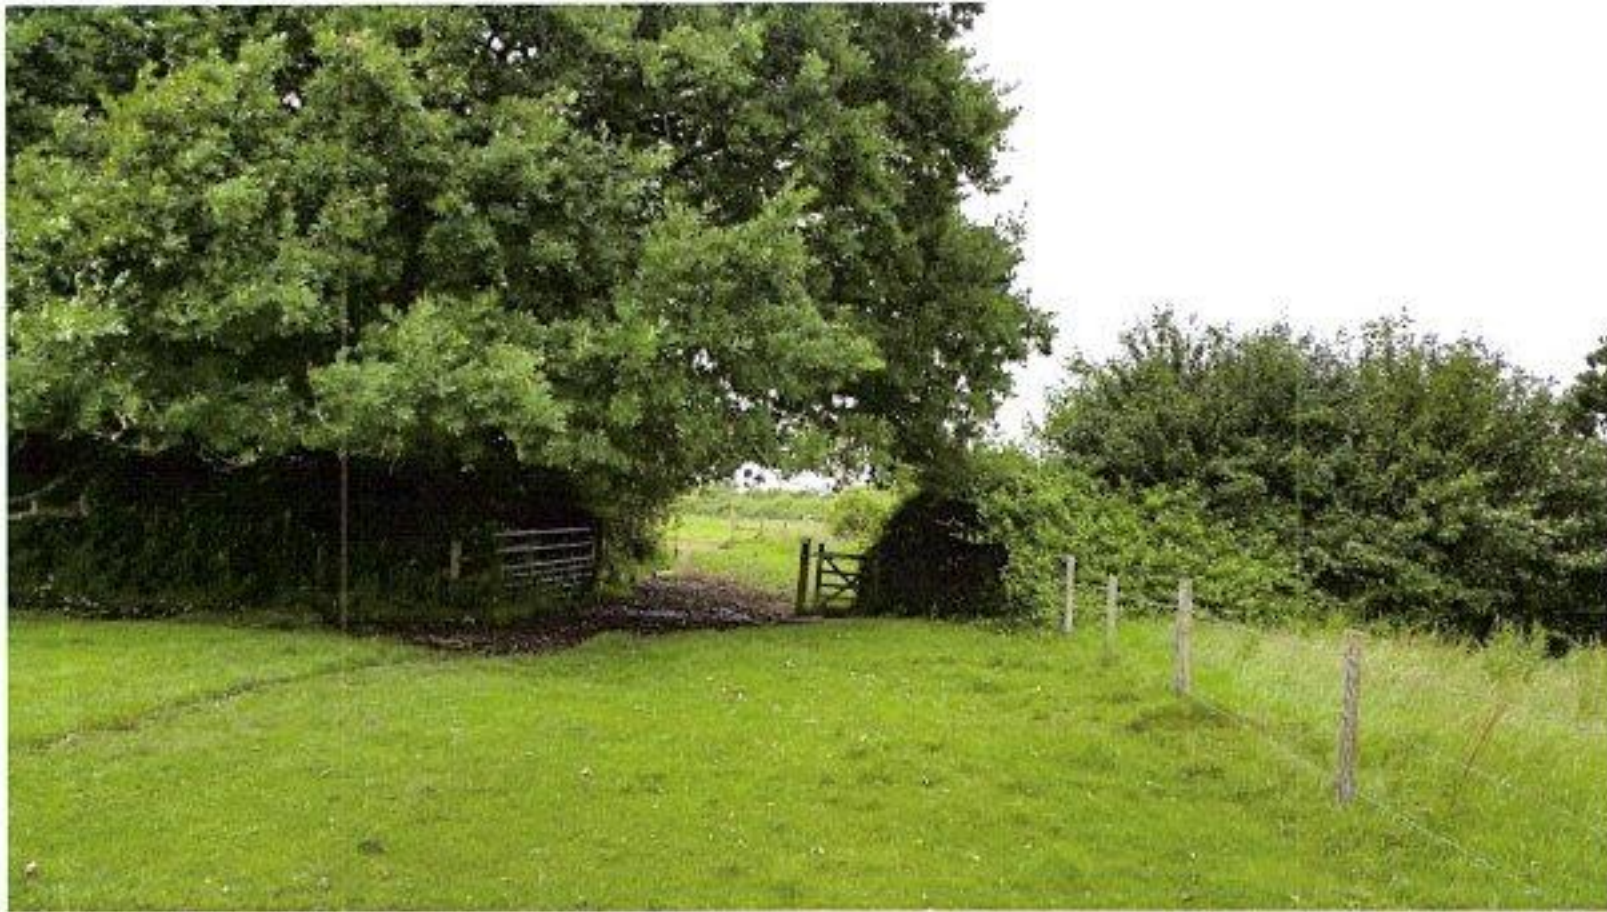
Image 3 View from east to west, T12 to left with G9 to right of gate

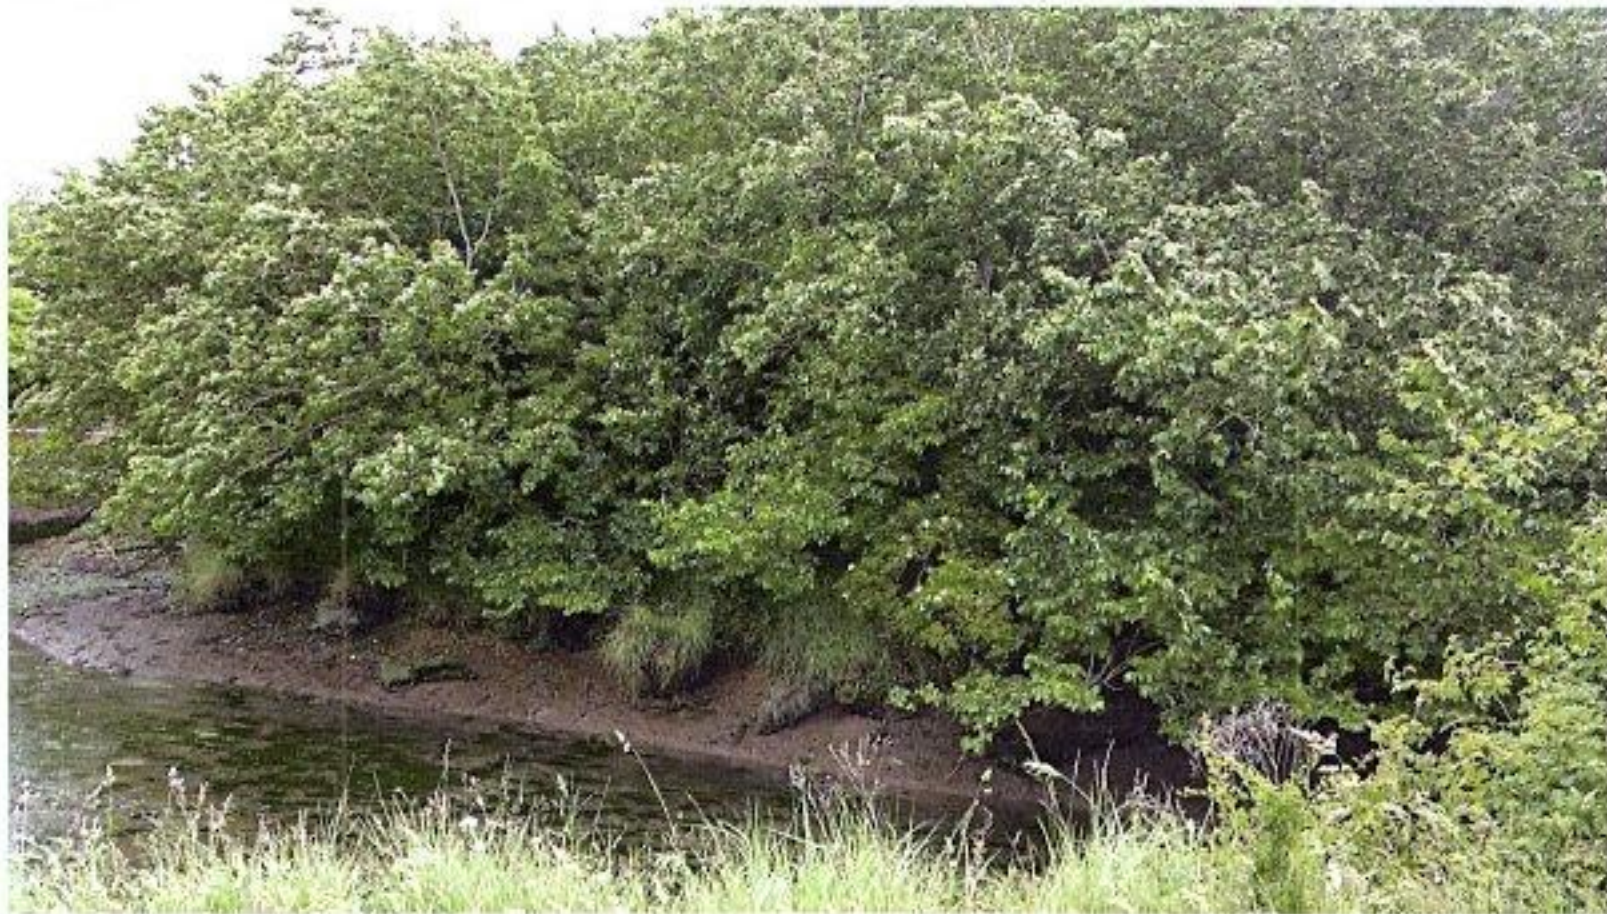
Image 4 English elm (G21) located to east of Site
