# BjH Property services.

## **126 Durley Avenue, Waterlooville, PO8 8TZ, Tree Report**

**12/01/2026**

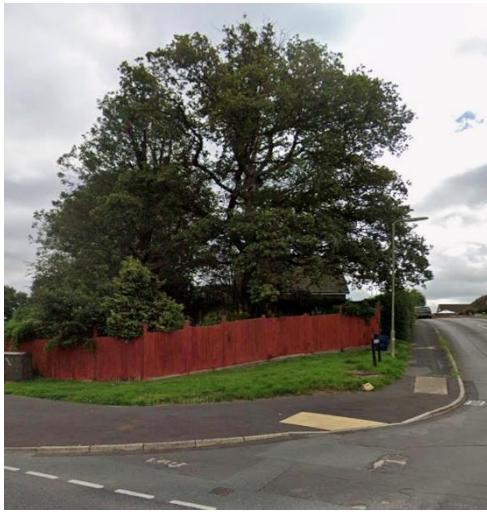
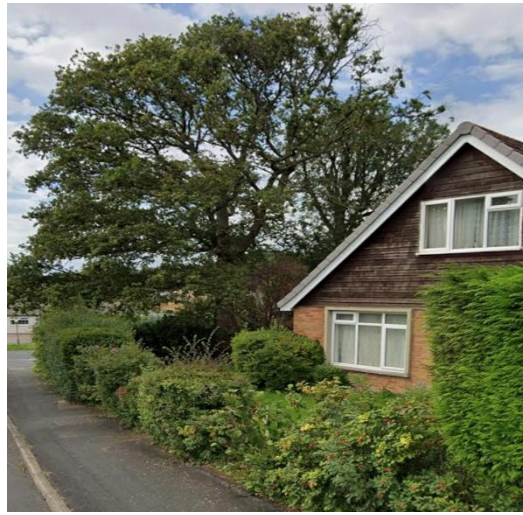
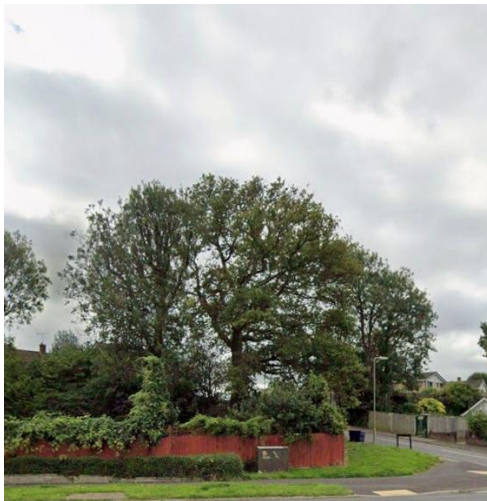
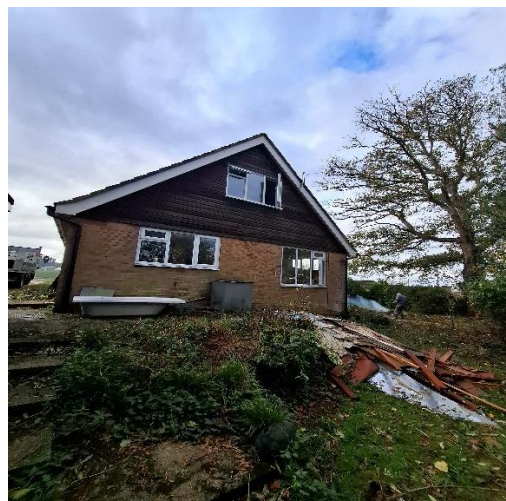
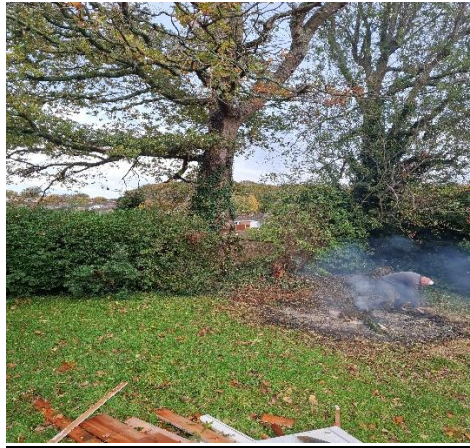
The two Oak Trees (*Quercus Rubor*) are situated on the West boundary of the site and form part of the side boundary hedgerow. The trees are approximately 12-15m in height and have a spread of around 9.0m. Circumference at the trunks are 1750mm at 1.0m from ground level, giving an estimated age of between 85-95 years old. The crowns are around 2.60m from ground level and each tree have 4 main boughs mainly stretching out North to South. The base of the trees are cover with vegetation from an unmanaged hedgerow. There is no evidence of poor health, and all boughs and limbs appear healthy and full of bud and the trees have been pruned in the past. There are no signs of the roots penetrating the ground in any direction and are likely to be of adequate depth to not be within the area of the proposed extension. The side garden is a sunken unkempt grassed area and lies approx. 1.0m below the DPC level of the property. The tree shares the area with a mixed sparse hedgerow boundary to property and has a light covering of Ivy (*Hedera Helix*) from ground to above crown height, but this may be thicker during growing months.

This report and photos were produced in Winter time while the tree is dormant and any obvious ill health may not be clear until the leaves have appeared and the tree is in full growth.

1, The immediate area under the trees will be harassed to prevent any vehicle or plant machinery making contact at any point. And all contractors on site to be made aware of the exclusion zone during induction onto site.

3, The foundation and floor to the proposed garage is to be of Raft type to minimise the impact into the ground. Excavation should be done by hand at the front (North) Elevation at the very least to avoid cutting through roots and any exposed roots be protected as the approved Plan notes. Any excavators should be monitored carefully by banksmen while digging and moving around the site paying attention to overhanging branches.

6, All new rainwater run off will be to a new soakaway which will be hand dug and situated as far from the tree as rules allow (min 5.0m from any building) see plan. Any roots exposed during the dig will be carefully dug around and have minimum disturbance.
