**Technical Drainage Note:**

**212–218 London Road, Waterloooville, PO7 7AJ**

**Prepared in response to consultation comments  
from Southern Water and Portsmouth Water.**

## CCTV Inspection Report

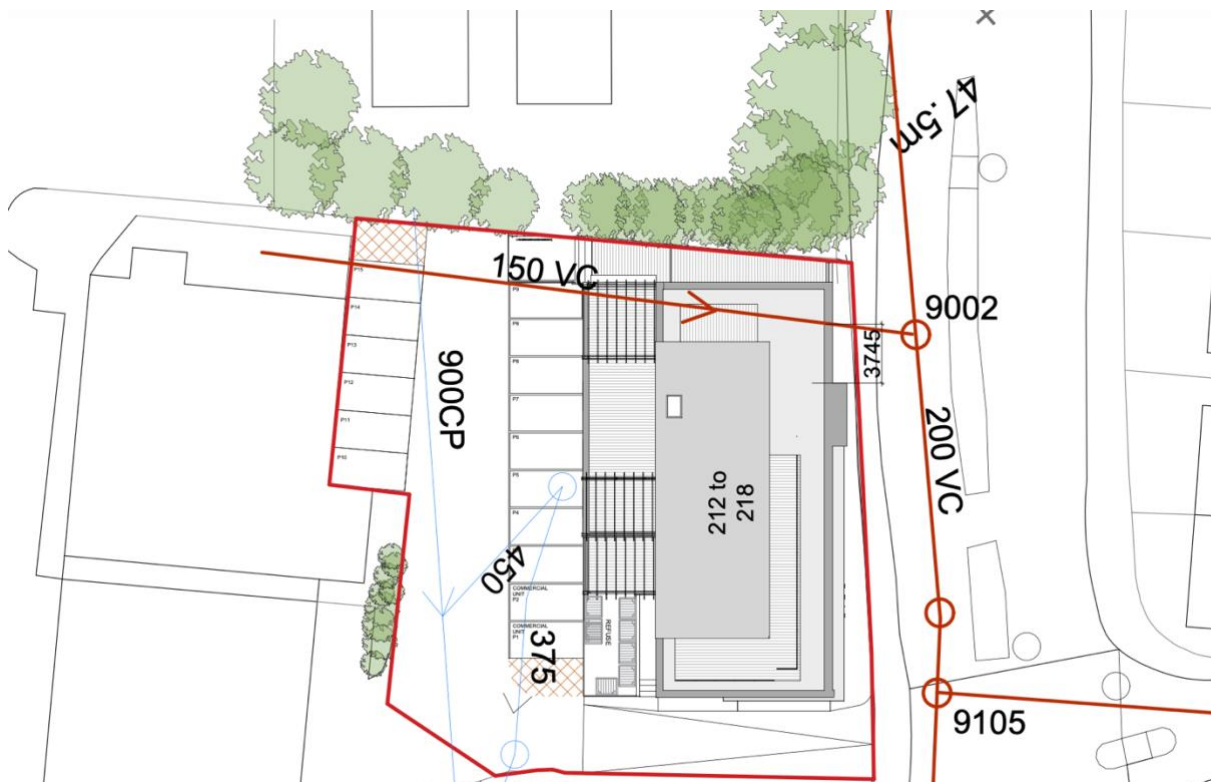
Figure 1 – Sewer alignment and stand-off distance relative to proposed development

The plan below illustrates the recorded sewer alignment relative to the proposed development footprint. A minimum clearance of approximately 3.7 metres is maintained between the sewer alignment and the proposed structure, exceeding the required stand-off distance.

The sewer alignment illustrated in Figure 1 has been derived from Southern Water asset records and verified against information obtained from the on-site CCTV drainage survey. An extract of the Southern Water asset location plan is included in Appendix B for reference.

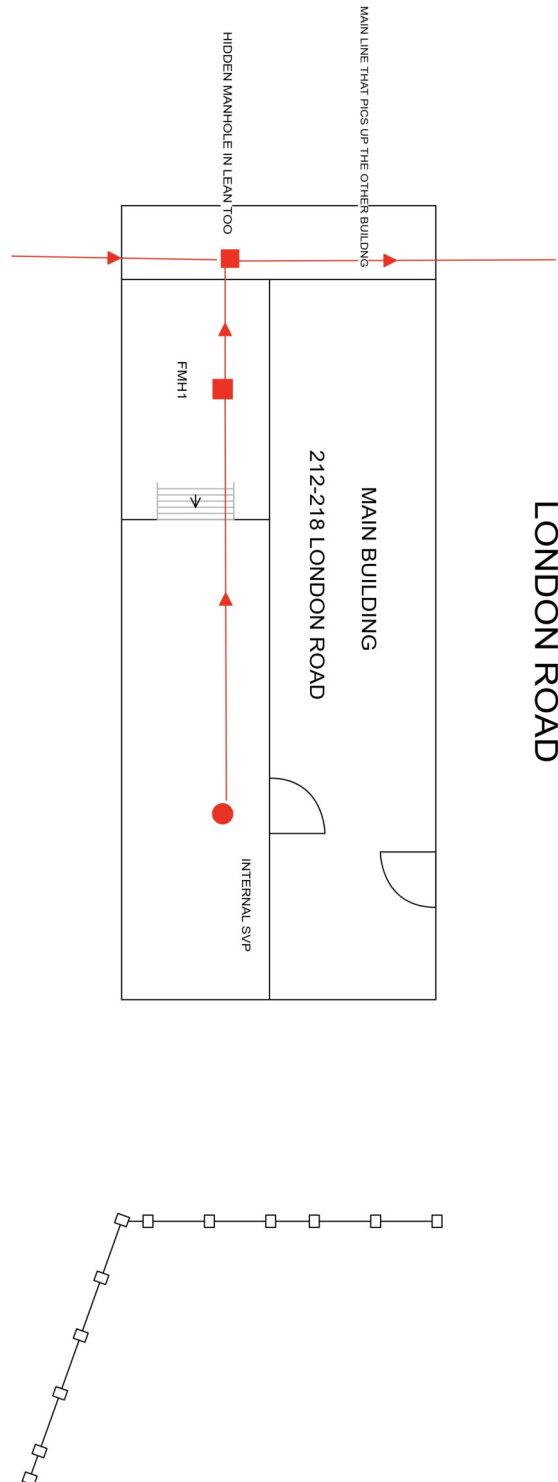
This sketch is not to scale and does not represent the exact routing of the drainage system

Manholes: **FMH1 to REST BEND**  
Pipe Length: **14.59 metres**  
Structural Grade: **0**  
Service Grade: **0**  
Material: **Polyvinyl chloride**  
Pipe Size: **100mm**  
Use: **Foul**

NO DEFECTS FOUND

Manholes: **FMH1 to PUBLIC MAIN SEWER**  
Pipe Length: **2.11 metres**  
Structural Grade: **0**  
Service Grade: **0**  
Material: **Polyvinyl chloride**  
Pipe Size: **100mm**  
Use: **Foul**
