# ARBORICULTURAL IMPACT ASSESSMENT AND PRELIMINARY METHOD STATEMENT

For the siting of 1No. Shepherd's Hut for Class C1 Tourist  
Accommodation on the land adjacent to Broad Oak,  
Copse Lane, Hayling Island, PO11 0QB

| Document reference: | MDJAC-BS25106-AIAPMS-01 Rev. A |
| Date: | 12 February 2025 |

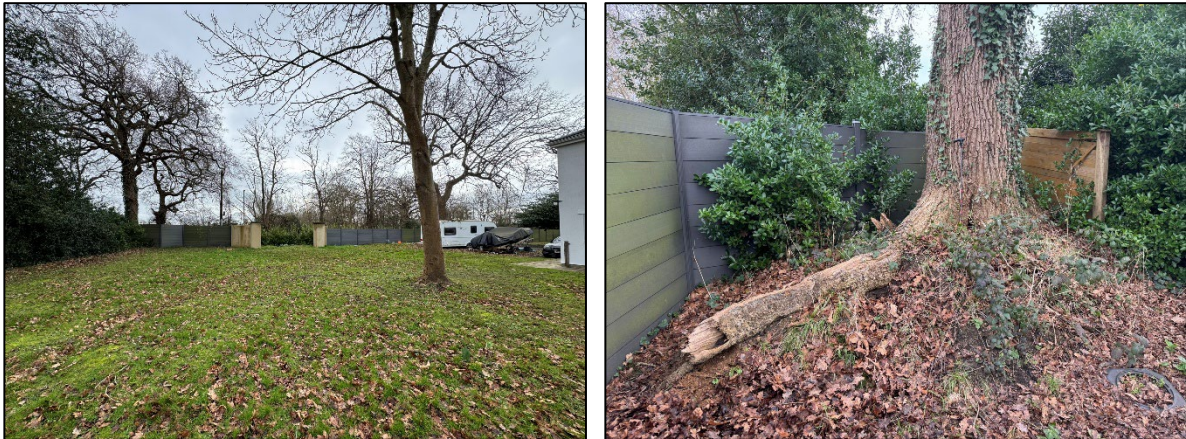
*Photograph 1: below left, looking southwards towards Copse Lane, showing the additional vehicular access point; and*

*Photograph 2: below right, showing historical root damage to T1, which may have been a result of the boundary treatment works.*

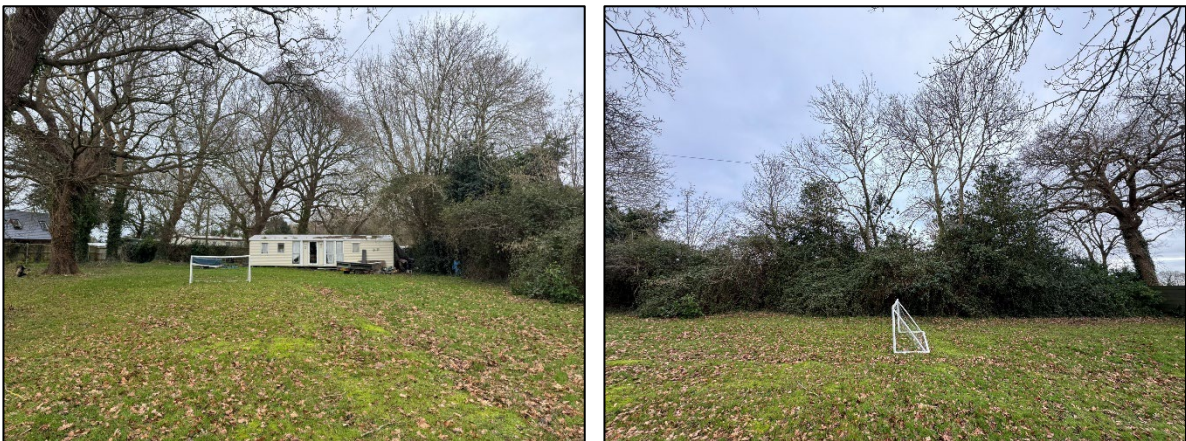
*Photograph 3: below left, looking northwards towards an existing static property and showing the mature trees along the western boundary of the application site; and*

*Photograph 4: below right, looking towards the eastern boundary, showing group G4 and T1 to the right of the frame.*
