# **ARBORICULTURAL IMPACT ASSESSMENT AND TREE PROTECTION PLAN**

**48 Park Lane, Cowplain, Waterlooville  
PO8 8BB**

**Date – 18<sup>th</sup> March 2026**

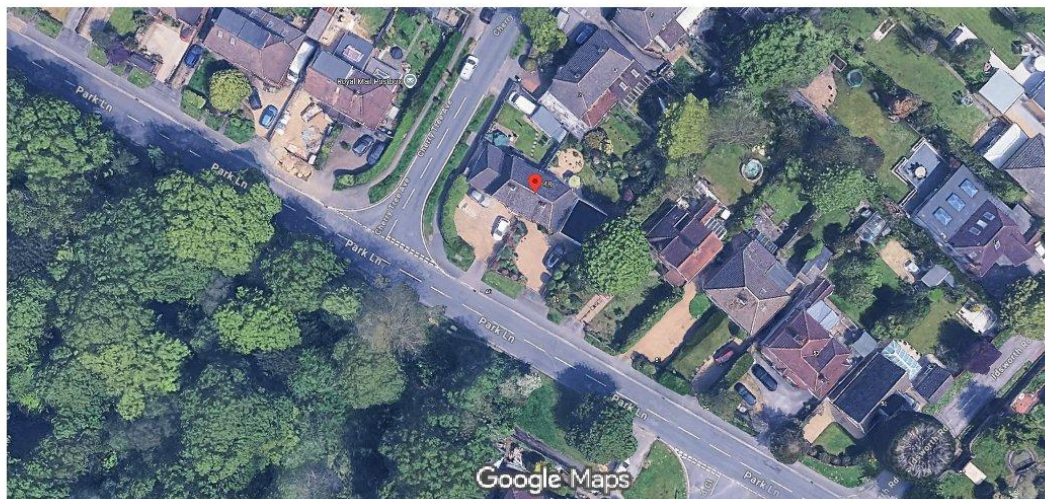
3.3 It is understood through correspondence with the Planning department that trees adjacent to the site are legally protected by a Tree Preservation Order. The online search facility does not show any protected trees on or immediately to the site but there is an application to fell an Oak tree immediately

to the east of the site due to a subsidence claim, unfortunately at the time of checking the decision is not available online but the tree subject to this application is no longer there.

**Figure 1:** Showing the offsite Oak visible on Google Maps that is no longer there.

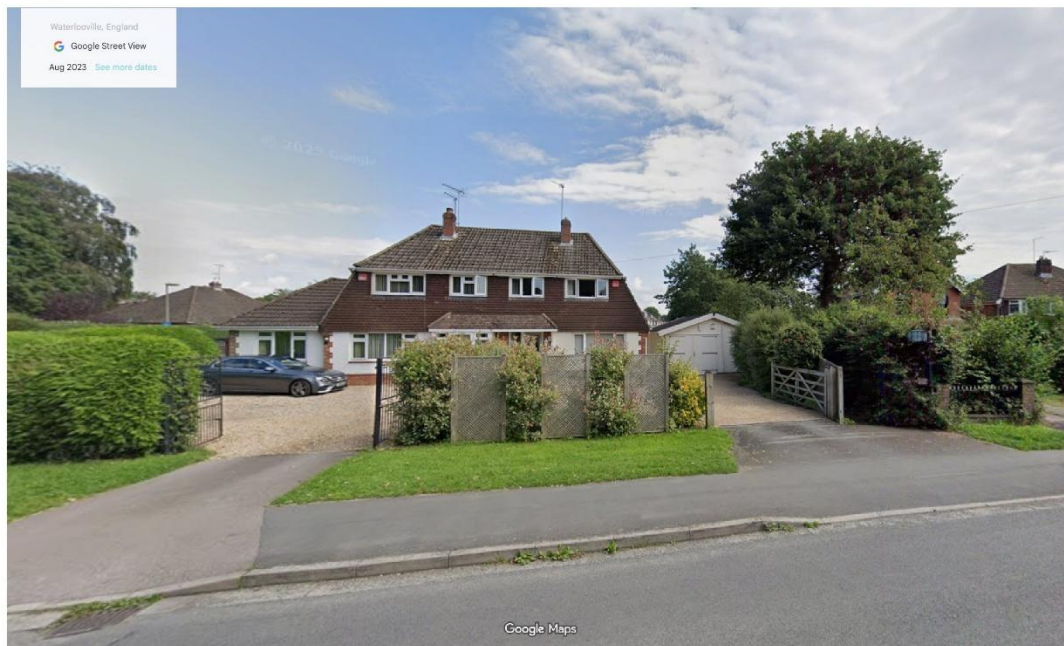
**Figure 2:** Showing the offsite Oak visible on Google Street View (dated 2023) that is no longer there.

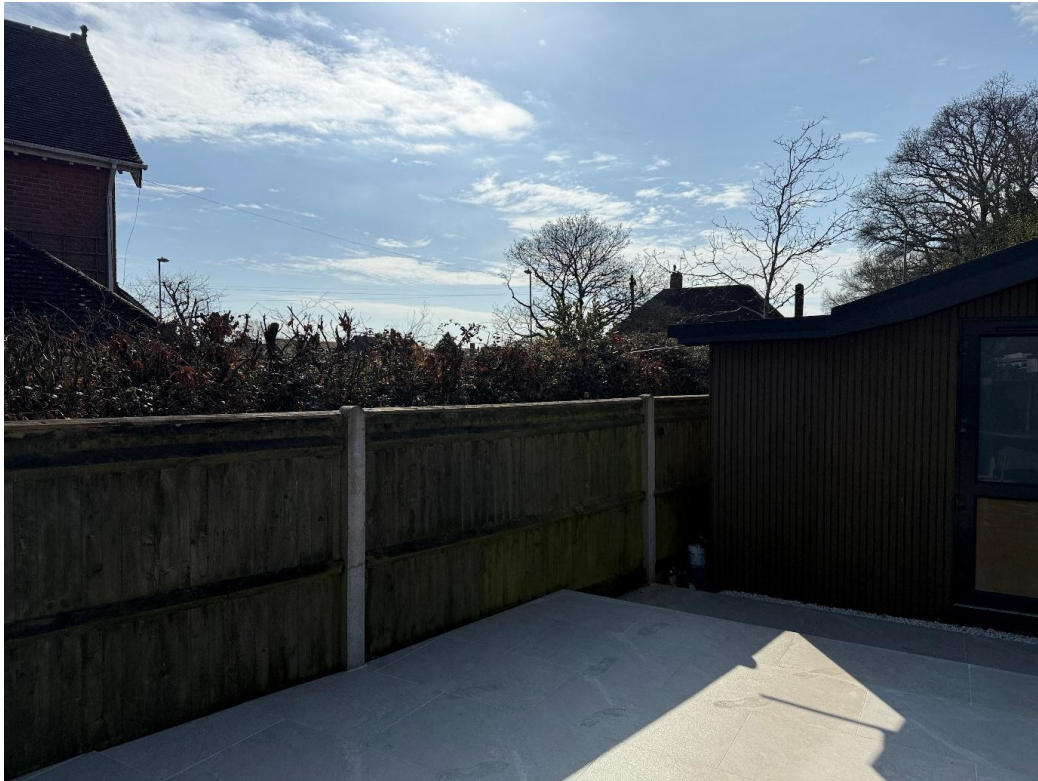
**Photograph 1:** Showing the absence of the Oak from the rear garden, looking southeast

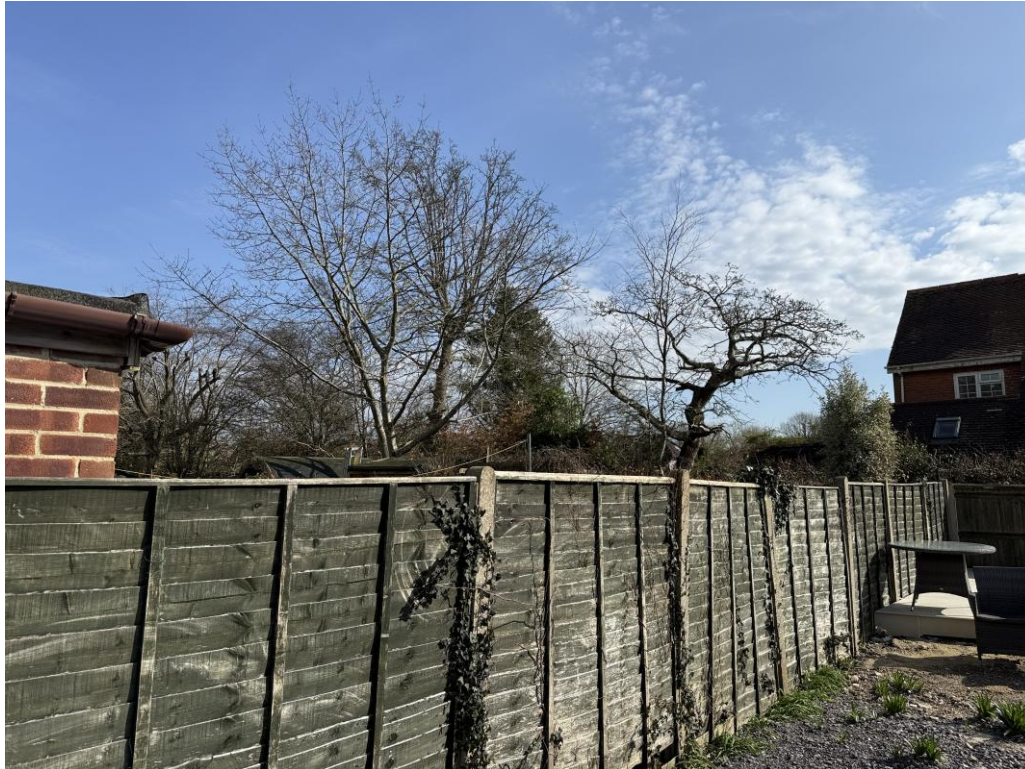
**Photograph 2:** Showing the relationship of the offsite trees from the rear garden, looking northeast

4.2 There is no potential damage that can occur to the significant trees beyond the site boundary as they are far enough away from the site boundary not to impact on the site.

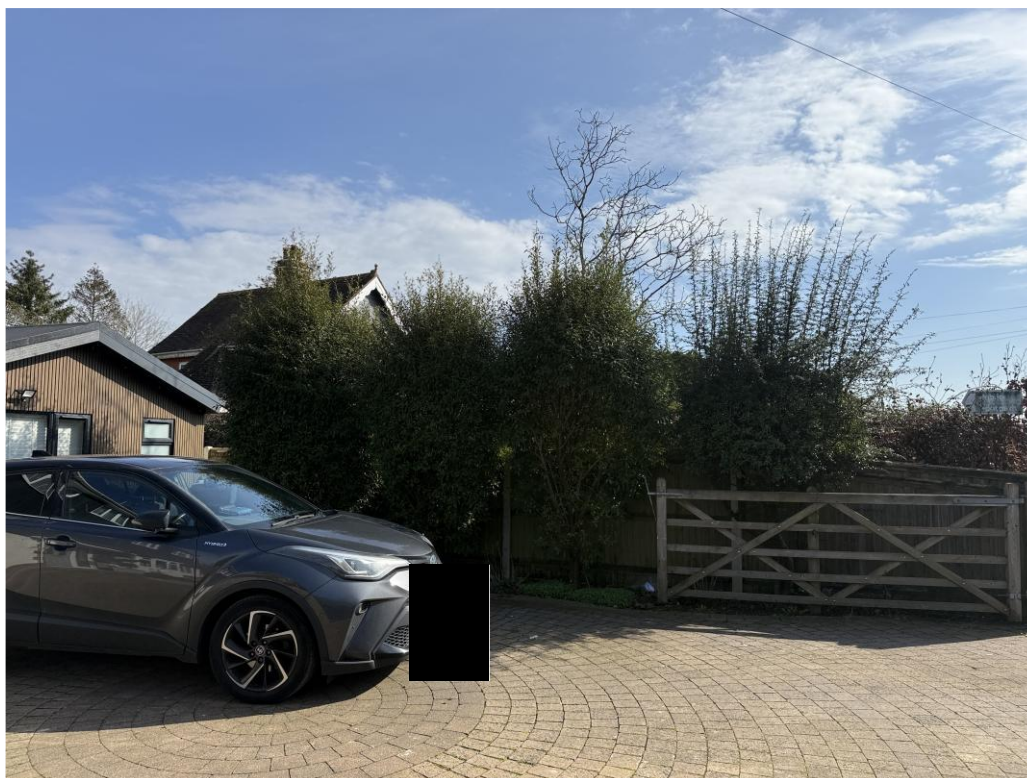
**Photograph 3:** Showing the only group of trees onsite large enough to survey and the absence of the Oak from the front garden, looking east

4.3 The potential for damage to the group of trees on site comes from the delivery and storage of materials and contractor parking where soft ground is damaged through compaction or through the leaching of chemicals into the ground.

4.4 The trees could also be damaged through indirect causes through ground compaction of soft ground whereby the soil structure is compromised which impacts on the tree's roots and rooting environment. Branches may also be snapped and damaged through the movement of vehicles and plant machinery.

6.5 The appropriate barrier adjacent to group 1 will be resistant to impact and require a positive or considered movement of the barrier to adjust its position. The robust barrier will be established along the edge of the driveway and area of soft ground to prevent materials being stored on the soft ground. The barrier should be formed by safety barriers (or similar) secured in place by weighted feet/sandbags or similar.
