## Arboricultural Impact Assessment

- Tree Survey
- Tree Protection Plan
- Arboricultural Method Statement

Langstone Park  
Langstone Road  
Havant  
PO9 1SA

Survey Date: 18<sup>th</sup> February 2026  
Report Date: 18<sup>th</sup> May 2026  
Project no: 1746.1

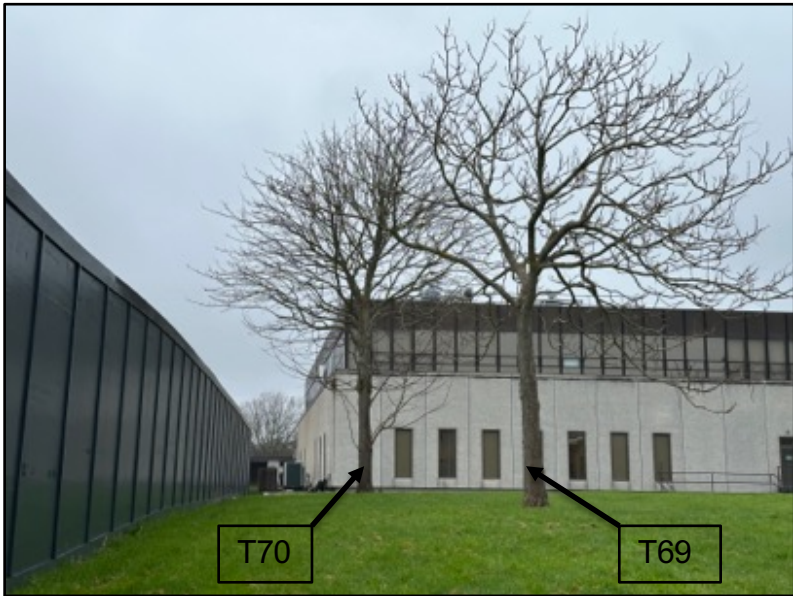
| Tree/<br>Group<br>No. | Species | Height<br>(m) | Stem<br>Diam. at<br>1.5m<br>(mm) | Branch Spread (m) | | | | Canopy<br>Clearance<br>(m) | Age<br>Class | Observations | Management<br>Recommendations | Estimated<br>Remaining<br>Contribution<br>(years) | BS 5837<br>Category<br>Grading | Protect-<br>ion<br>Distance<br>(m) | Root<br>Protect.<br>Area<br>(m2) |
|---|---|---|---|---|---|---|---|---|---|---|---|---|---|---|---|
| T69 | Indian bean tree | 6 | 230 | 4 | 3 | 3.5 | 3 | 1.5 | Semi-<br>mature | Asymmetric crown. Reasonable vitality. | Previously approved for removal under outline planning ref: APP/22/00172 | 10-20 | C2 | 2.8 | 24 |
| T70 | Norway maple | 8 | 300 | 3 | 2.5 | 3 | 3.5 | 2.0 | Early<br>mature | Good form and structure. Low limbs removed with multiple pruning wounds on stem. Stem shoots. | Previously approved for removal under outline planning ref: APP/22/00172 | 20-40 | B2 | 3.6 | 41 |

T69 & T70 located to the east side of the Phase 3 development area. Both trees approved for removal under outline planning permission however removal is not required for the Phase 3 development.

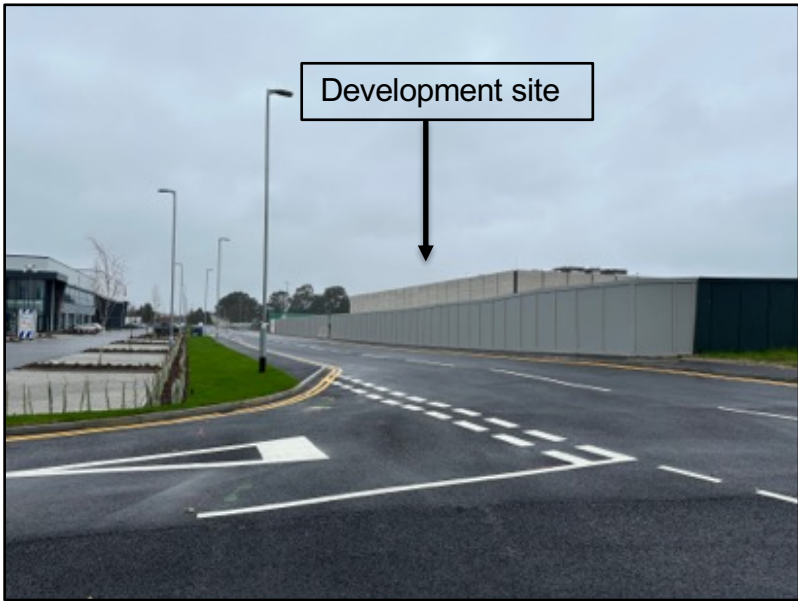
View to west along access road on south side of Phase 3 development area.

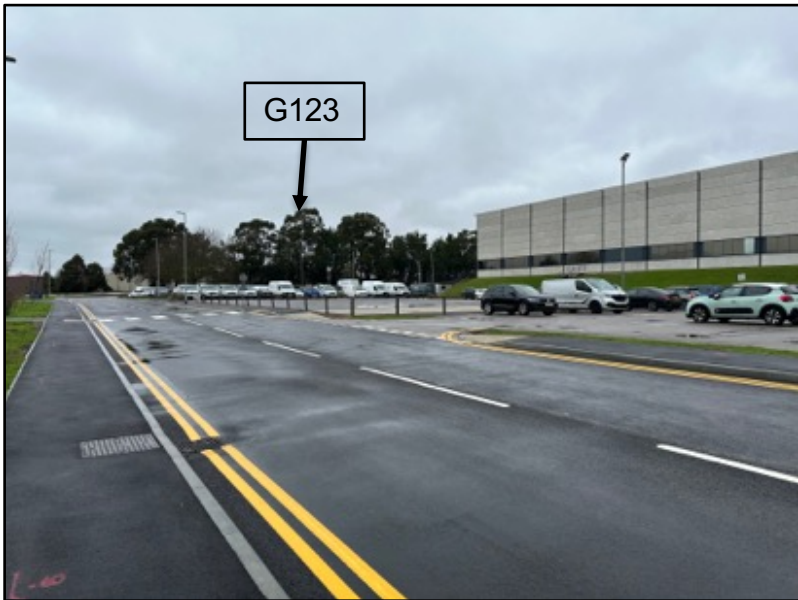
Further view to west, at western end of Phase 3 development site.

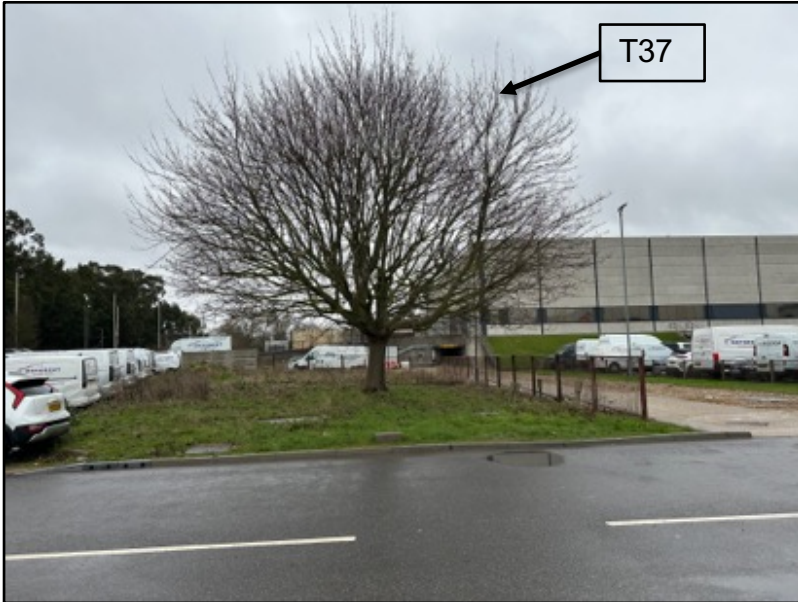
| Tree/<br>Group<br>No. | Species | Height<br>(m) | Stem<br>Diam. at<br>1.5m<br>(mm) | Branch Spread (m) | | | | Canopy<br>Clearance<br>(m) | Age<br>Class | Observations | Management<br>Recommendations | Estimated<br>Remaining<br>Contribution<br>(years) | BS 5837<br>Category<br>Grading | Protect-<br>ion<br>Distance<br>(m) | Root<br>Protect.<br>Area<br>(m2) |
|---|---|---|---|---|---|---|---|---|---|---|---|---|---|---|---|
| T37 | Norway maple | 10 | 540 | 7 | 5 | 5.5 | 5.5 | 1.5 | Mature | Crown break at 1.8m. Previously reduced. Old pruning wounds and one tear out wound to low lateral to east. | Remove to facilitate Phase 3 development. Previously approved for removal under outline planning ref: APP/22/00172 | 15-30 | B-C2 | 6.5 | 132 |

T37 within Phase 3 development area. Previously approved for removal under outline planning permission.

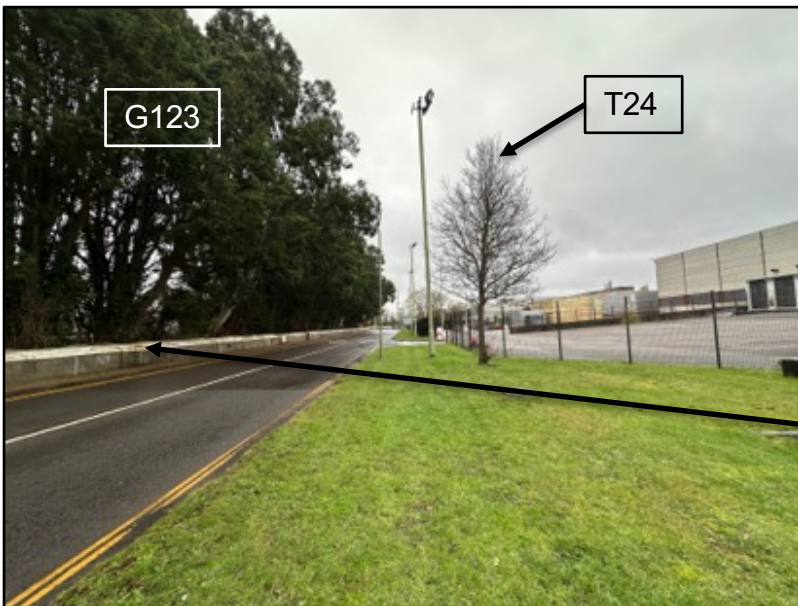
| Tree/<br>Group<br>No. | Species | Height<br>(m) | Stem<br>Diam. at<br>1.5m<br>(mm) | Branch Spread (m) | | | | Canopy<br>Clearance<br>(m) | Age<br>Class | Observations | Management<br>Recommendations | Estimated<br>Remaining<br>Contribution<br>(years) | BS 5837<br>Category<br>Grading | Protect-<br>ion<br>Distance<br>(m) | Root<br>Protect.<br>Area<br>(m2) |
|---|---|---|---|---|---|---|---|---|---|---|---|---|---|---|---|
| G123 | Eucalyptus/Leyland cypress | 12 - 18.5 | est 600 - 1000 | | | | | 4.0 | Mature | Stems located to back of concrete wall - bases not inspected. Eucalyptus with high vigour and of immense size. Low limbs removed from Leyland. Elder, ivy and bay inbetween and around bases. Tree at northern end fire damaged. Large accumulation of tree debris around bases, including flaked bark from eucalyptus which is a potential fire hazard. | Remove fire damaged tree from northern end of line. Carry out hazard assessment. | 15-30 | B-C2 | 12.0 | 452 |

T24 within Phase 3 development area, previously approved for removal under outline planning permission.

Line of eucalyptus and Leyland cypress G123 located to west side of pavement, along access road to main entrance. A large service duct runs along the west edge of the pavement which prevents access to the tree stems.

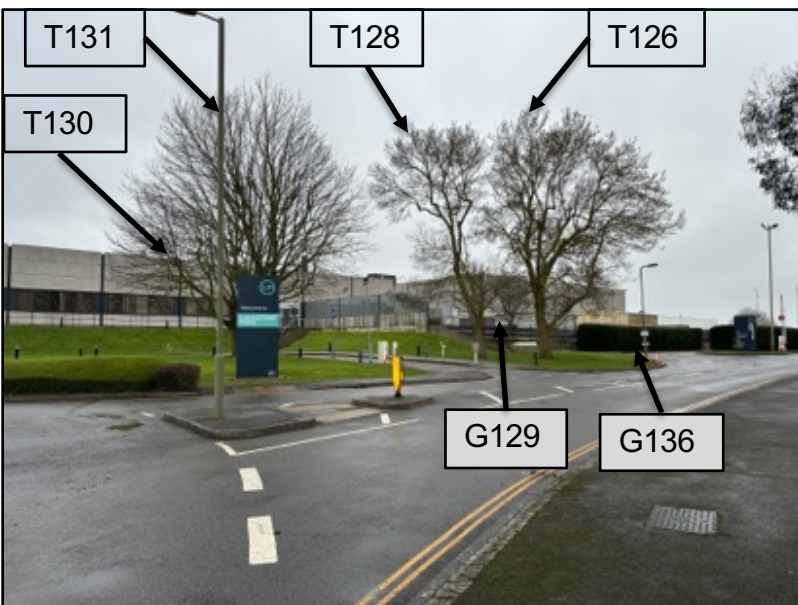
Trees and hedge located to east side of access road – not within the Phase 3 development area.

T126, T128, G129, T130 & T131 together with hedge G136 previously approved for removal under outline planning permission.
