# North Street House

## Heritage Statement

**North Street House, 6 North Street, Emsworth, PO10 7DD**

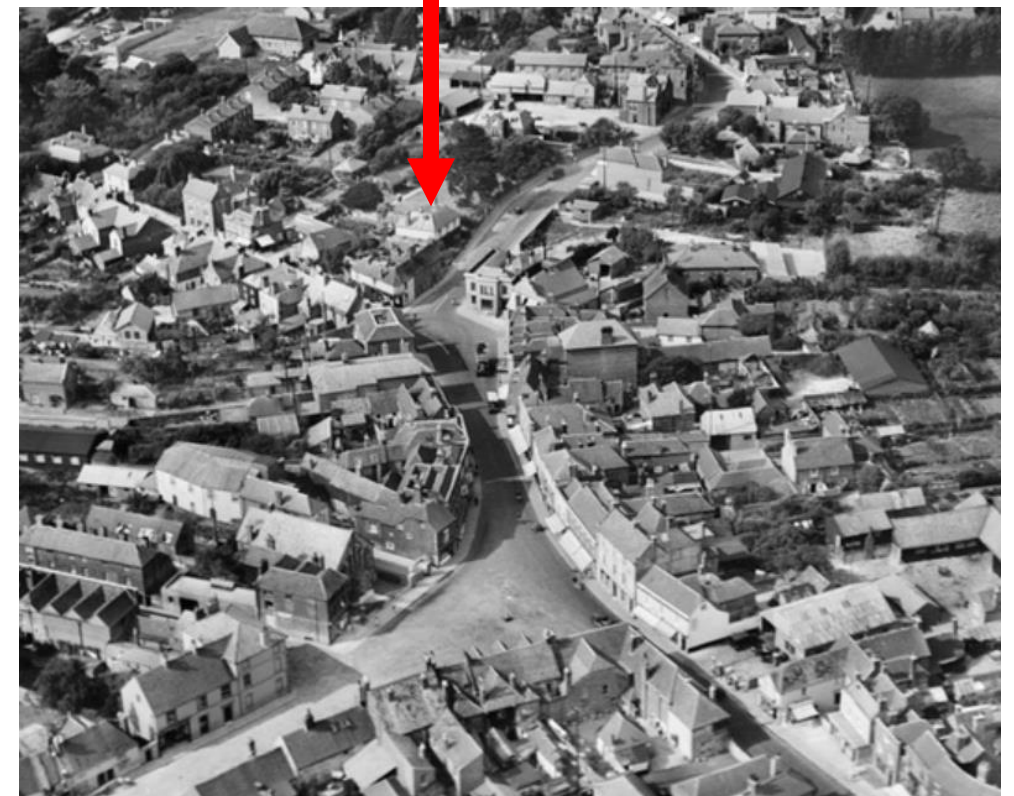
NORTH STREET HOUSE

Overview of the site development following research and a review of the historic maps and photographs:

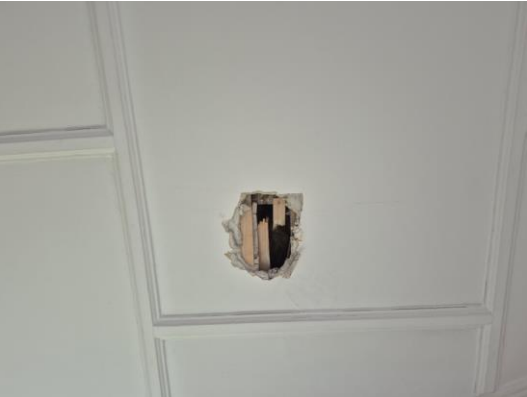
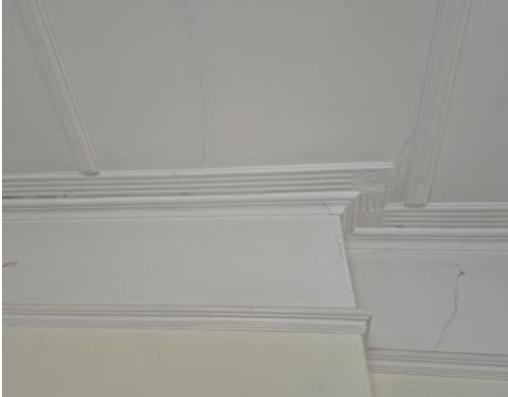
Ceiling details

Panelled ceilings are found in two of the first-floor rooms, these are considered to be feature of historic interest. It is proposed to install a new ceiling below the existing ceilings to ensure the historic fabric is retained.

Many of the rooms within the original Georgian building feature mouldings around the ceilings.

With some rooms also featuring cornice details. (Example above)

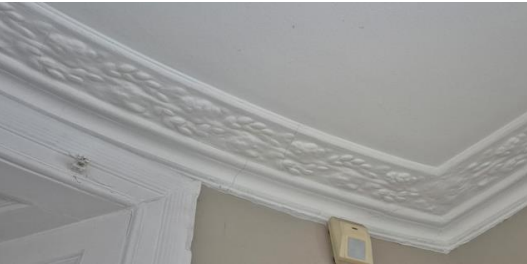
It proposed to insulate within the existing floor voids to both improve thermal efficiency and to reduce sound travelling between floors. To do this, the existing timber floorboards will be taken up and insulation fitted between existing floor joists. The existing timber floorboards are then to be reinstated. At ceiling level existing plasterboard ceilings are to be replaced . All laths and plaster ceilings are to be retained, and a new plasterboard ceiling lined below.

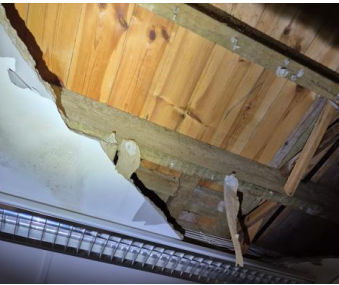
Whilst it is determined that some of the ceiling are laths and plaster, many are modern plasterboard as evidenced.

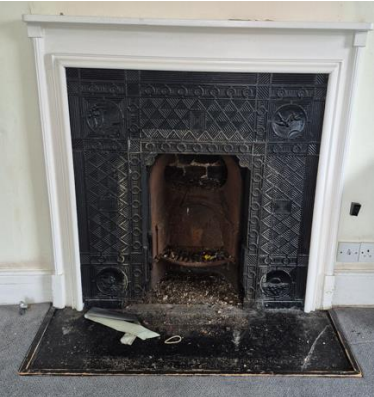
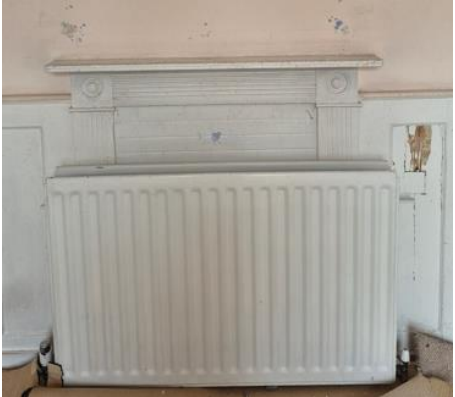
Fireplace details

Only 2 original fireplaces remain. They are both located on the first floor. The first features a highly decorated cast iron panel with moulded timber surround. The second is currently partly obscured by a modern radiator (as pictured), though it features a painted timber surround with fluting and bulls eye mouldings. These are considered to features of historic interest.

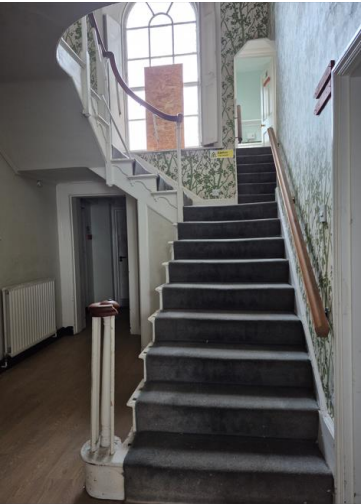
Current photo of staircase

The main staircase is of timber construction with moulded string and pendant drop.

The existing balustrade to the main stair was previously identified as an important architectural feature, but large sections have since been lost due to vandalism. This is to be reinstated, replicating the original design.

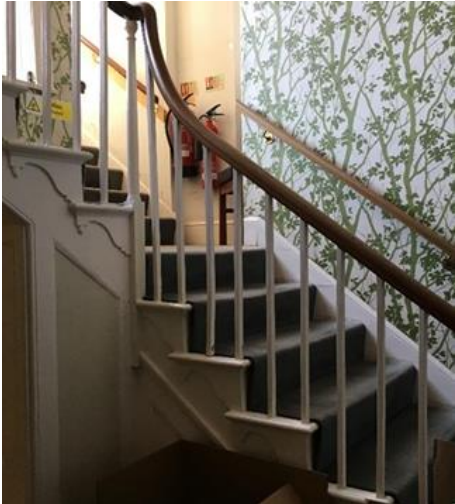
Historic photo of balustrade detail prior to vandalism

The balustrade was formed of simply moulded balusters and a timber continuous handrail with a voluted end. It is proposed to repair the damaged sections to match the existing.
