WELLINGTON WAY, WATERLOOVILLE

PHASE 1 DESK STUDY

This Phase 1 Desk Study has been prepared for the clearance and redevelopment of an existing retail site located off Wellington Way, in Waterlooville, Hampshire, PO7 7ED by Lustre Consulting Limited (Lustre) for CPI Wellington Way 2 Ltd. CPI Wellington Way 2 Ltd requires this Phase 1 Desk Study to support a new planning application, which is understood will involve the demolition and clearance of the existing Shopping Centre and construction of a residential apartment block, with amenities and communal residential garden.

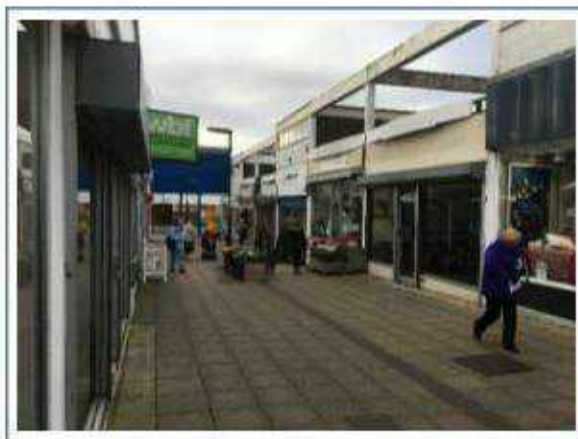
- 2.4 At the time of the walkover, half of the units were recorded as vacant. The vacant units appeared to have once been occupied by a charity shop, an angling and bait shop, a baby goods outlet, a café and a toy shop. The remaining occupied units included charity shops, a health food shop, an estate agent, a greengrocer and a clothing shop. There was no notable sign of ground contamination associated with the current use of the site.

*View of retail units and precinct towards Hambledon Road*

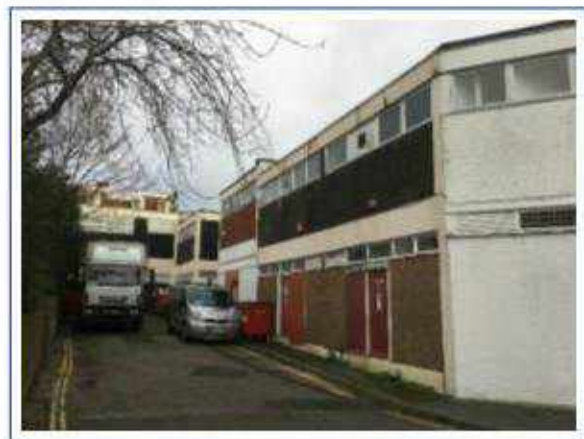
*Tradesman entrance behind north western block*

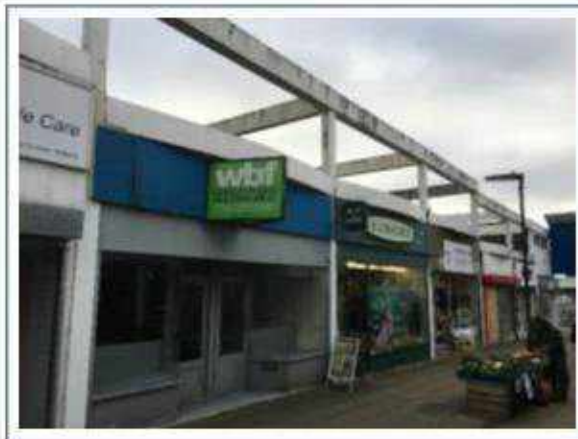
- 2.5 No evidence of ground stability hazards or significant structural damage was observed on site. However, this report does not constitute a structural survey or similar survey. It was noted that some of the exposed concrete frame had appeared broken away from the main structure, most likely due to some localised corrosion.

*Retail units and view of concrete frame*

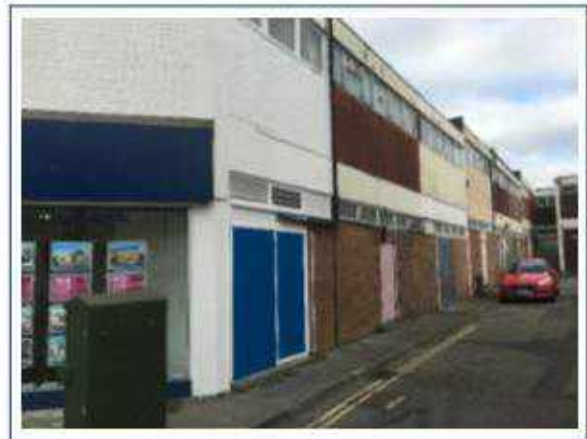
*Shared tradesman entrance to the rear of south eastern block*

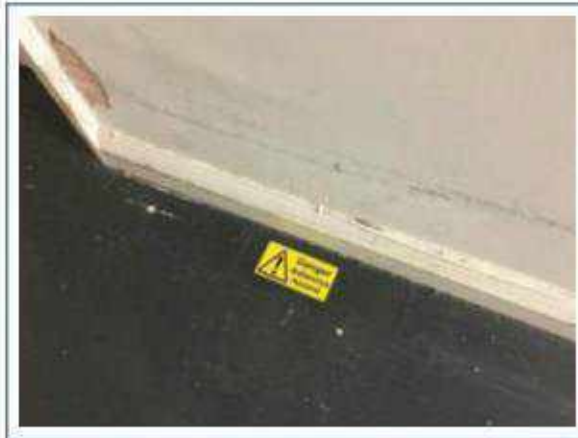
- 2.7 ACM was commonly used in construction and refurbishment projects until their use was prohibited in 1999. Given the age of the buildings present on site (including any refurbishment works), the potential for ACM to be present within the building fabric and curtilage is highly likely. The presence of a boiler room in M&Co. at roof level lead to the internal investigation of that room to check for the potential of ACMs. On arrival, it was clear that this unit had undergone its own asbestos management survey which was confirmed by the manager. However, it was not made available at the time of the survey. Asbestos warning signs were noted on the floor tiles (likely present in the vinyl tiles and bitumen) and on the door of the boiler room. A quick inspection of the boiler room noted the presence of asbestos containing materials in the pipe lagging, water cisterns, electronic switch gear and redundant boilers. The lagging was in good condition and had been painted.

*View of vinyl floor tiles in M&Co.*

- The current use of the site as part of the Wellington Way Shopping Centre will not be considered further reflecting the nature of the on-site activities and the fact that no visual evidence of contamination was noted during the site walkover. It is assumed that a pre-construction asbestos survey will be undertaken, and all ACMs removed before the existing structure is removed.

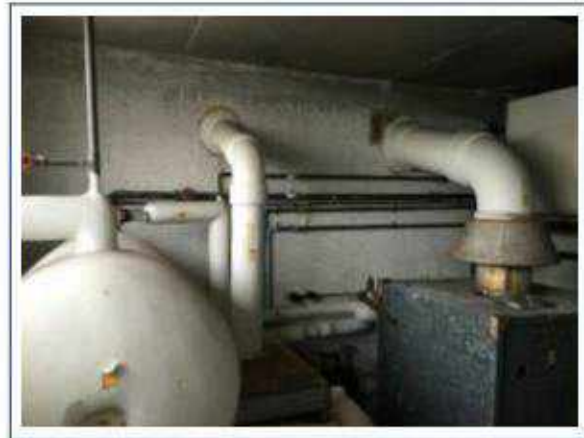
*View of ACM lagging and pipework in M&Co. Boiler room*
