**Phase I - II  
Geo-Environmental Site Assessment**

**Helmsley House, Bartons Road, Havant, PO9 5NA**

**June 2022**

***Omnia ref: A11840/1.0***

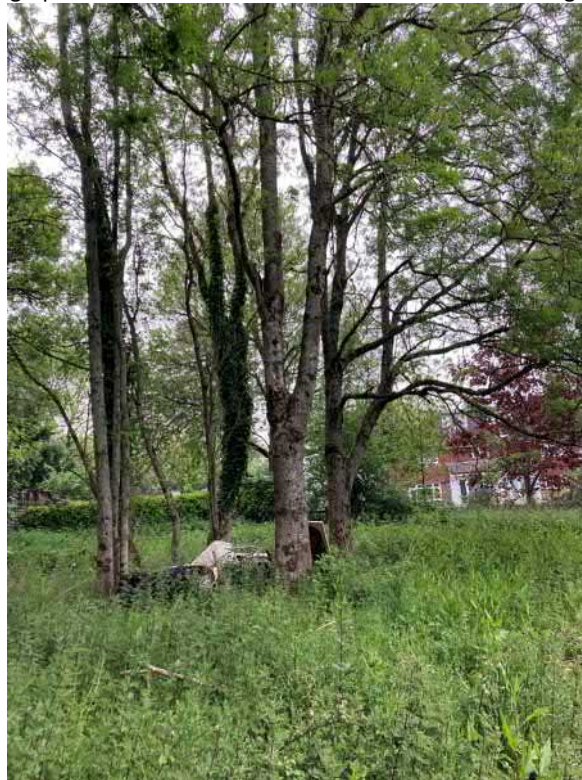
Photograph 6 – View of waste around trees on site

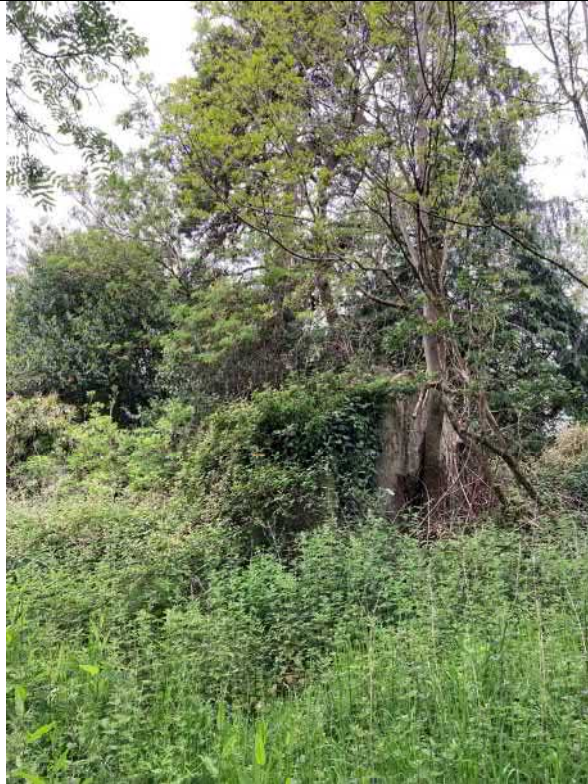
Photograph 7 – View of partially demolished building with overgrown vegetation around it

It is therefore recommended that an asbestos survey is undertaken in accordance with the Control of Asbestos Regulations (2012) prior to the commencement of any refurbishment or demolition works.
