## Preliminary Roost Assessment

66 Bedhampton Hill, Bedhampton, Havant, Hampshire, PO9 3JP

Proposed loft conversion and erection of an annexe following the demolition of the existing garage.

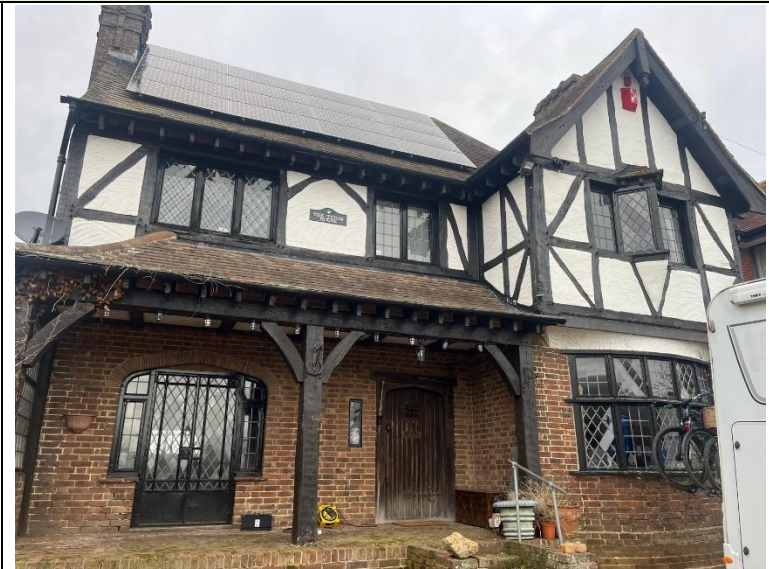
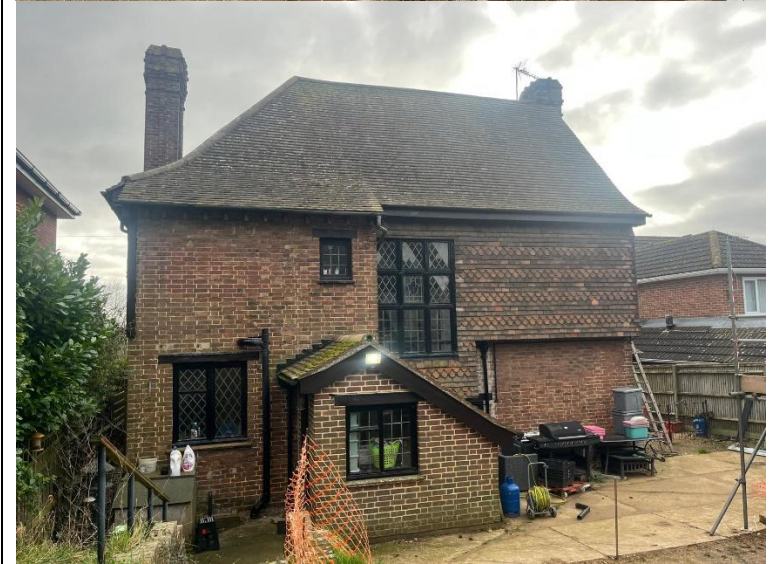
B1 is a detached brick built residential dwelling with a rendered first floor with timber inlays. The gabled roof is clad in clay tiles with a single storey porch on the front elevation and a cat sliding porch on the rear. The rear of B1 is clad in clay club hanging tiles which provide roosting opportunities for crevice dwelling bats. Solar panels cover the southern elevation which may block any access points within the main roof.

B1 has **high value** for roosting bats.

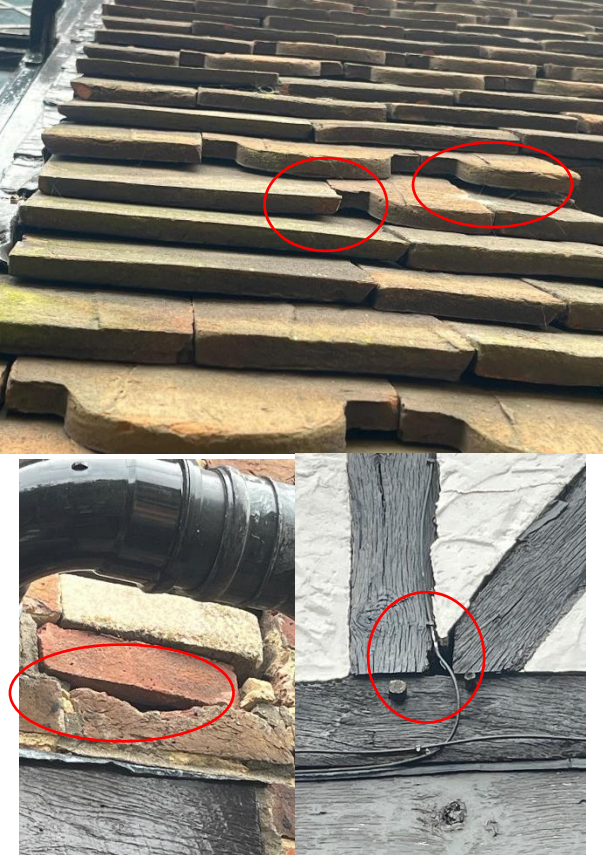
| Feature | Materials | Condition/description /suitability | Photographs |
|---|---|---|---|
| Walls | Brick, render, timber inlays, clay hanging tiles | <p>Numerous gaps within the hanging tiles alongside a gap within the timber and another within the brickwork.</p> <p>Gaps within hanging tiles provide ideal roosting habitat for crevice dwelling bats and could support maternity roosts. No evidence found but recent and current rain would wash this away externally.</p> | |

| <i>Recommendations</i> | <p><b>B1</b></p> <p>Three bat emergence surveys are required during the active bat season (optimal May to August, suboptimal September) to confirm presence or likely absence of a bat roost in the building. At least 2 of the surveys should be completed during the optimal survey period May to August inclusive and surveys should be spread at least three weeks apart.</p> <p>Infra-red cameras should be used as an aid both inside and outside the building.</p> <p>Four surveyors are required to provide full coverage of the building from the outside.</p> <p>If any bat roosts are confirmed from this survey schedule, a bat license would be required to carry out the works as it would involve the destruction of roosts. This is applied for with the help of a class 2 licensed bat ecologist after planning permission is granted, but before commencement of works.</p> <p>If bat roosts are confirmed in the building an EPSL application will be required to Natural England. The EPSL application requires that all surveys have been undertaken within the most recent active bat season and planning permission must have been granted and all relevant wildlife-related conditions have been discharged prior to submission.</p> <p><b>B2</b></p> <p>In the unlikely event that a bat or evidence of bats is discovered during the development all work must stop, and a bat licensed ecologist contacted for further advice.</p> |

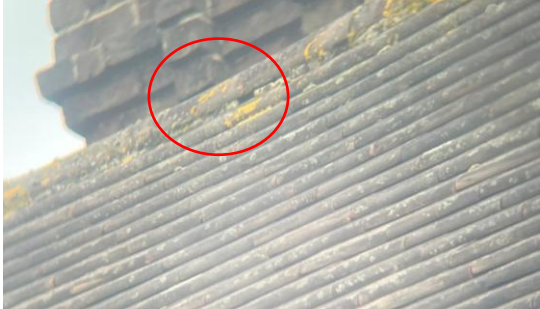
| Feature | Materials | Condition/description /suitability | Photographs |
|---|---|---|---|
| Roof | Clay | <p>The tiles on the main roof appear to be generally in good condition with no gaps that could provide roosting opportunities or access into the roof structure however there are areas of missing mortar along the ridge line which could be utilized by roosting bats.</p> <p>No evidence found but recent and current rain would wash this away externally.</p> | |

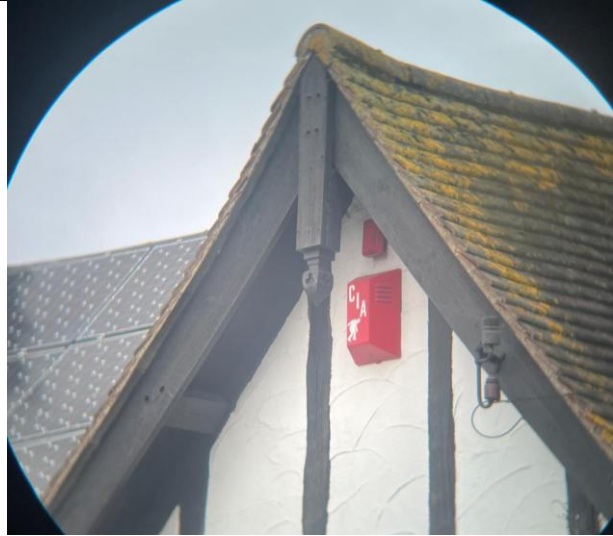
| Eaves | Overhanging | Gaps/crevices on wall tops.<br>Provides possible bat access into internal void and crevices on wall tops. Bat droppings were found at the top gable wall within the loft which would indicate the presence of crevice dwelling bats roosting within the wall tops. | |

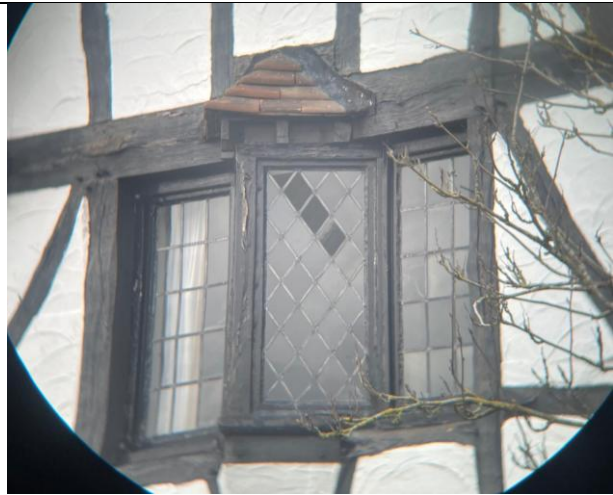
| Window/doors frames and lintels | Timber | Tightfitting | |

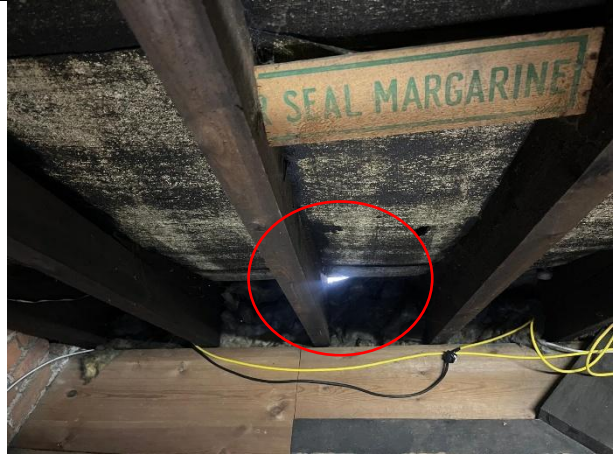
| Internal voids | Timber rafters and ridge beam.<br>Bitumen felt and timber boarding | <p>The loft is lined with bitumen felt which appears to be in good condition with no obvious gaps into the loft space. Gaps along the wall tops are present and the beams provide roosting opportunities.</p> <p>The approximate internal dimensions of the whole loft area are: 11m (L) x 3.8m (W) x 3.8m (H) [Height is measured to the highest point of the loft space].</p> | |

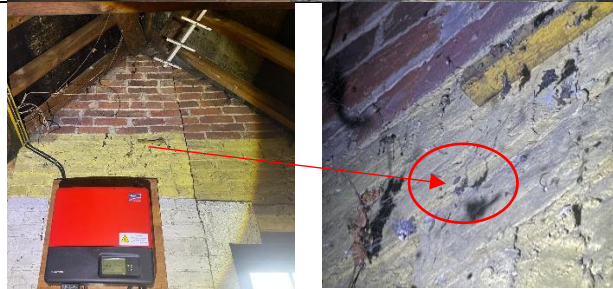
| Bat evidence | 4 x bat droppings | <p>Approximately four bat droppings were found caught in cobwebs at the gable end on the south-western elevation. Due to the location of the droppings it would appear they belong to a crevice dwelling species that is roosting within the wall tops of the gable end and the droppings have fallen through into the loft void. The droppings appeared of similar age. A sample has been collected for DNA analysis.</p> | |

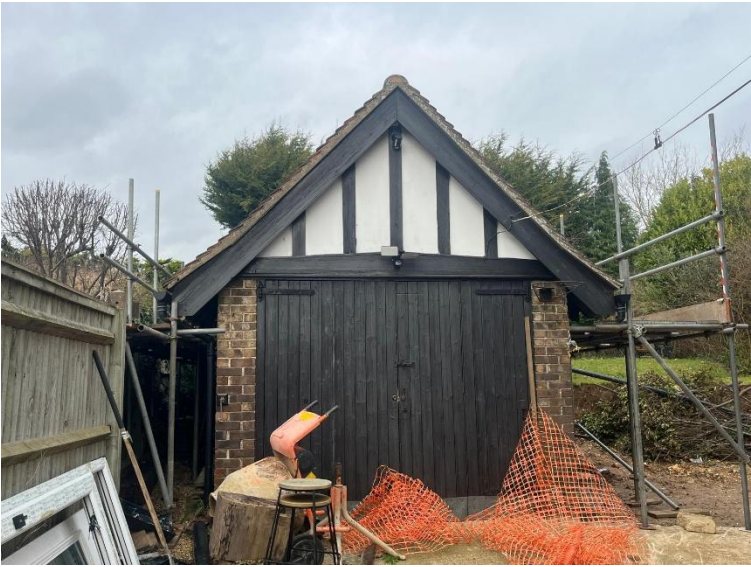
| <b>Field survey results</b> | |
|---|---|
| <p><i>Summary</i></p> <p>B2 is a brick and rendered with timber inlays detached garage with a gabled roof clad in clay roof tiles which appear in good condition with no gaps that could provide roosting opportunities. The timber inlays are all tightfitting with the brickwork and the wall tops appear to be well sealed. Internally the ceiling is timber boarded, creating a loft void above. No evidence of roosting bats was identified internally or externally during the survey.</p> <p>B2 has <b>negligible value</b> for roosting bats.</p> | |
