# **Berewood, Town Park Phase B**

## **Ground Investigation Report**

WYG

CS-J-0161

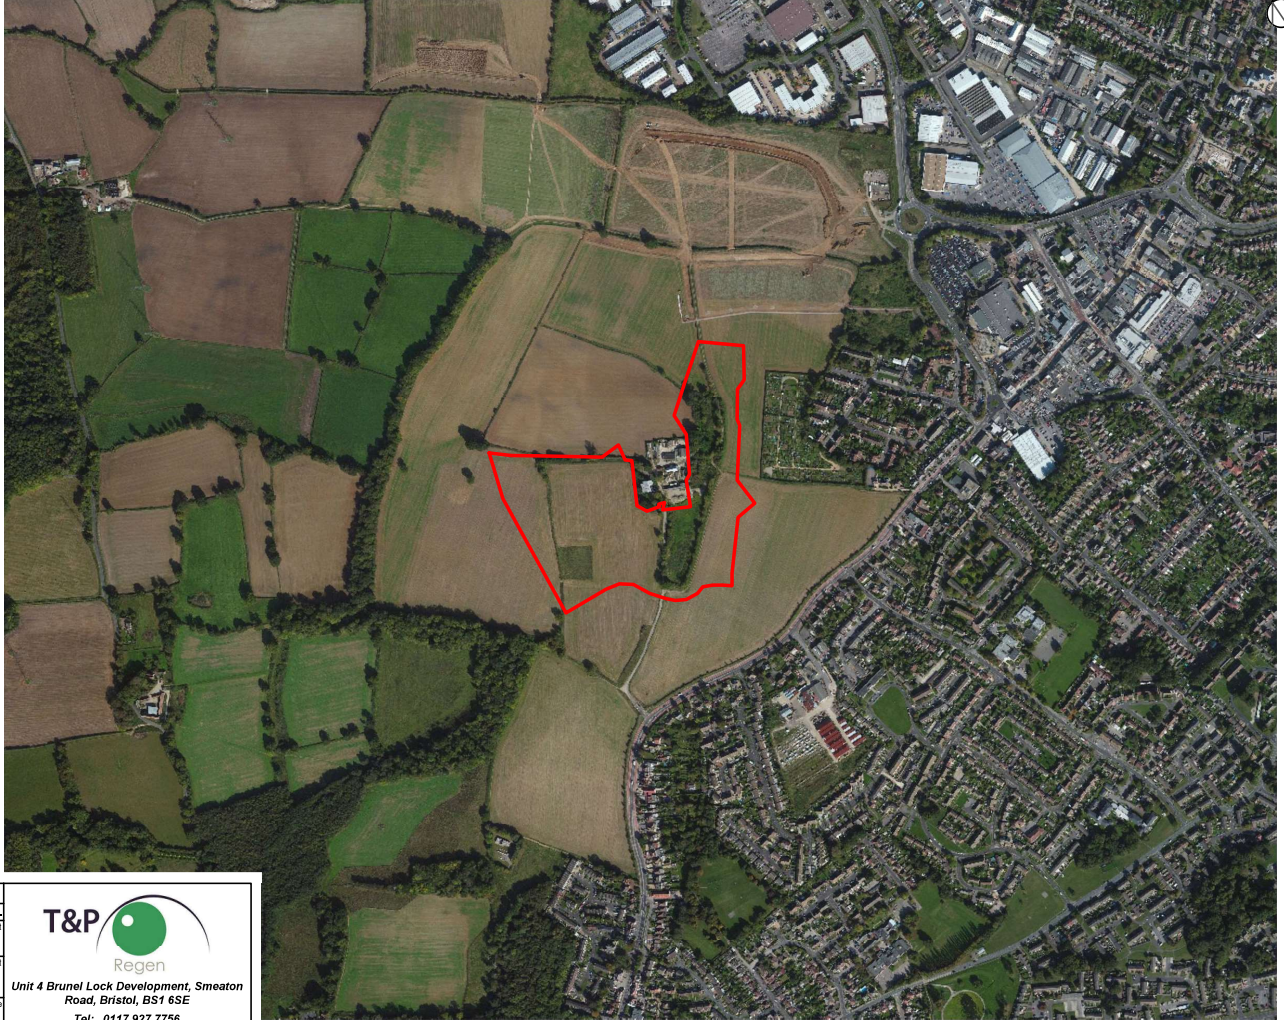
| - | CS-J-0161-01-001 |

— Site Boundary

Site location information is summarised in Table 2.1. A Site Location Plan is presented within Appendix A.

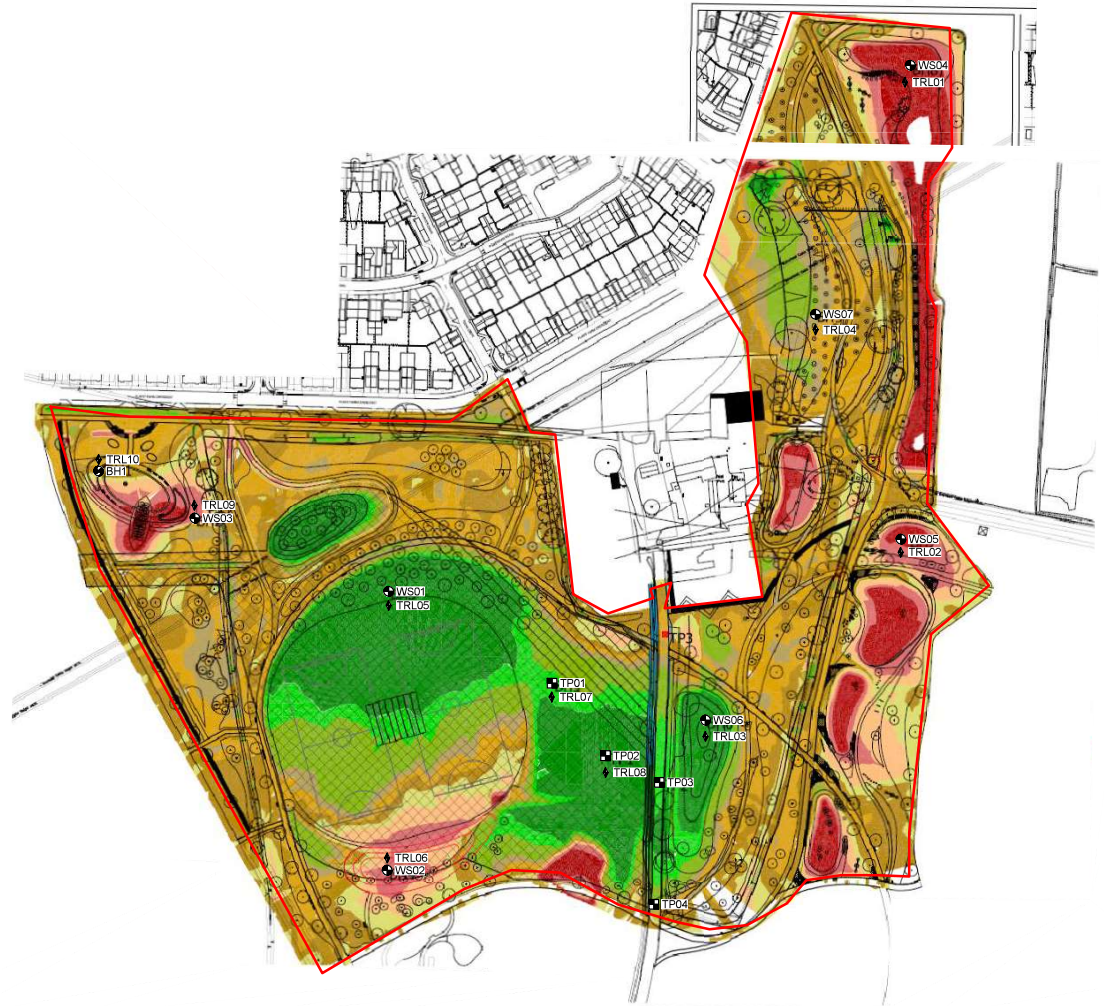
**Base Map**  
 Company - Mayer Brown Limited  
 DWG Title - Proposed Oil Test Locations  
 DWG Number - 011WVRLLE\_17259K06  
 Date - July 2019

- Rotary Borehole Locations (BH1)
- Windowless Sampling Locations (WS01 - WS07)
- Trial Pit Locations (TP01 - TP04)
- ◆ TRL Locations (TRL01 - TRL10)
- Site Boundary

An exploratory location plan is presented in Appendix A. A selection of photographs is provided within Appendix B. Exploratory logs are presented in Appendix C.

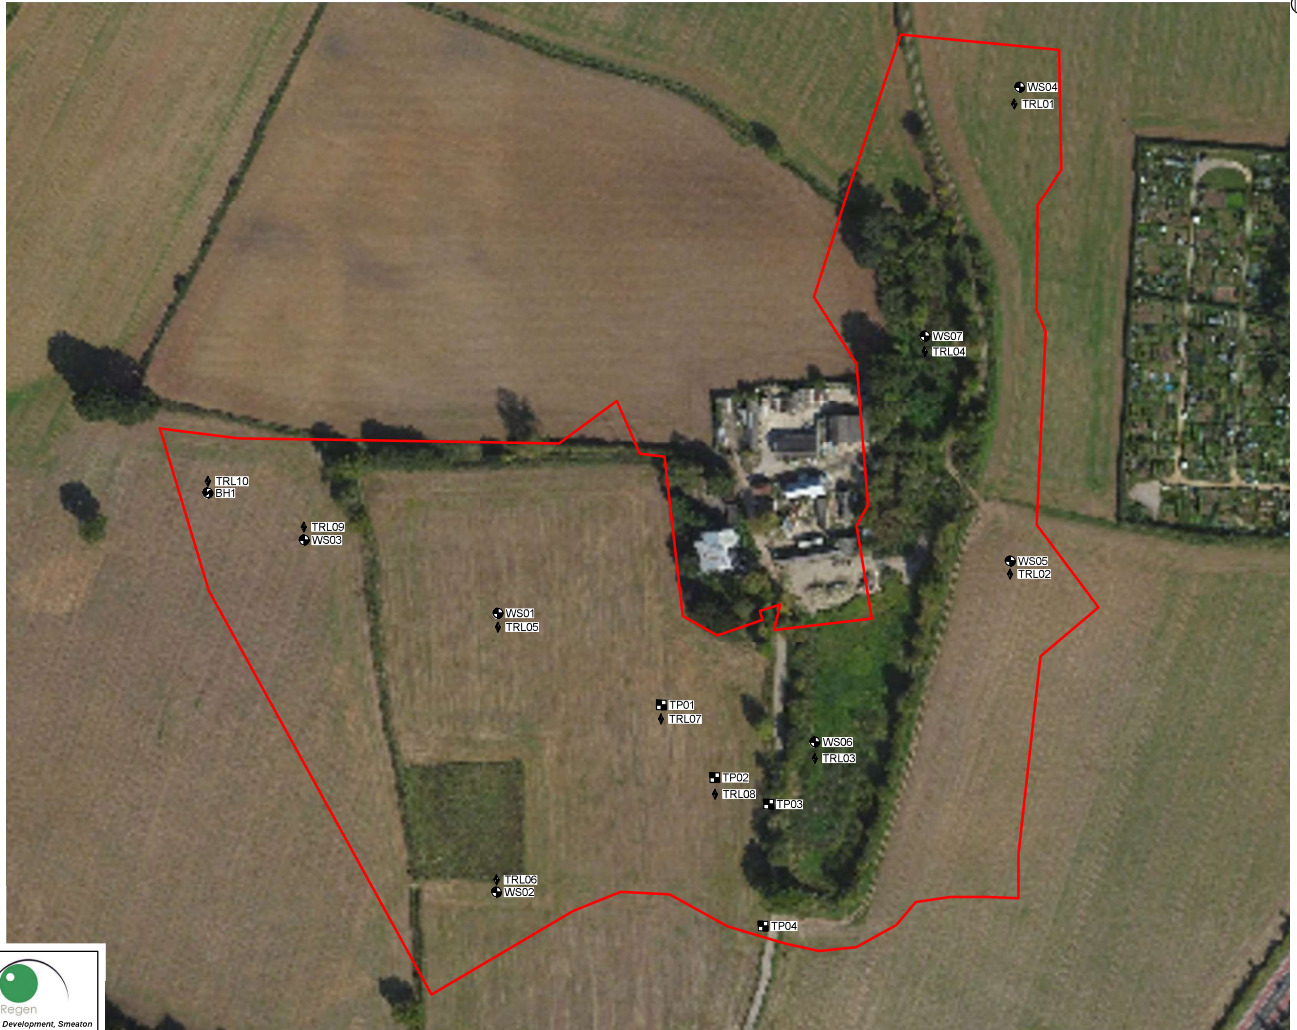
- Rotary Borehole Locations (BH1)
- Windowless Sampling Locations (WS01 - WS07)
- Trial Pit Locations (TP01 - TP04)
- ◆ TRL Locations (TRL01 - TRL10)
- Site Boundary
