## Southleigh Park House: Window frame condition investigation

Site note A9 for 9 and 10 December 2020, job no. 152.09

The aim of this survey was to investigate the condition of the timber window frames and to provide remedial advice to inform refurbishment

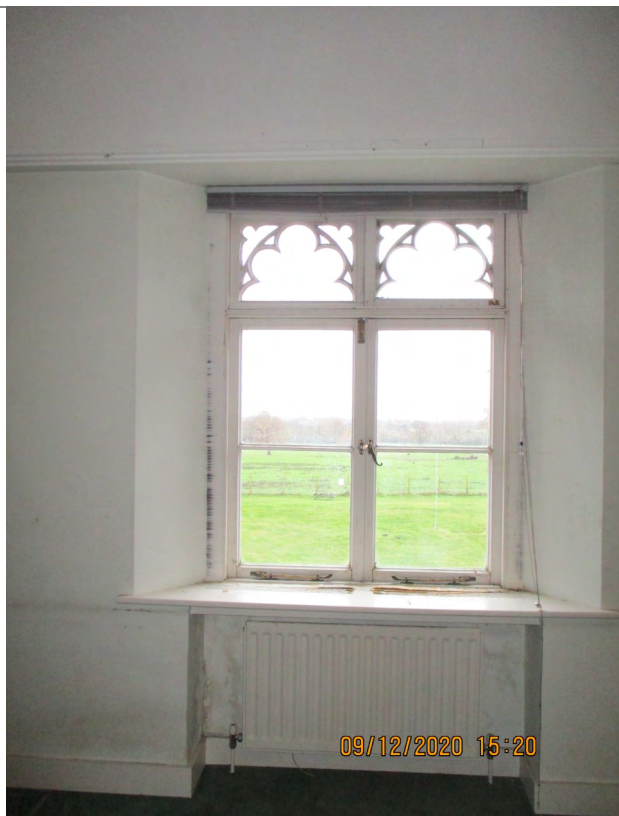
| Type | Softwood timber double side hung casement. There were 2no. panes to each side and 2no. Antique brass stay bars and lock on the right casement and bolt on the left casement. Above each window was a timber toplight with tracery detail the right side also featured a sliding glazed window with handle | | |

| Timber decay | Replace the sill in hardwood | | |
| Loose elements | Bottom left joint of the sliding glazed window should be re-adhered and clamped (this may be done on site as it is a small section, however if not then the sliding section would need to be removed and taken to a workshop) | | |

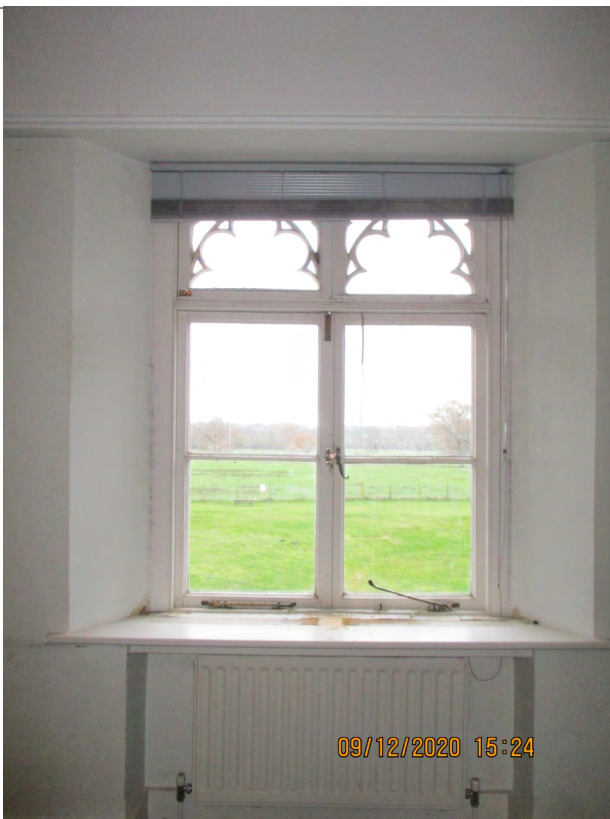
| Type | Softwood timber double side hung casement. There were 2no. panes to each side and 2no. Antique brass stay bars and lock on the right casement and bolt on the left casement. Above each window was a timber toplight with tracery detail the right side also featured a sliding glazed window with handle | | |

| Timber decay | Replace the sill in hardwood | | |
| Loose elements | Bottom left joint of the sliding glazed window should be re-adhered and clamped (this may be done on site as it is a small section, however if not then the sliding section would need to be removed and taken to a workshop) | | |

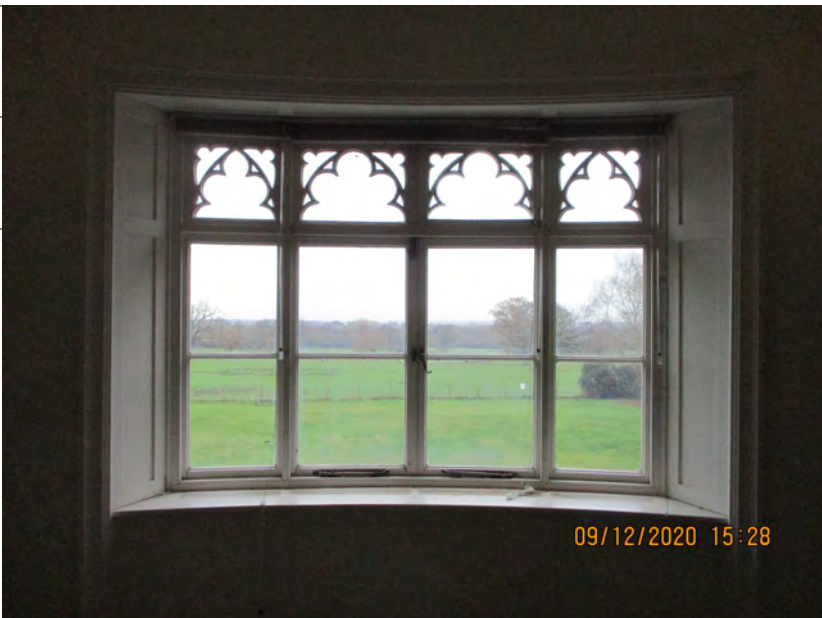
| <b>Type</b> | Softwood timber double side hung casement with fixed windows either side. There were 2no. panes to each window and 2no. Antique brass stay bars on each casement and lock on the right casement and bolt on the left casement. Above each window was a timber toplight with tracery detail the right side also featured a sliding glazed window with handle | | |

| <b>Timber decay</b> | Replace the sill in hardwood | | |

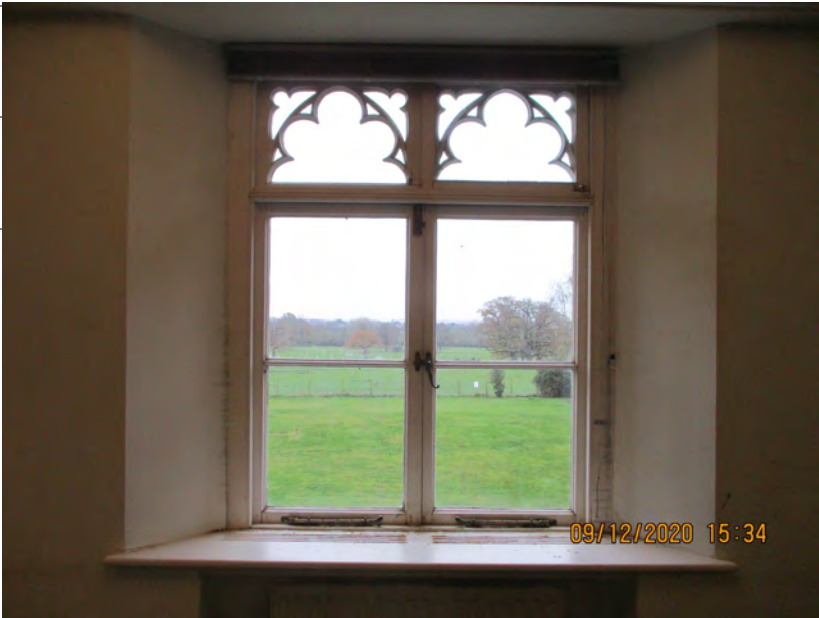
| <b>Type</b> | Softwood timber double side hung casement. There were 2no. panes to each side and 2no. Antique brass stay bars and lock on the right casement and bolt on the left casement. Above each window was a timber toplight with tracery detail the right side also featured a sliding glazed window with handle | | |

| <b>Timber decay</b> | Replace the sill in hardwood | | |
| <b>Loose elements</b> | <p>Bottom left joint of the sliding glazed window should be re-adhered and clamped (this may be done on site as it is a small section, however if not then the sliding section would need to be removed and taken to a workshop)</p> <p>Bottom right joint of the toplight should be re-adhered and clamped</p> | | |

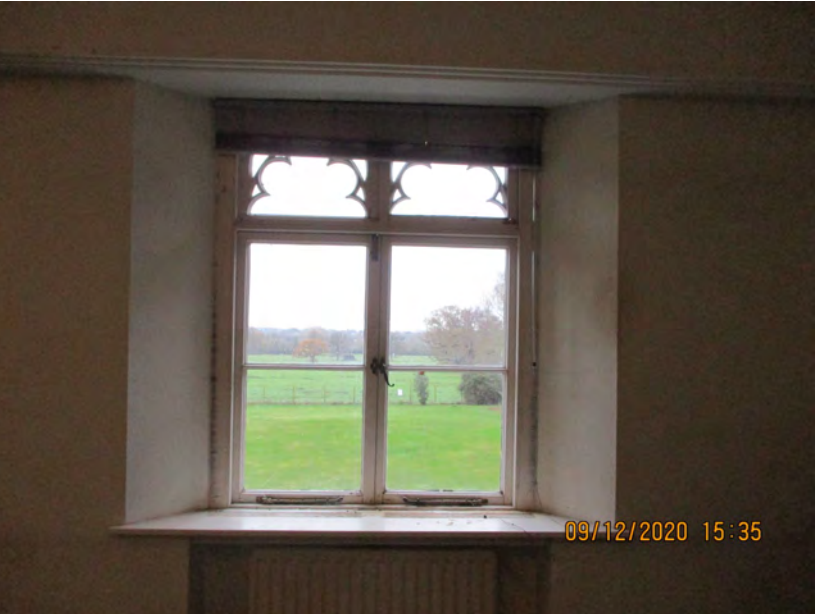
| <b>Type</b> | Softwood timber double side hung casement. There were 2no. panes to each side and 2no. Antique brass stay bars and lock on the right casement and bolt on the left casement. Above each window was a timber toplight with tracery detail the right side also featured a sliding glazed window with handle | | |

| <b>Timber decay</b> | Both (2no.) bottom joints of the lock stiles should be dressed-back to sound timber and resin-repaired | | |

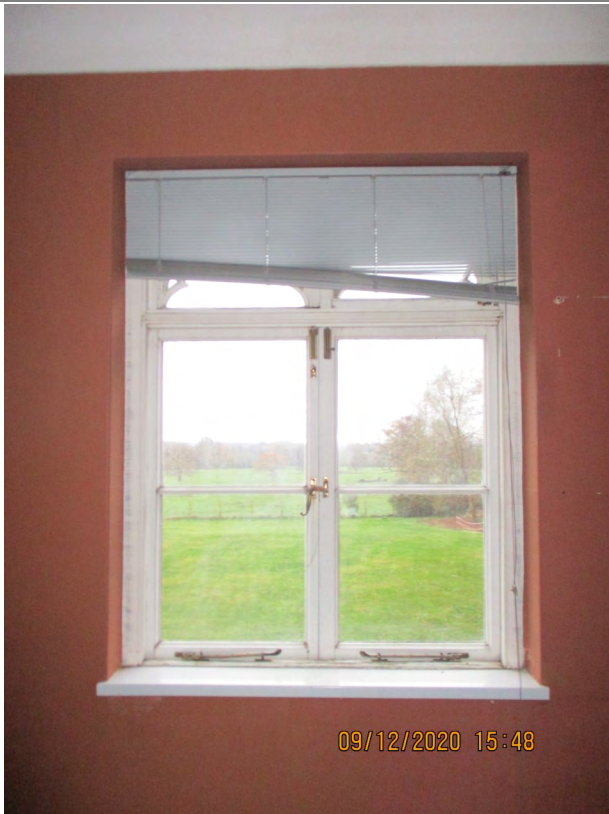
| Type | Softwood timber double side hung casement. There were 2no. panes to each side and 2no. Antique brass stay bars and lock on the right casement and bolt on the left casement. Above each window was a timber toplight with tracery detail the right side also featured a sliding glazed window with handle | | |

| Timber decay | Left bottom mortise and tenon joint of the sliding glazed window should be dressed-back to sound timber and resin-repaired with | | |

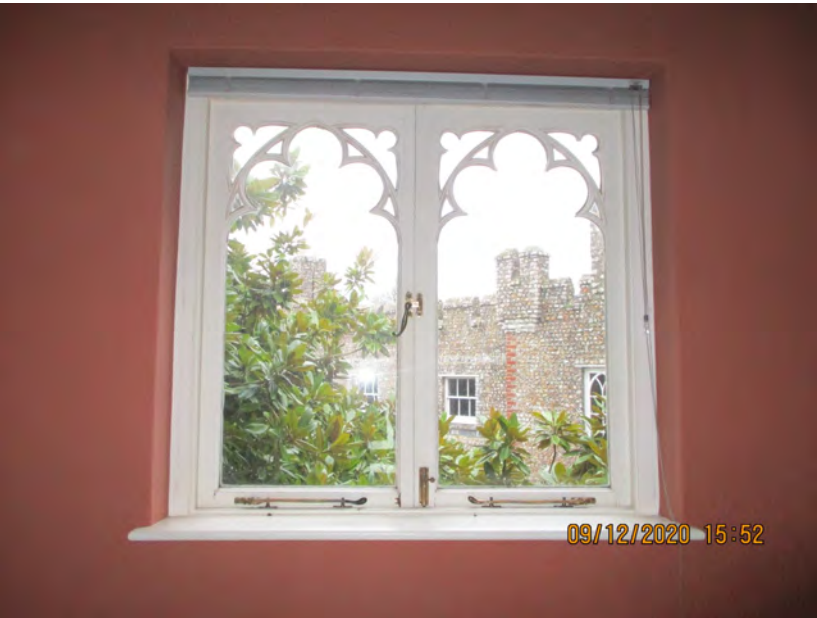
| <b>Reference</b> | Wf.08 | | |

| <b>Type</b> | Softwood timber double side hung casement with tracery detail to top. There were 7no. separate panes to each side and 2no. Antique brass stay bars and lock on the left casement and bolt on the right casement | | |

| <b>Timber decay</b> | Joint between lock stile and bottom rail of left casement should be dressed-back to sound timber and resin-repaired | | |

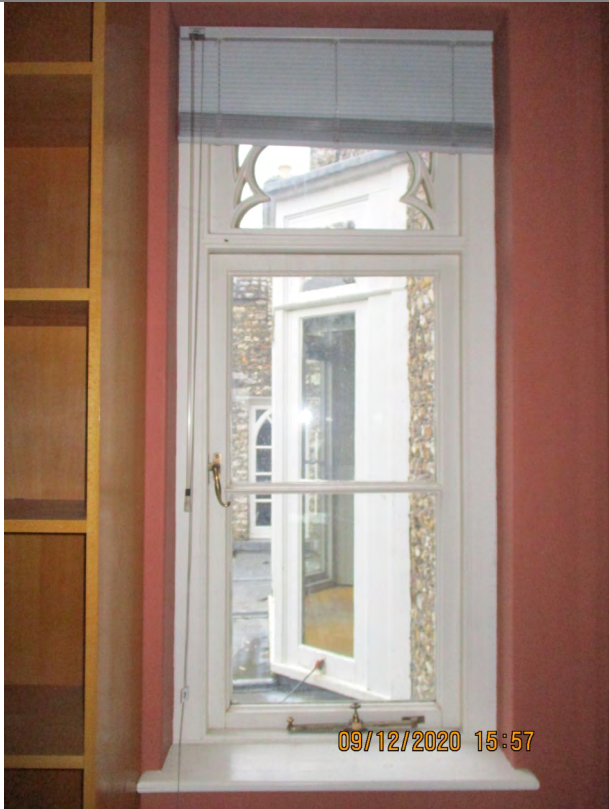
| Reference | Wf.09 | | |

| Type | Softwood timber single side hung casement with tracery detail to top. There were 7no. separate panes to each side and 2no. Antique brass stay bars and lock on the left casement and bolt on the right casement | | |

| Glazing | Allow to replace 1no. bottom glazing pane | | |

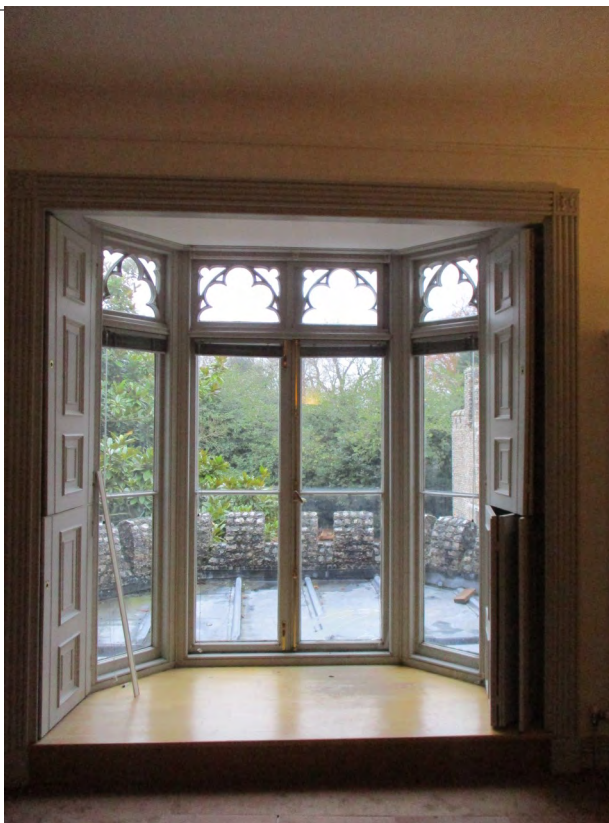
| Type | Softwood timber French Doors with fixed windows to either side. There was 1no. pane to each door and side section and a brass door bolt to the right side. Above 3no. sections there were fixed timber toplights with tracery detail including 7no. separate panes to each top-light there was 1no. pane above the right door which was set into a sliding window | | |

| Timber decay | Allowance should be made to remove right mullion, prop structure above and replace with new structural timber, preferably hardwood<br><br>Cut-back the bottom of right stile of the right door for ~150mm or to sound timber, splice-in new timber<br><br>right bottom joints of the left window should be dressed-back to sound timber and resin-repaired | | |
| Glazing | Allow to replace 1no. glazing pane | | |
| Loose elements | Bottom left joint of the sliding glazed window should be re-adhered and clamped (this may be done on site as it is a small section, however if not then the sliding section would need to be removed and taken to a workshop) | | |

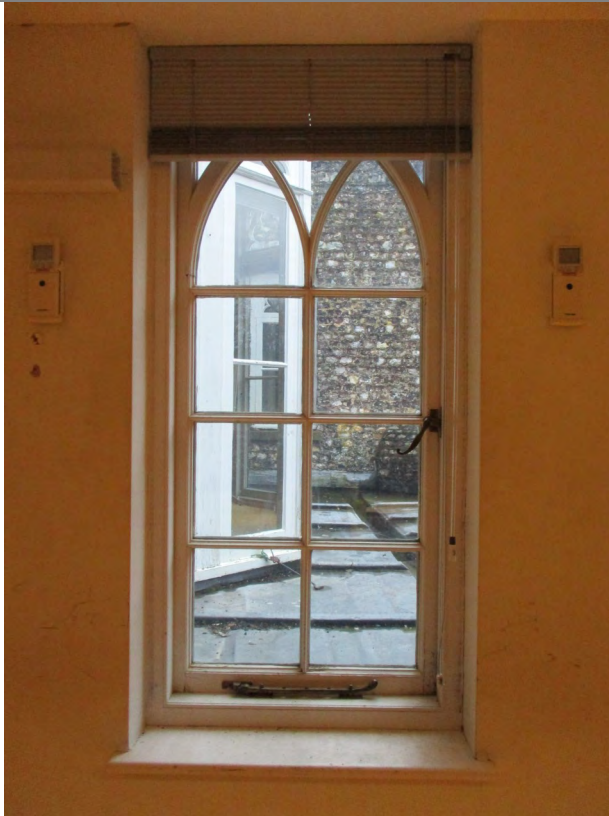
| Reference | Wf.11 | | |

| Type | Softwood timber single side hung casement with gothic arched mullion detail towards top. There were 7no. separate panes to each side and 1no. stay bar and lock | | |

| Furniture | Stay bar needs lubrication to encourage ease of use on failing adequate operability then replacement would be necessary | | |

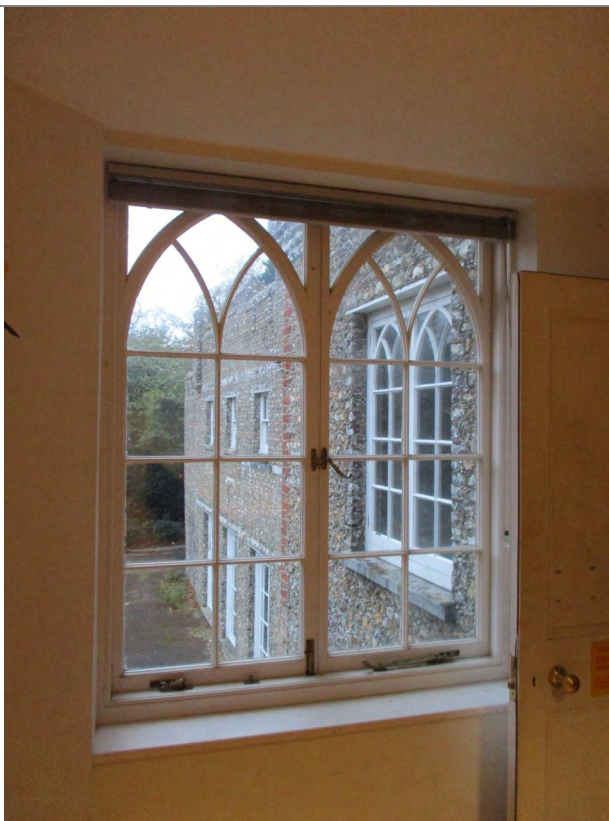
| Reference | Wf.12 | | |

| Type | Softwood timber double side hung casement with gothic arched mullion detail towards top. There were 11no. separate panes to each side and 2no. Antique brass stay bars and land lock on the right casement and bolt on the left casement | | |

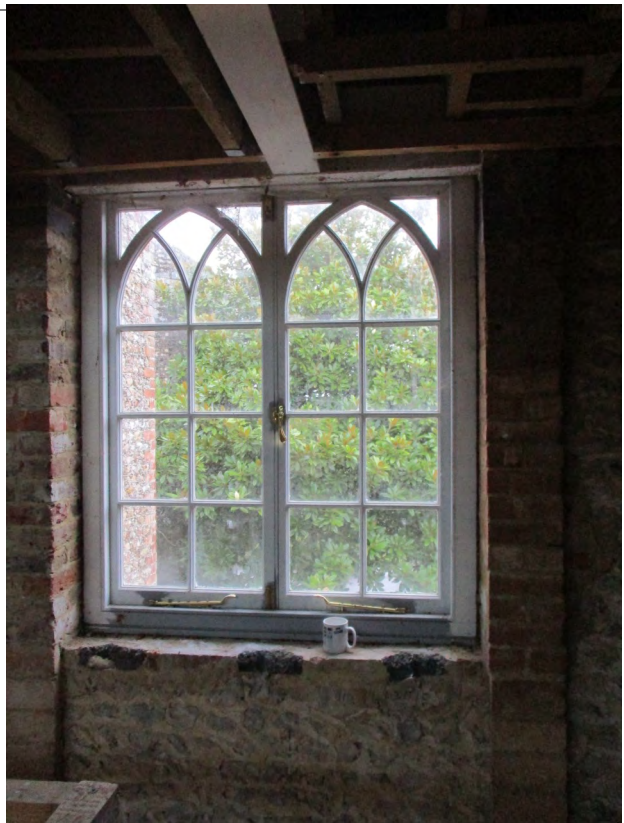
| Reference | Wf.13 | | |

| Type | Timber double side hung casements with gollic arched mullion detail to top. There were 11no. panes to each casement and 2no. stay bars and lock on the right casement and bolt on the left casement | | |

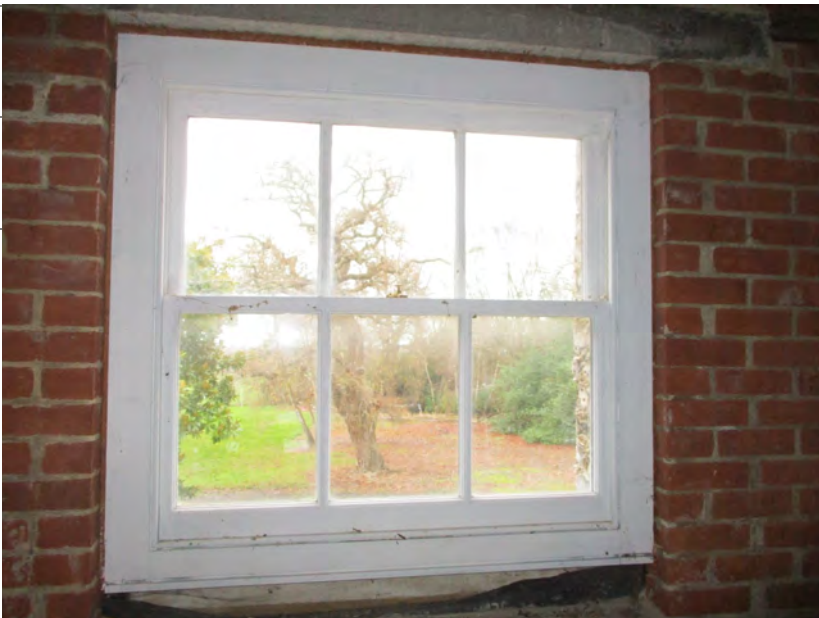
| <b>Reference</b> | Wf.14 | | |

| <b>Type</b> | '3 over 3' vertical sliding sash with cords and sash lock on meeting rails | | |

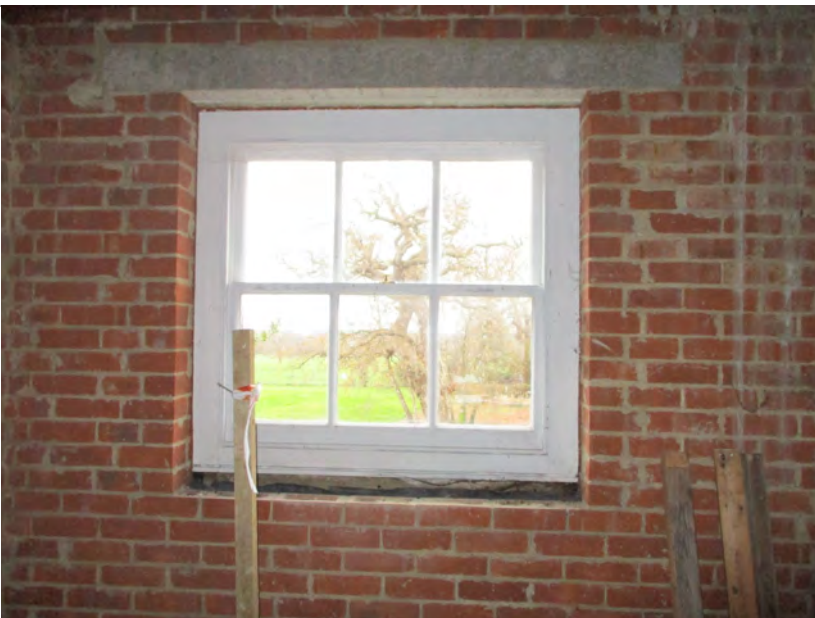
| <b>Reference</b> | Wf.15 | | |

| <b>Type</b> | '3 over 3' vertical sliding sash with cords and sash lock on meeting rails | | |

| <b>Operation</b> | Allow to replace sash balances | | |

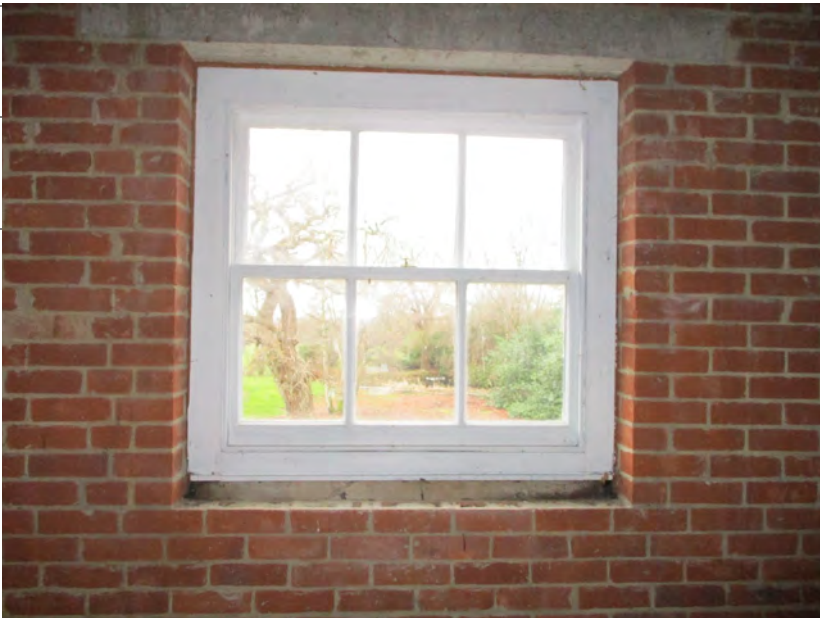
| <b>Reference</b> | Wf.16 | | |

| <b>Type</b> | '3 over 3' vertical sliding sash with cords and sash lock on meeting rails | | |

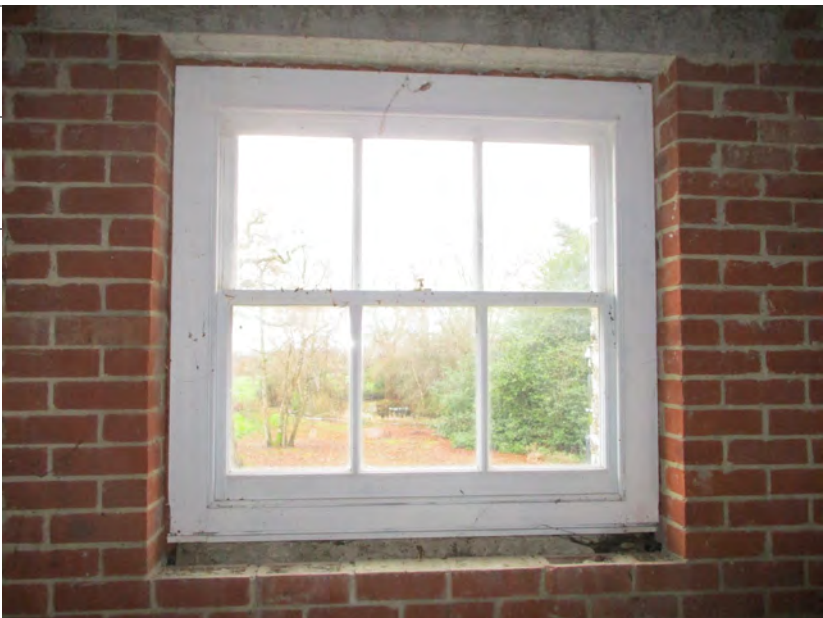
| <b>Reference</b> | Wf.17 | | |

| <b>Type</b> | '3 over 3' vertical sliding sash with cords and sash lock on meeting rails | | |

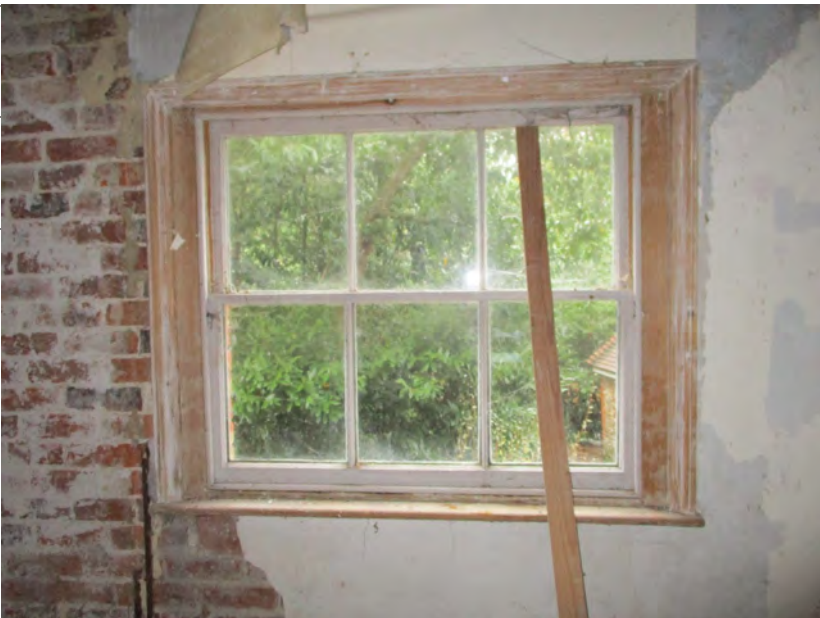
| <b>Reference</b> | Wf.18 | | |

| <b>Type</b> | '3 over 3' vertical sliding sash with cords | | |

| <b>Furniture</b> | Furniture should be replaced if window is to be operable on future occupancy | | |
| <b>Operation</b> | Allow to replace sash balances | | |

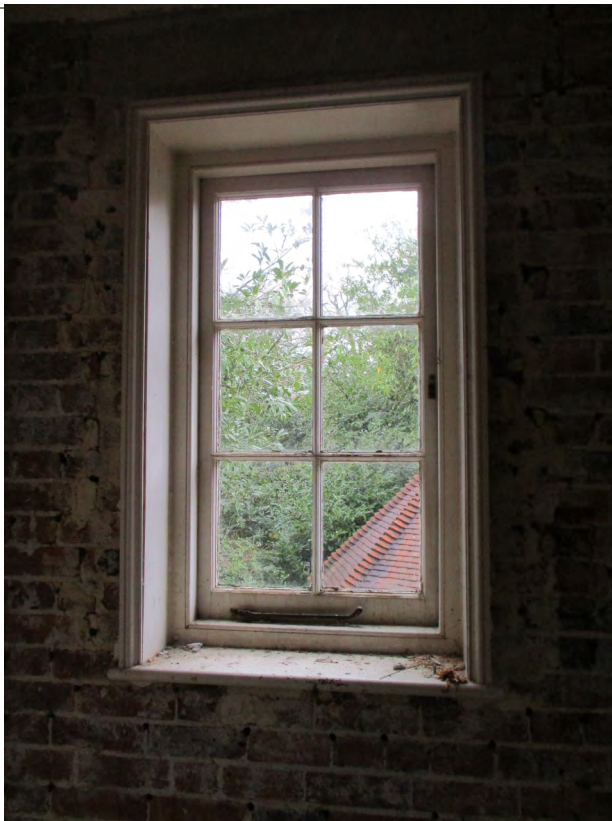
| Reference | Wf.19 | | |

| Type | Side hung casement with 1no. Stay bar and casement lock. There were 6no. panes | | |

| Furniture | Corroded furniture should be replaced if window is to be operable on future occupancy | | |

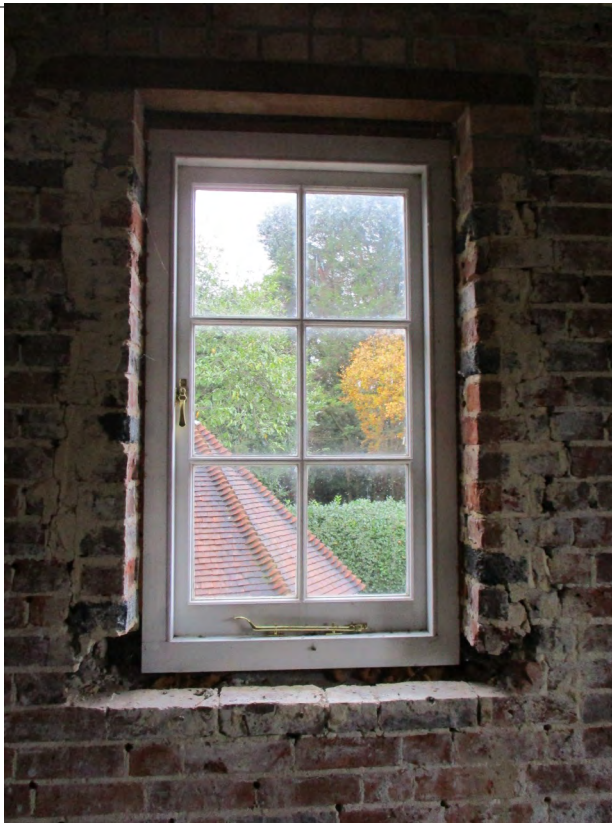
| Reference | Wf.20 | | |

| Type | Modern side hung case-ment with 1no. Stay bar and casement lock. There were 6no. panes | | |

| Missing elements | Reinstate timber window stool board and architrave | | |

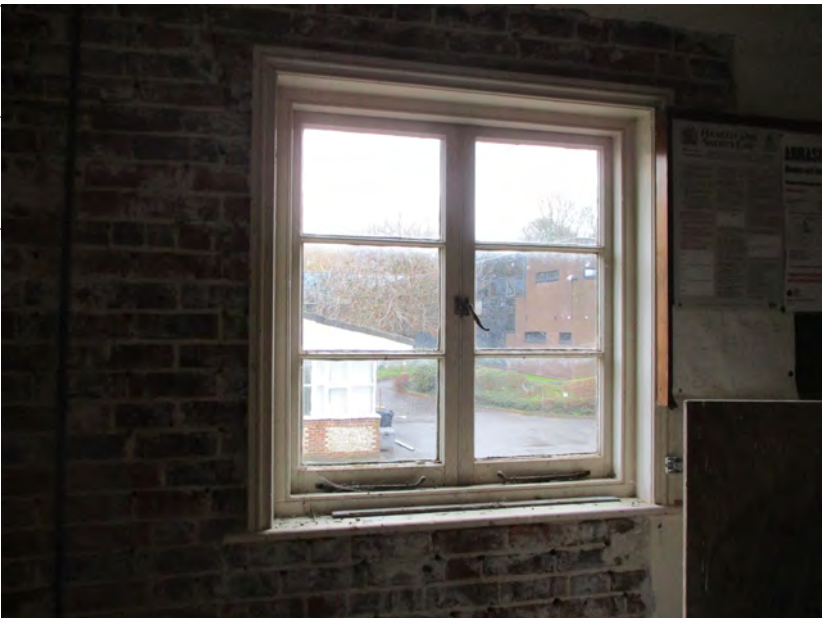
| <b>Reference</b> | Wf.21 | | |

| <b>Type</b> | Softwood double side opening casement with 3 no. panes on each casement. There was 1no. stay bar on each casement and 1no. lock. | | |

| <b>Furniture</b> | Corroded furniture should be replaced if window is to be operable on future occupancy | | |
| <b>Loose elements</b> | Remove loose or damaged putty, apply new putty and smooth | | |

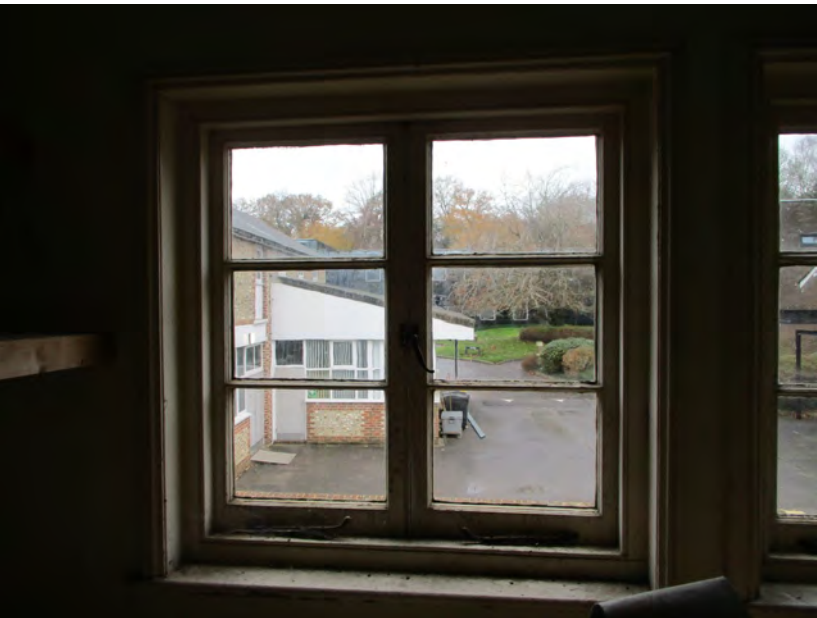
| <b>Reference</b> | Wf.22 | | |

| <b>Type</b> | Softwood double side opening casement with 3 no. panes on each casement. There was 1no. stay bar on each casement and 1no. lock. | | |

| <b>Loose elements</b> | Remove loose or damaged putty, apply new putty and smooth | | |

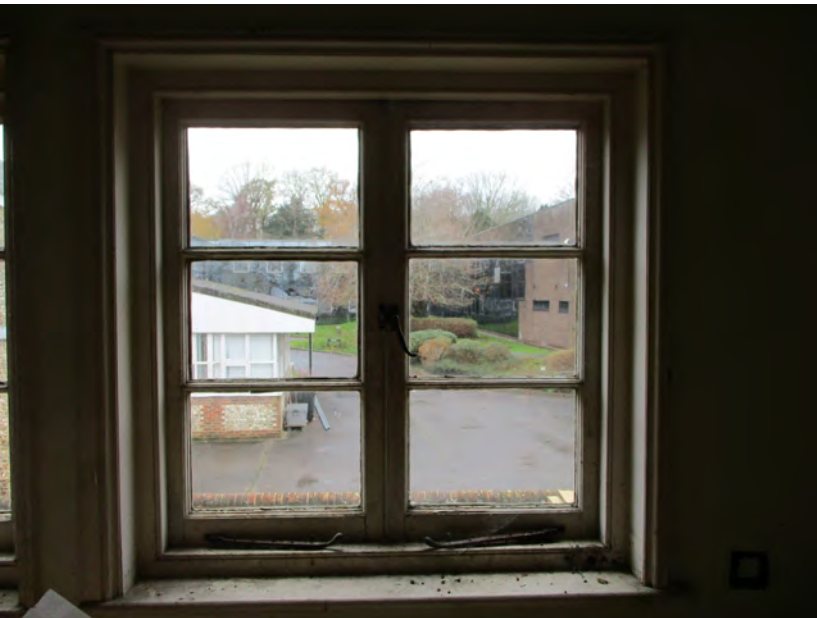
| <b>Reference</b> | Wf.23 | | |

| <b>Type</b> | Softwood double side opening casement with 3 no. panes on each casement. There was 1no. stay bar on each casement and 1no. lock. | | |

| <b>Loose elements</b> | Remove loose or damaged putty, apply new putty and smooth | | |

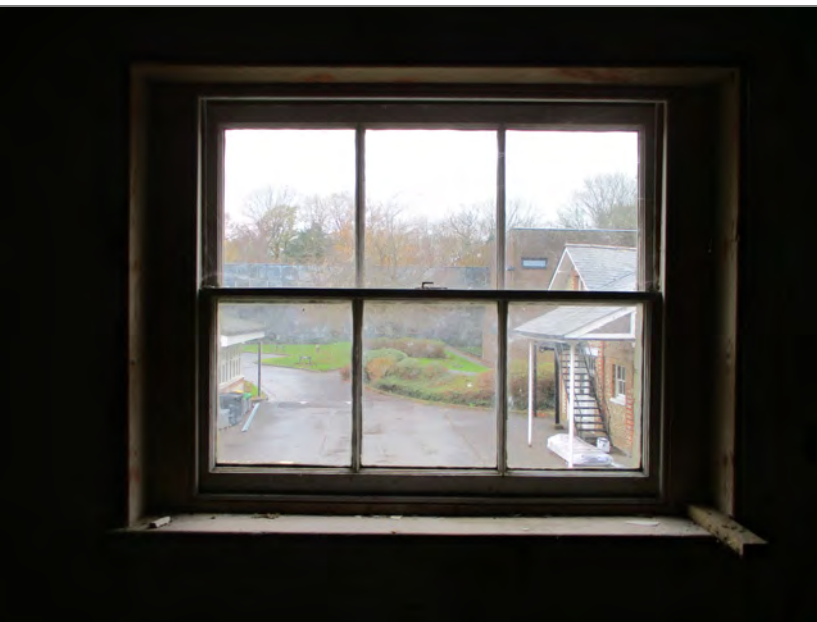
| <b>Reference</b> | Wf.24 | | |

| <b>Type</b> | Timber '3 over 3' vertical sliding sash with sash lock and cords | | |

| <b>Furniture</b> | Replace sash lock | | |
| <b>Operation</b> | Allow to replace sash balances<br>Allow to ease both sashes | | |

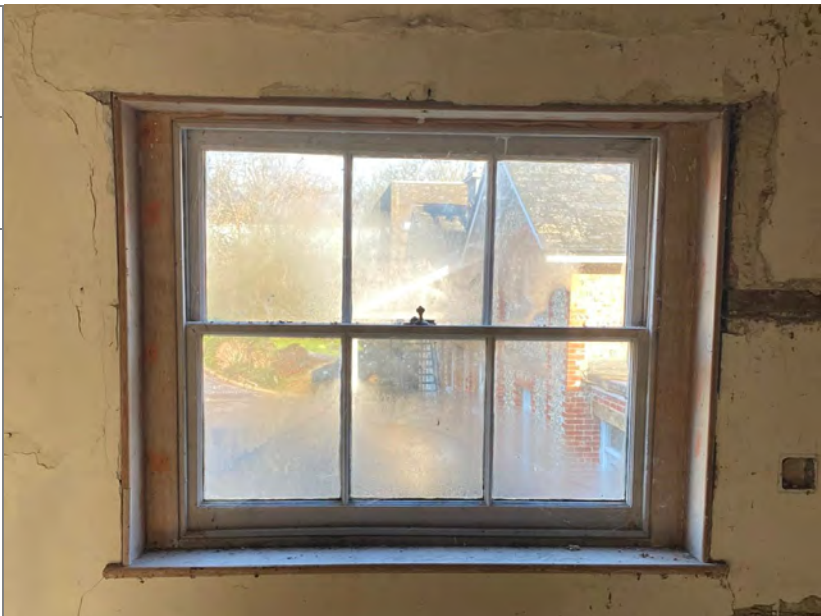
| <b>Reference</b> | Wf.25 | | |

| <b>Type</b> | Timber '3 over 3' vertical sliding sash with sash lock and cords | | |

| <b>Furniture</b> | Replace sash lock | | |
| <b>Operation</b> | Allow to replace sash balances<br>Allow to ease both sashes | | |

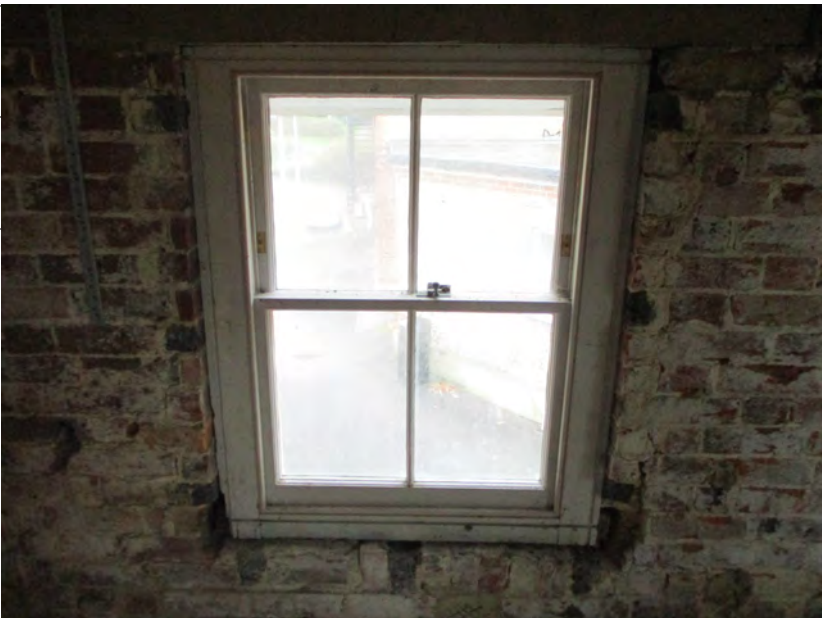
| <b>Reference</b> | Wf.26 | | |

| <b>Type</b> | Timber '2 over 2' vertical sliding sash with cords and sash lock. There were 2no. Panes to each sash divided by horizontal glazing bars | | |
| <b>Timber decay</b> | No visual signs of decay | | |

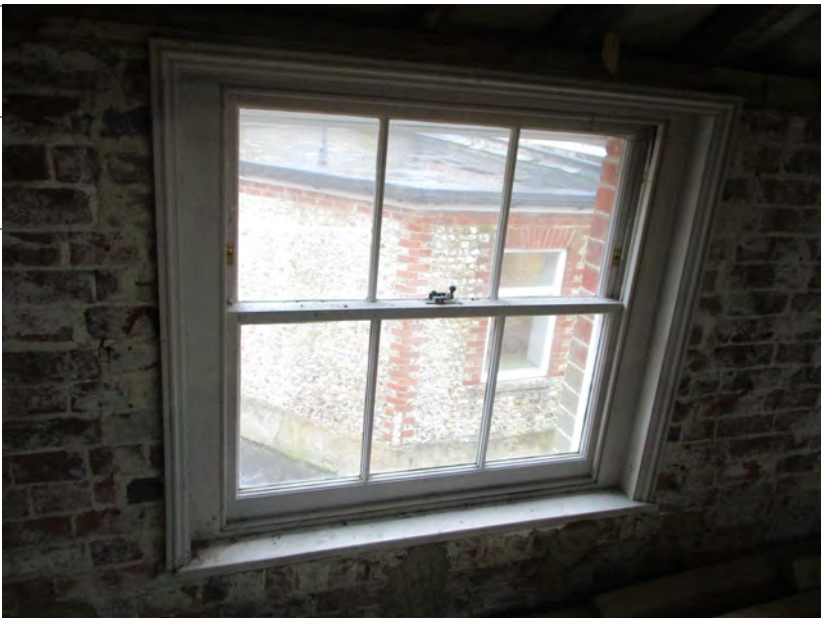
| <b>Reference</b> | Wf.27 | | |

| <b>Type</b> | Timber '3 over 3' vertical; sliding sash with lock to meeting rails | | |

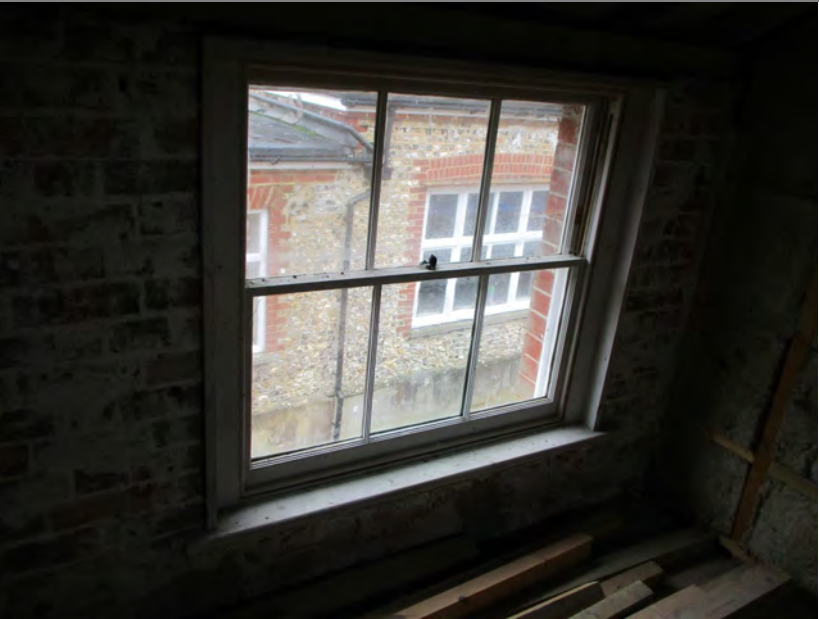
| <b>Reference</b> | Wf.28 | | |

| <b>Type</b> | Timber '3 over 3' vertical; sliding sash with lock to meeting rails | | |

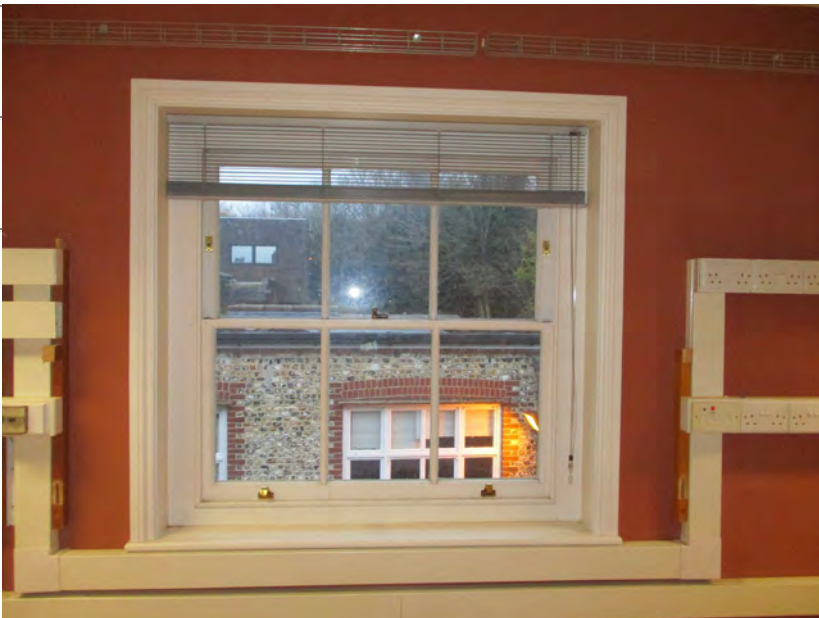
| <b>Reference</b> | Wf.29 | | |

| <b>Type</b> | Timber '3 over 3' vertical; sliding sash with lock to meeting rails. There were pulley cords and 2no. sash pulls on the bottom rail | | |

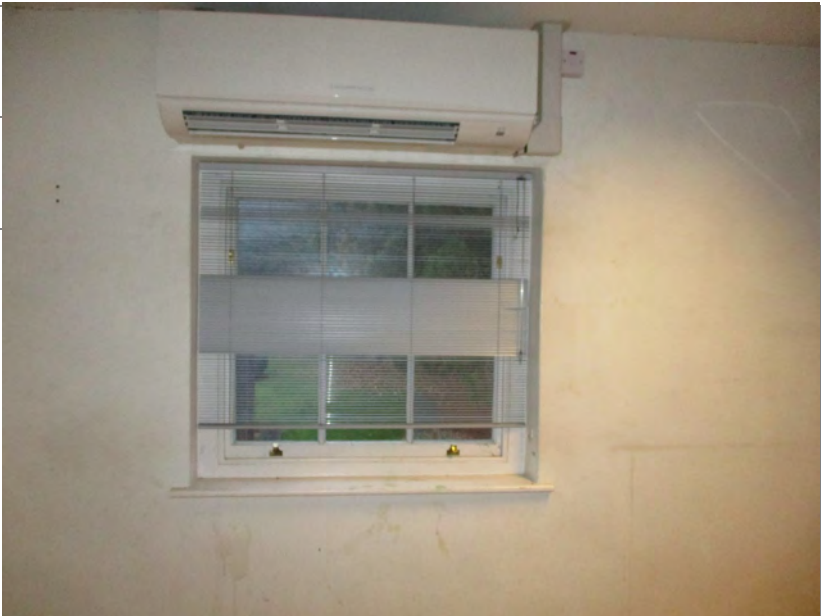
| <b>Reference</b> | Wf.32 | | |

| <b>Type</b> | Timber '3 over 3' vertical; sliding sash with lock to meeting rails. There were pulley cords and 2no. sash pulls on the bottom rail | | |

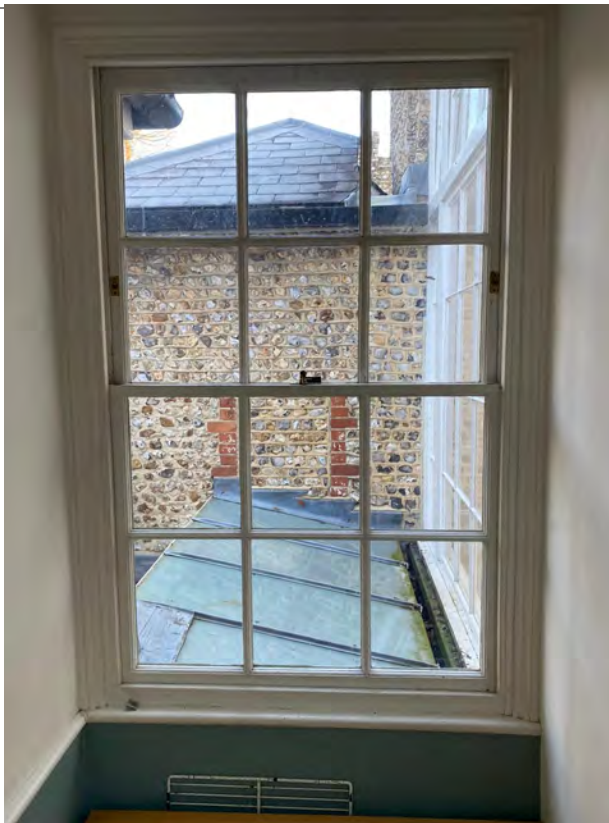
| Reference | Wf.33 | | |

| Type | Timber '6 over 6' vertical; sliding sash with lock to meeting rails | | |

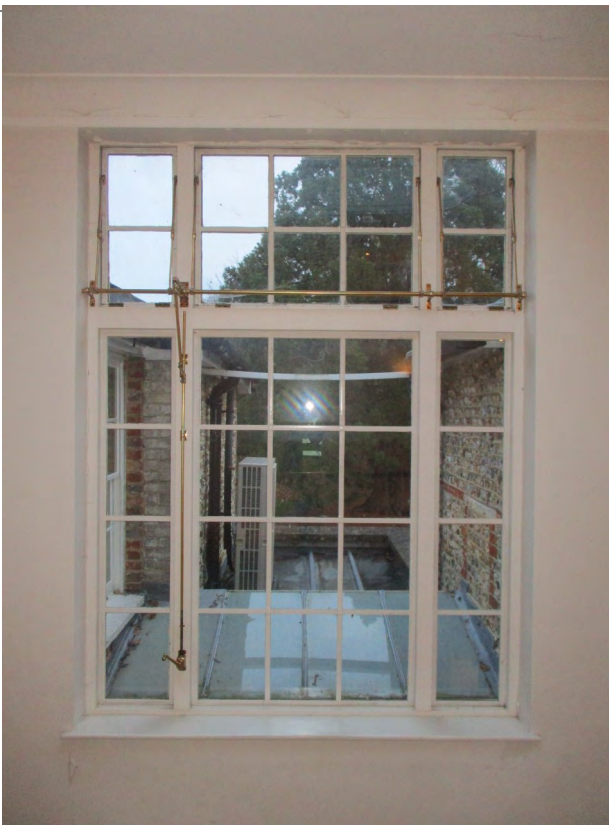
| Type | Fixed window divided by two mullions with glazing panes arrangement 4/12/4 divided by metal glazing bars Above were toplights also separated by two mullions with glazing panes arrangement 2/6/2 divided by metal glazing bars, these windows opened by pivoting at the centre with assistance from a twist handle opening mechanism | | |

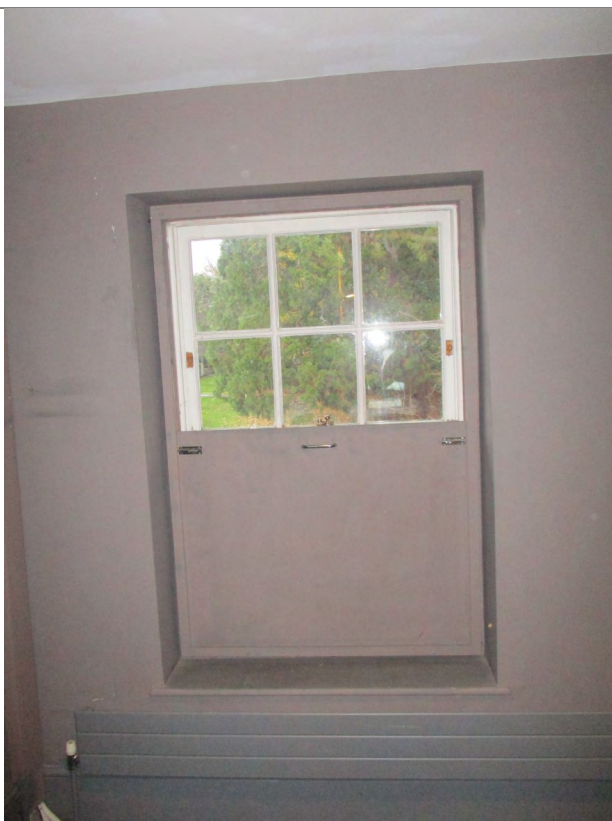
| Reference | Wf.35 | | |

| Type | Timber '6 over 6' vertical; sliding sash with lock to meeting rails and sliding timber shutters | | |

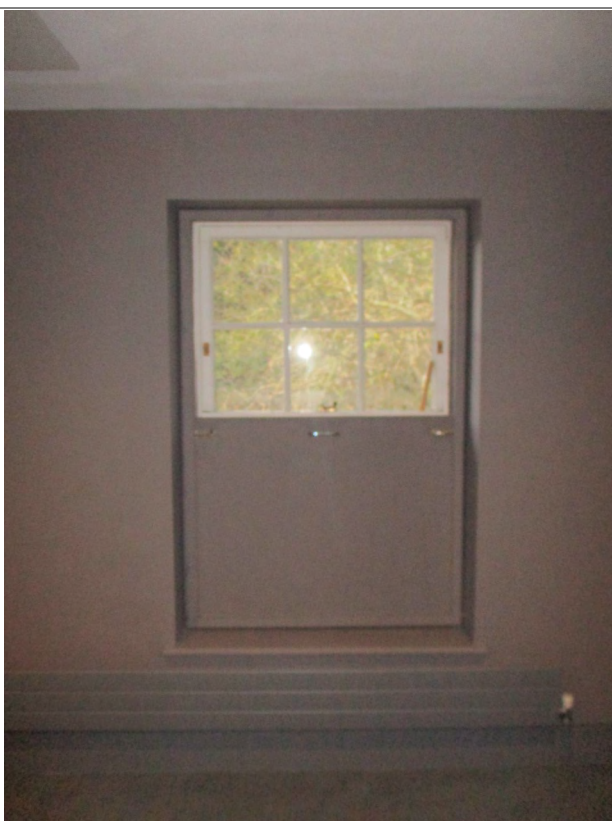
| Reference | Wf.36 | | |

| Type | Timber '6 over 6' vertical; sliding sash with lock to meeting rails and sliding timber shutters | | |

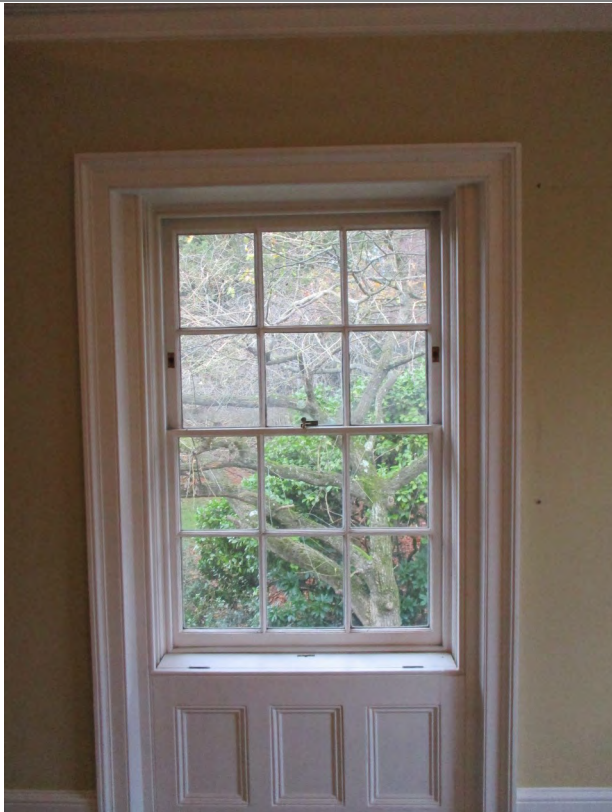
| Reference | Wf.37 | | |

| Type | Timber '6 over 6' vertical sliding sash with cords and sliding sash lock | | |

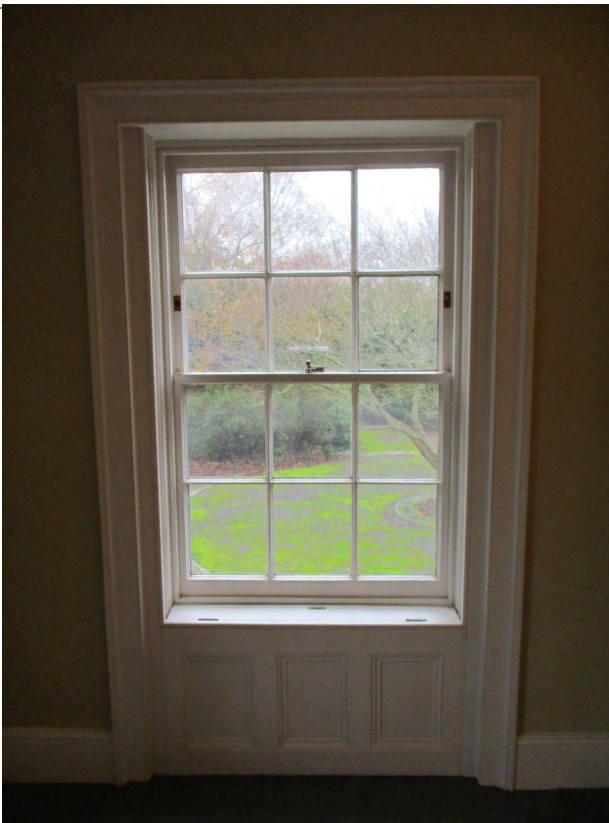
| Reference | Wf.38 | | |

| Type | Timber '6 over 6' vertical sliding sash with cords and sliding sash lock | | |

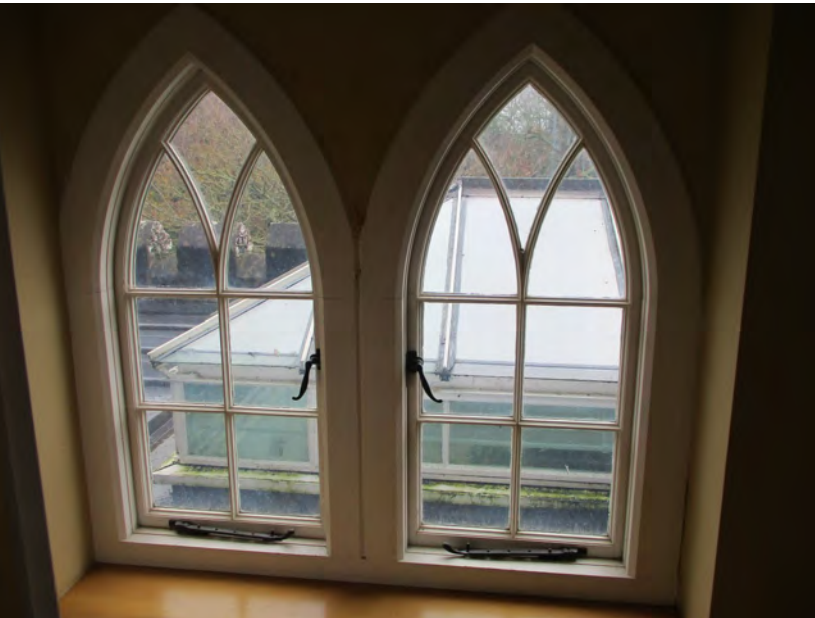
| <b>Reference</b> | Wf.39 | | |

| <b>Type</b> | Timber gothic arched side hung casements divided by mullion. 2no stay bars and 2no. Locks. The were 7no. Panes to each casement | | |

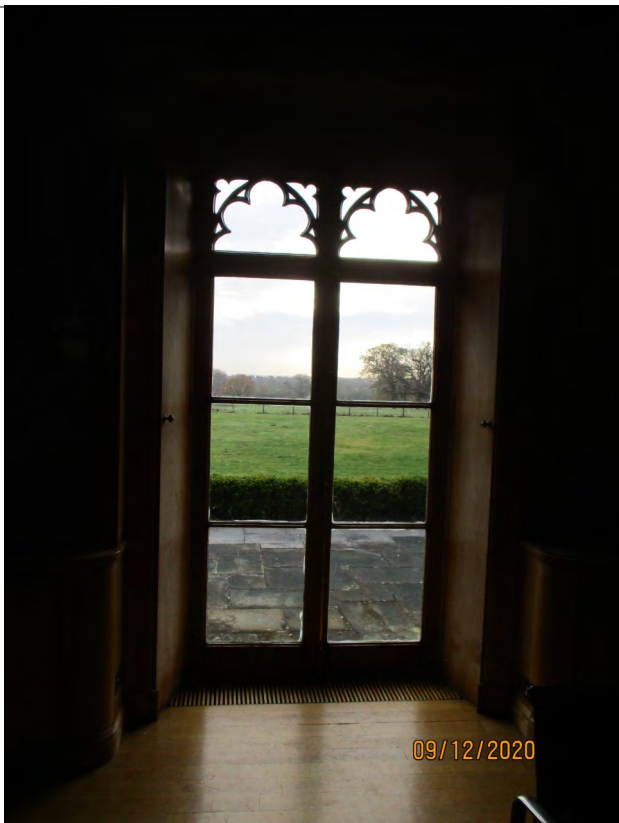
| Reference | Wg.01 | | |

| Type | Softwood timber double French Door. There were 3no. panes to each side and a brass door bolt to the right side. Above each door there was a fixed timber toplight with tracery detail | | |

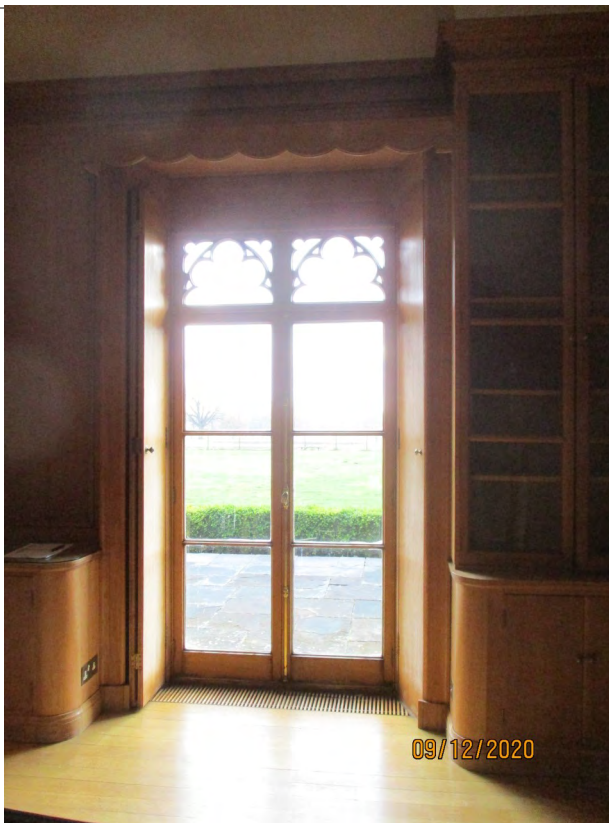
| Reference | Wg.02 | | |

| Type | Softwood timber double French Door. There were 3no. panes to each side and a brass door bolt to the right side. Above each door there was a fixed timber toplight with tracery detail | | |

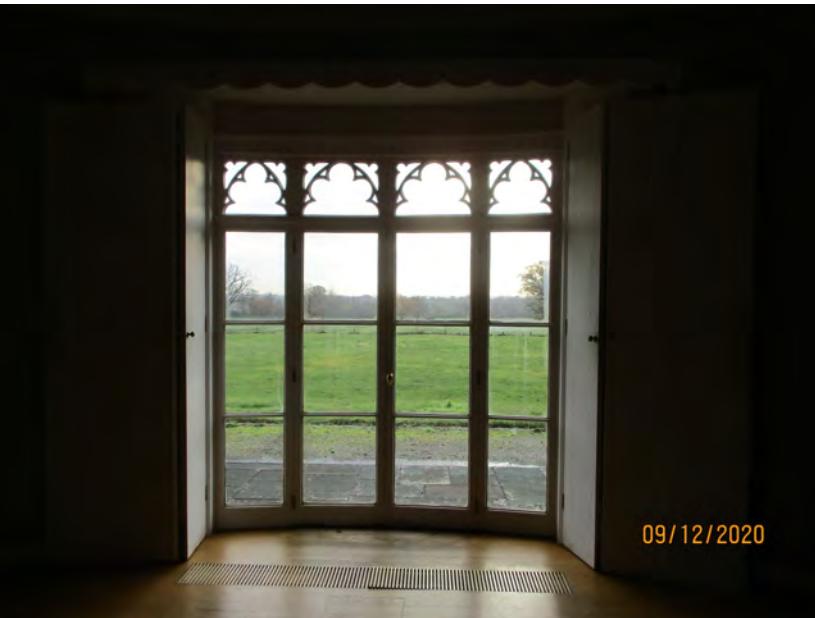
| <b>Type</b> | Softwood timber French Doors with fixed windows to either side. There were 3no. panes to each side and a brass door bolt to the right side. Above each door there was a fixed timber toplight with tracery detail | | |
