## Southleigh Park House: Window frame condition investigation

Site note A9 for 9 and 10 December 2020, job no. 152.09

The aim of this survey was to investigate the condition of the timber window frames and to provide remedial advice to inform refurbishment

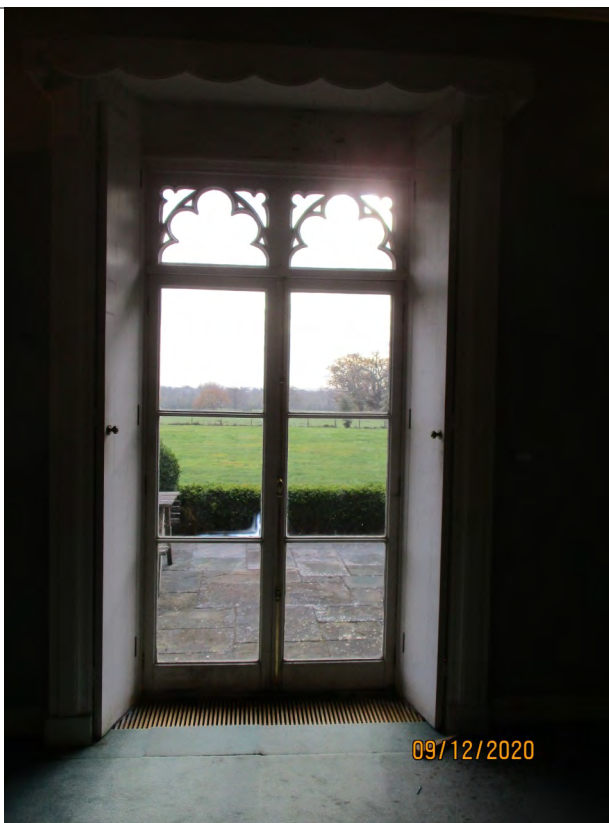
| Reference | Wg.04 | | |

| Type | Softwood timber double French Door. There were 3no. panes to each side and a brass door bolt to the right side. Above each door there was a fixed timber toplight with tracery detail | | |

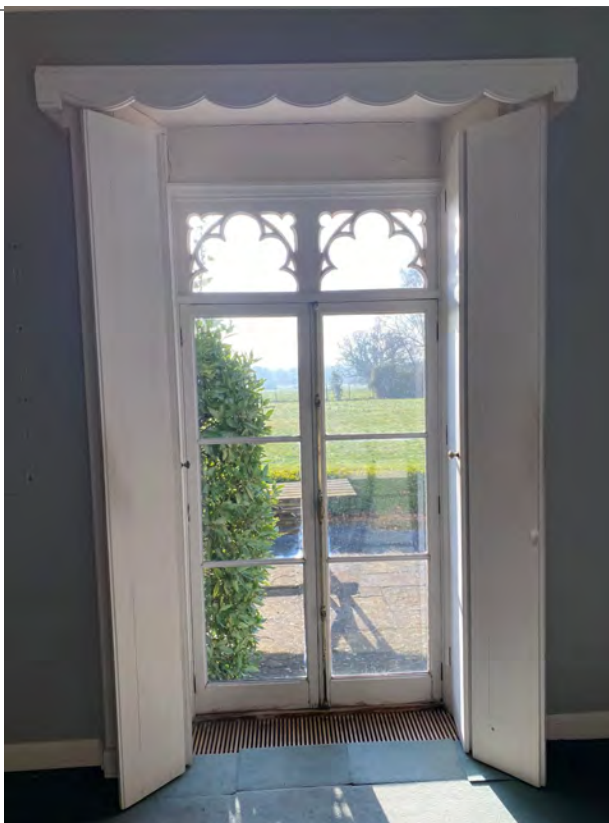
| Reference | Wg.05 | | |

| Type | Softwood timber double French Door. There were 3no. panes to each side and a brass door bolt to the right side. Above each door there was a fixed timber toplight with tracery detail | | |

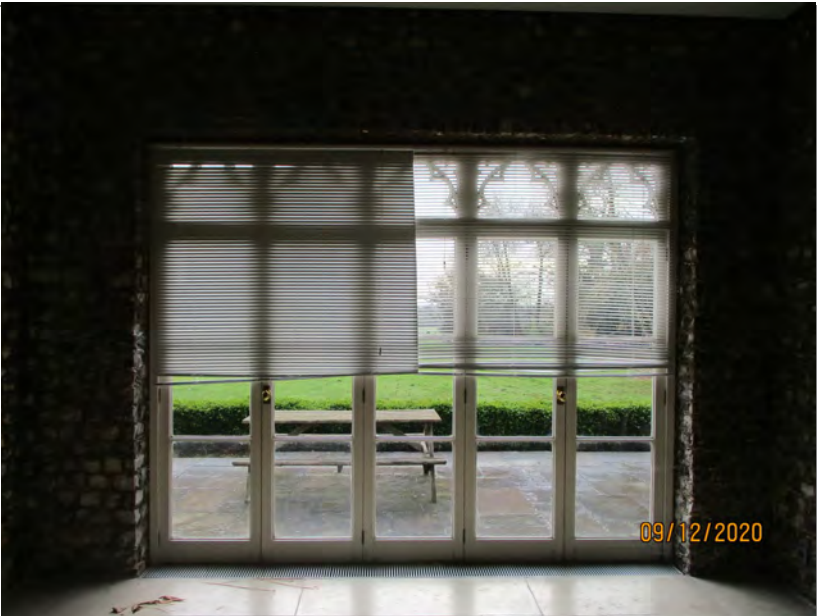
| <b>Type</b> | Softwood timber French Doors with fixed windows between the doors and to either side. There were 3 no. panes to each of the 5no. sections, fixed timber tracery toplights above each section and a door handle to each door. Handles appeared to be brass and the hinges antique effect brass | | |

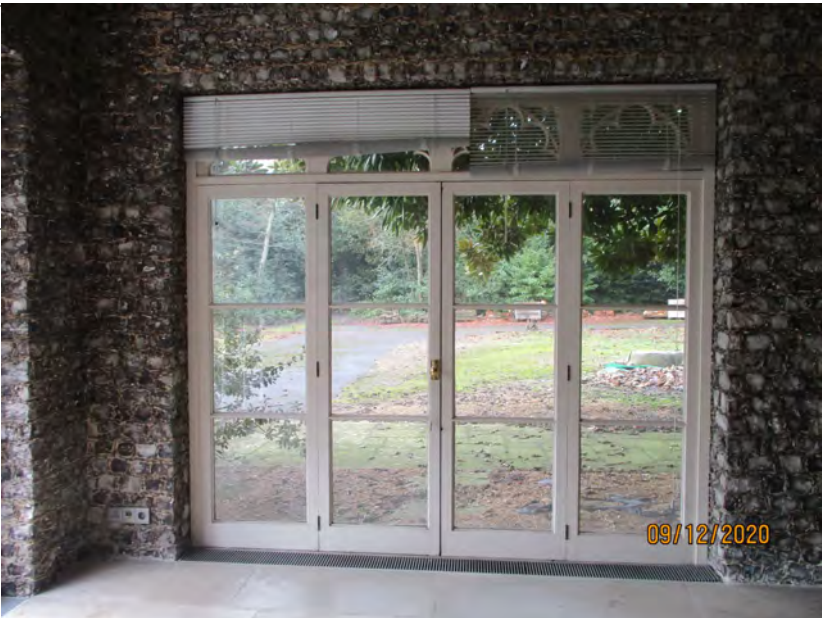
| <b>Reference</b> | Wg.07 | | |

| <b>Type</b> | Softwood timber double French Door with fixed windows either side. There were 3 no. panes to each of the 4no. sections, fixed timber tracery toplights above each section and a door handle to the left side door | | |

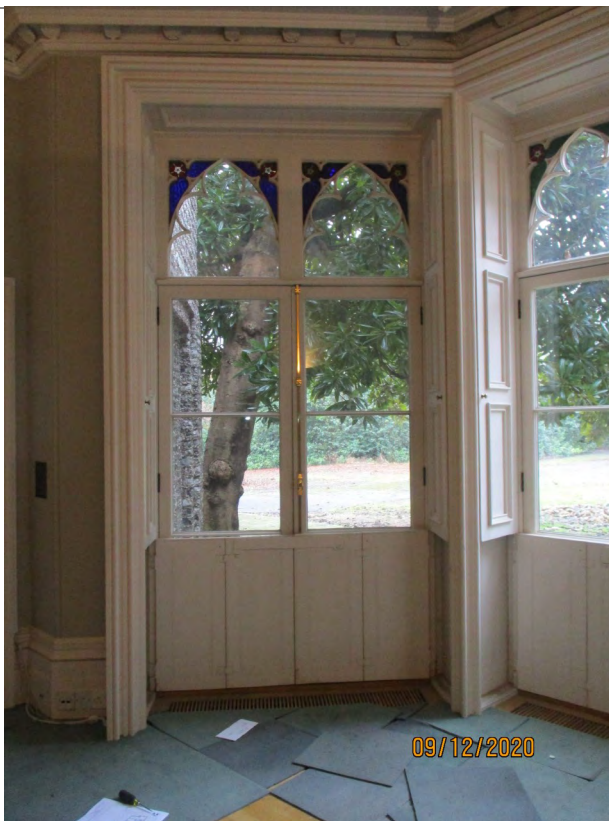
| Reference | Wg.09 | | |

| Location | G.16 Boardroom (former dining room) | | |
| Type | Softwood timber double French Door. There were 3 no. panes to each side and a French door bolt to the right side. There was a fixed timber toplight with ornate tracery and stained glass featuring blue and yellow sections and a red and white tudor rose at the top corners | | |
| Timber decay | None found to accessible structures | | |

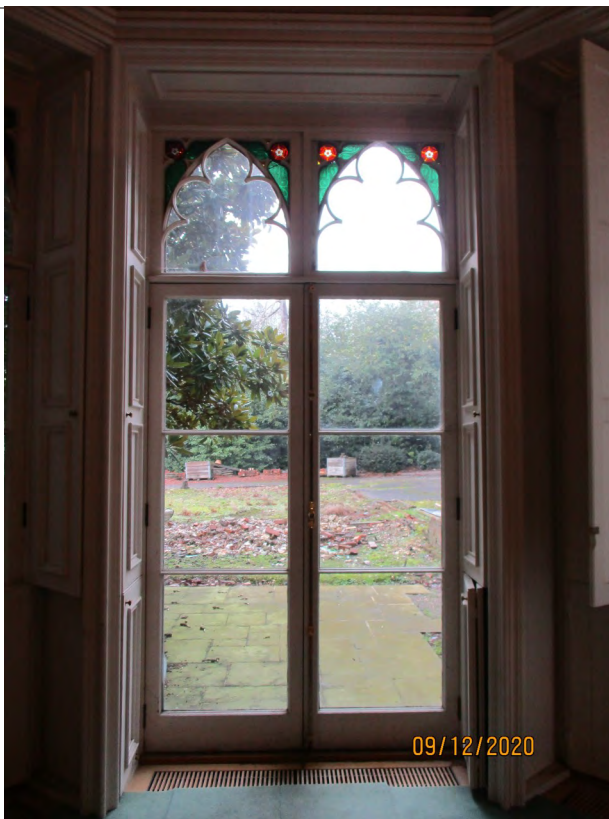
| Reference | Wg.10 | | |

| Location | G.16 Boardroom (former dining room) | | |
| Type | Softwood timber double French Door. There were 3 no. panes to each side and a French door bolt to the right side. There was a fixed timber toplight with ornate tracery and stained glass featuring green and yellow sections and a red and white tudor rose at the top corners | | |

| Glazing | Allow to replace approx. 2no. 'blown' laminated glazing | | |

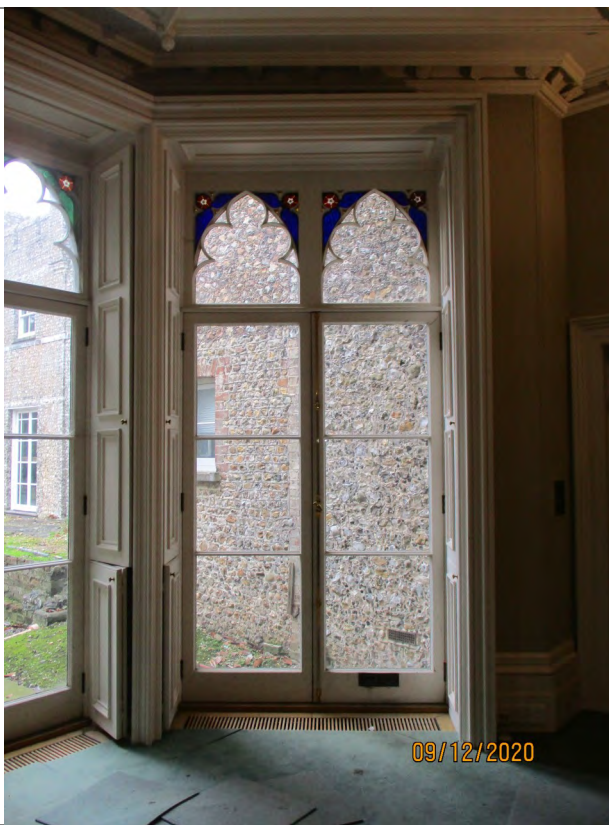
| Reference | Wg.11 | |

| Location | G.16 Boardroom (former dining room) | |
| Type | Softwood timber double French Door. There were 3 no. panes to each side and a French door bolt to the right side. There was a fixed timber toplight with ornate tracery and stained glass featuring blue and yellow sections and a red and white tudor rose at the top corners | |

| Furniture | Corroded furniture should be replaced | |

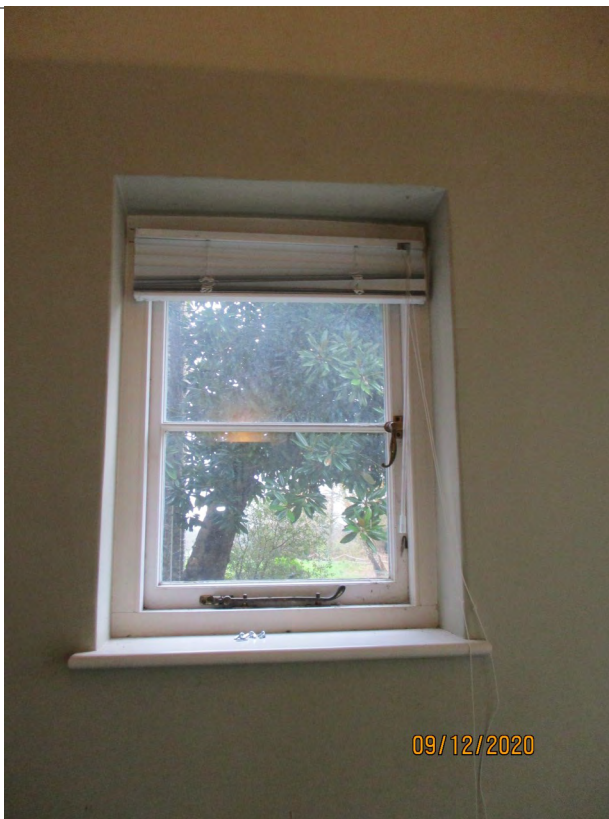
| Reference | Wg.11a | | |

| Location | G.18 Office | | |
| Type | Softwood timber side hung casement with 2no. Panes divided horizontally. The was a stay bar and a case-ment latch which both had the appearance of antique brass | | |

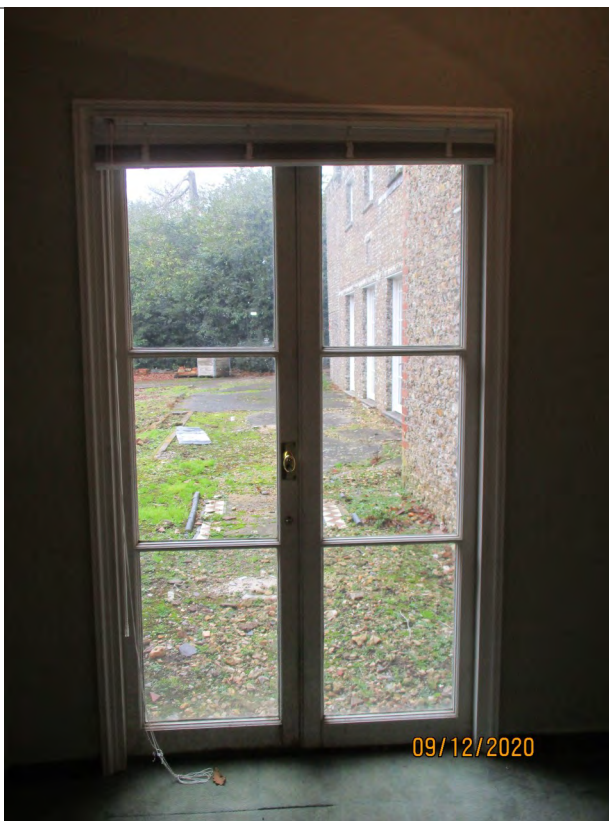
| Reference | Wg.12 | | |

| Location | G.18 Office | | |
| Type | Softwood timber double French Door. There were 3 no. panes to each side and a door handle on the left side | | |

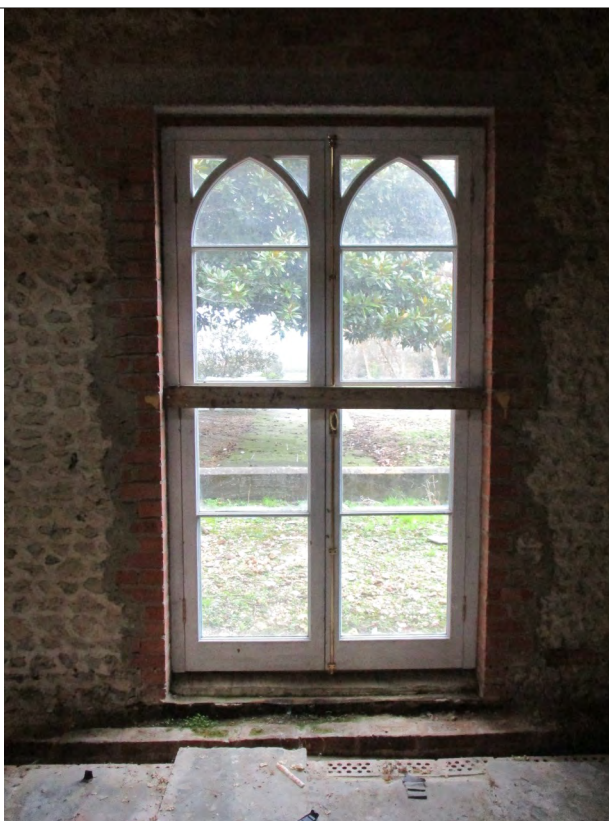
| Reference | Wg.13 | | |

| Location | Ground floor | | |
| Type | Softwood timber double French Door with gothic arch detail to top. There were 6 no panes to each side and a door bolt to the right side | | |

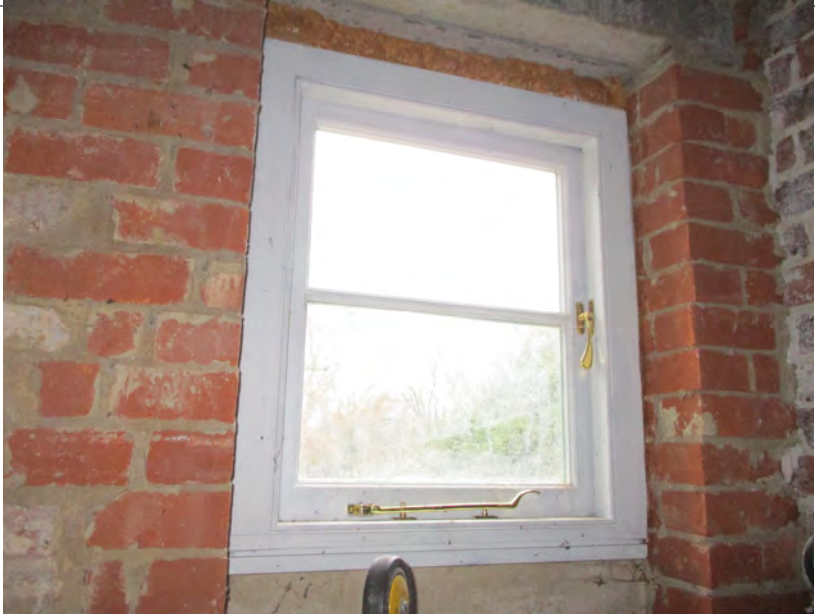
| <b>Reference</b> | Wg.14 | | |

| <b>Location</b> | Ground floor, west wing | | |
| <b>Type</b> | Softwood timber casement with casement lock and stay bar. There were 2 no. panes divided by a horizontal glazing bar | | |

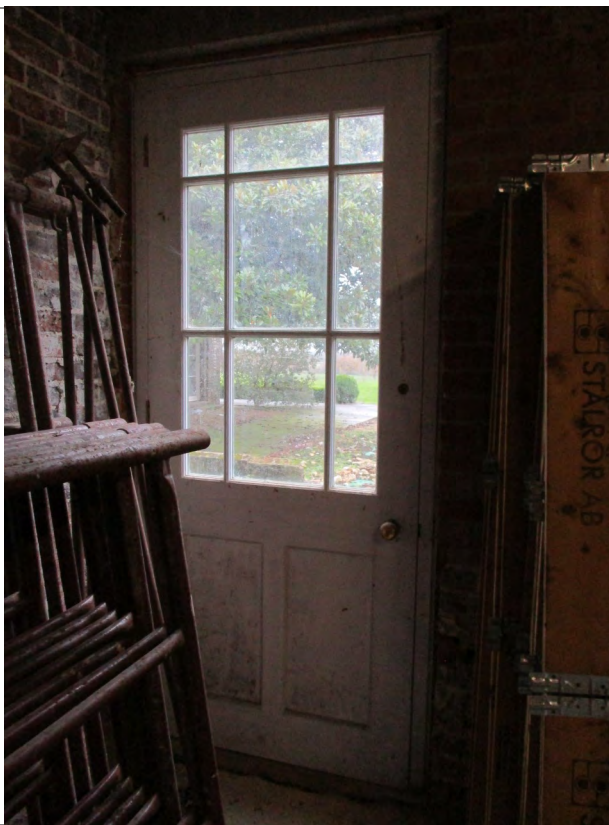
| Reference | Wg.15 | | |

| Location | Ground floor, west wing | | |
| Type | Softwood timber door with 9 no. panes of assorted sizes and a door handle and lock | | |

| Furniture | Corroded areas should be treated or replaced | | |

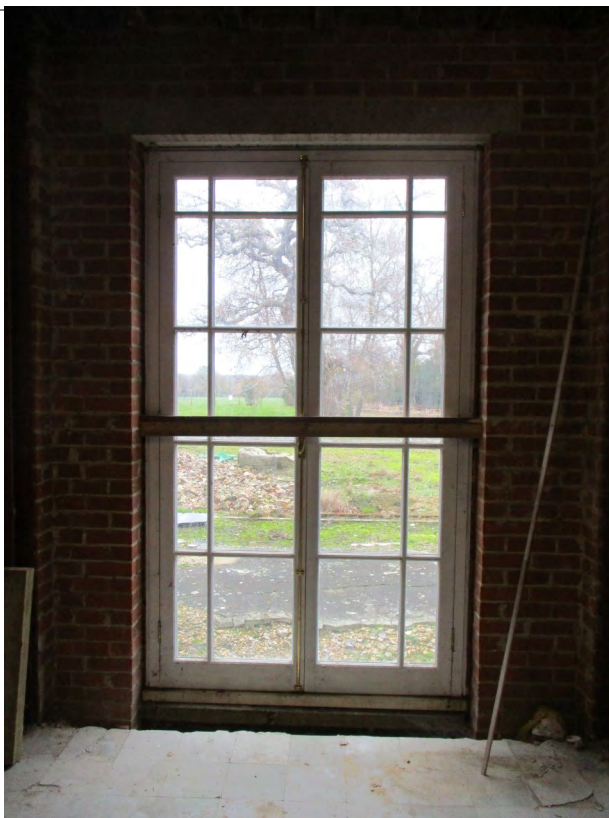
| Reference | Wg.16 | | |

| Location | Ground floor, west wing | | |
| Type | Softwood timber double French Door. There were 10 no. panes to each side and a door bolt to the left side | | |

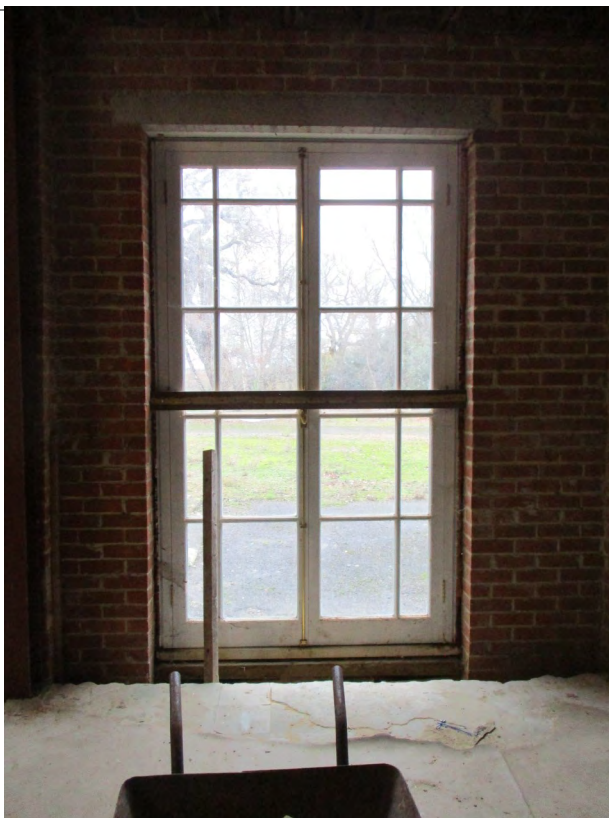
| Reference | Wg.17 | | |

| Location | Ground floor, west wing | | |
| Type | Softwood timber double French Door. There were 10 no. panes to each side and a door bolt to the left side | | |

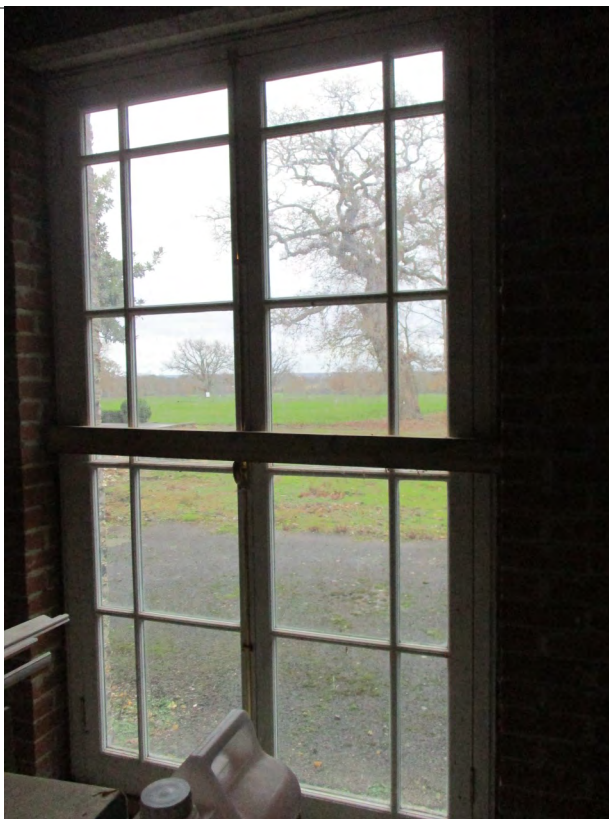
| Reference | Wg.18 | | |

| Location | Ground floor, west wing | | |
| Type | Softwood timber double French Door. There were 10 no. panes to each side and a door bolt to the left side | | |

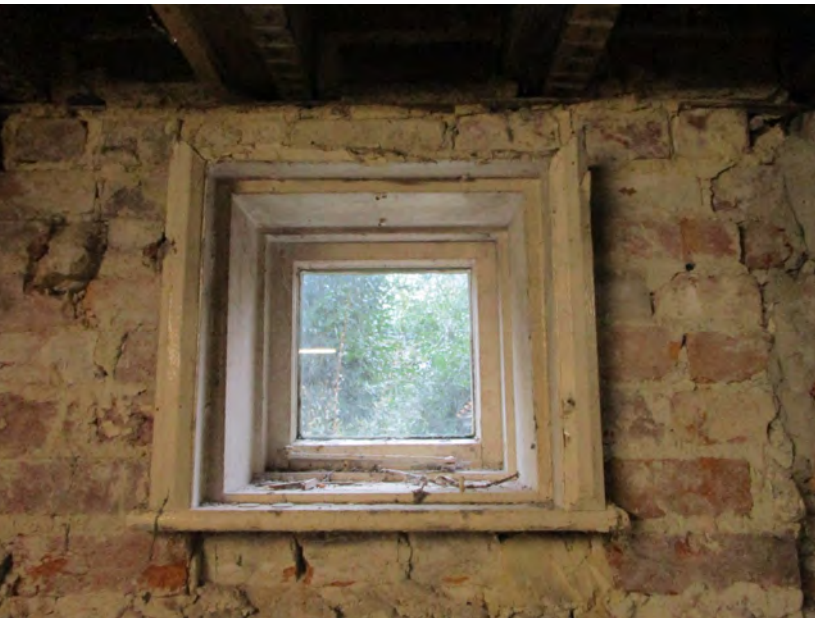
| <b>Reference</b> | Wg.19 | | |

| <b>Location</b> | Ground floor, west wing | | |
| <b>Type</b> | Side hung casement with 1 no. pane | | |

| <b>Furniture</b> | Corroded furniture should be replaced if window is to be operable on future occupancy | | |
| <b>Timber decay</b> | Cut back and replace base of (exterior) south vertical stile | | |

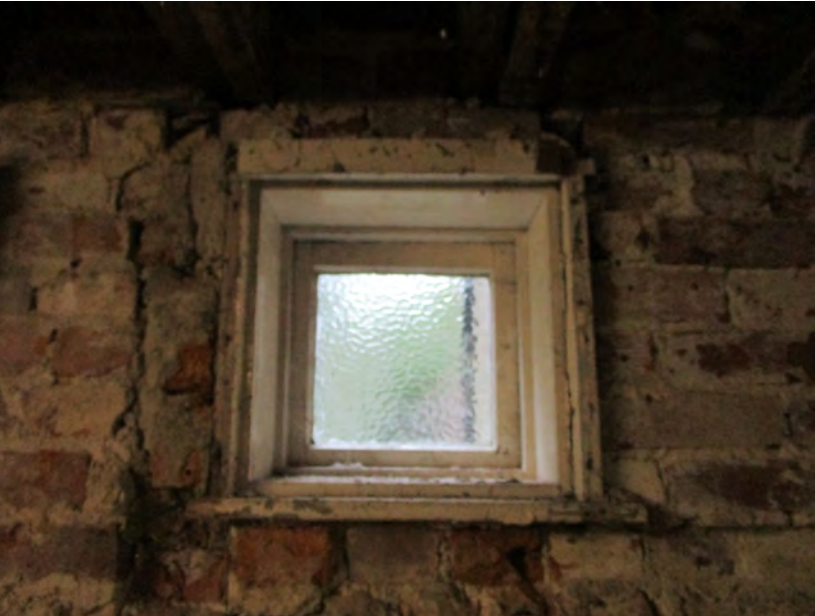
| <b>Reference</b> | Wg.20 | |

| <b>Location</b> | Ground floor, west wing | |
| <b>Type</b> | Side hung casement with 1 no. pane frosted glazing | |

| <b>Furniture</b> | Replace missing stay bar if window is to be operable on future occupancy (this may be difficult a part of the window appeared to be covered by exterior wall finishes | |
| <b>Timber decay</b> | Cut back and replace base of (exterior) south vertical stile | |

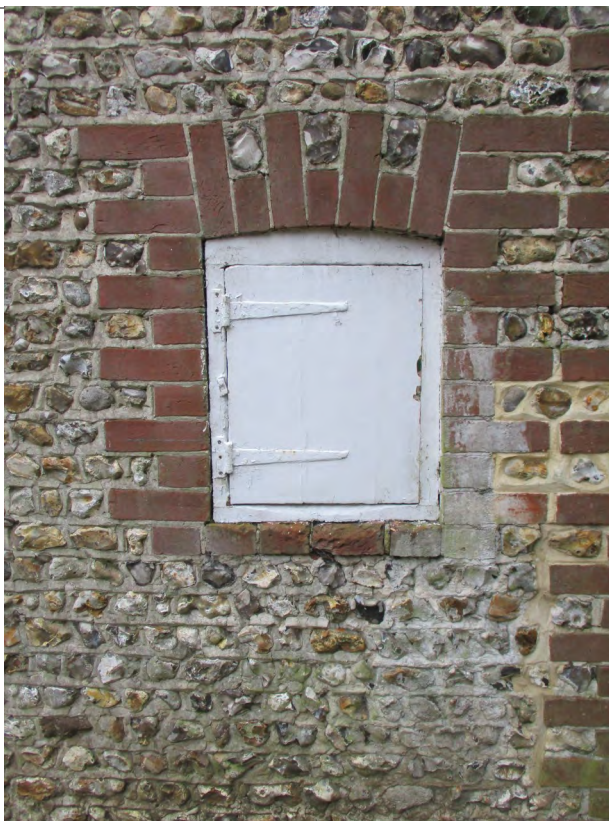
| Reference | Wg.20a | | |

| Location | Ground floor, west wing | | |
| Type | Softwood timber panelled door in timber frame with large hinges | | |

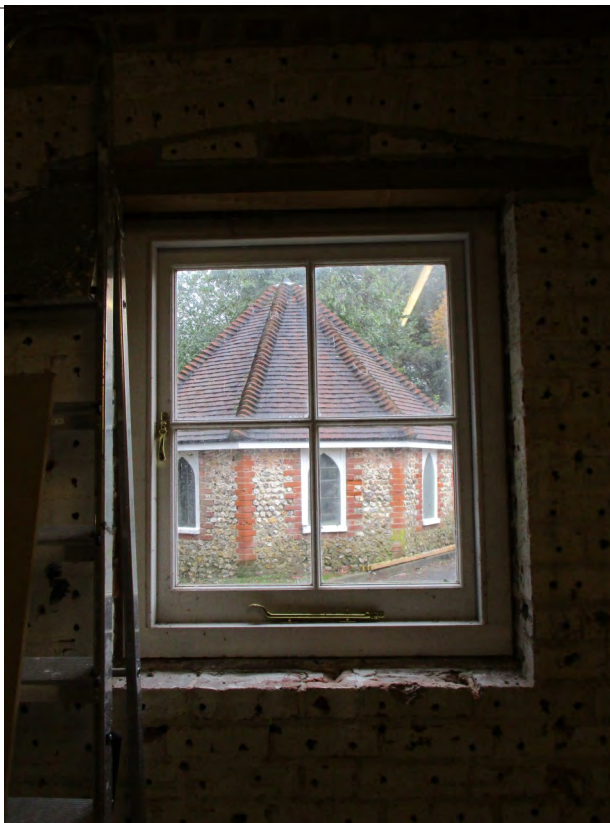
| Reference | Wg.21 | | |

| Location | Ground floor, west wing | | |
| Type | Modern softwood timber side hung casement, with modern furniture | | |

| Missing elements | Replace missing window stool board and architrave | | |

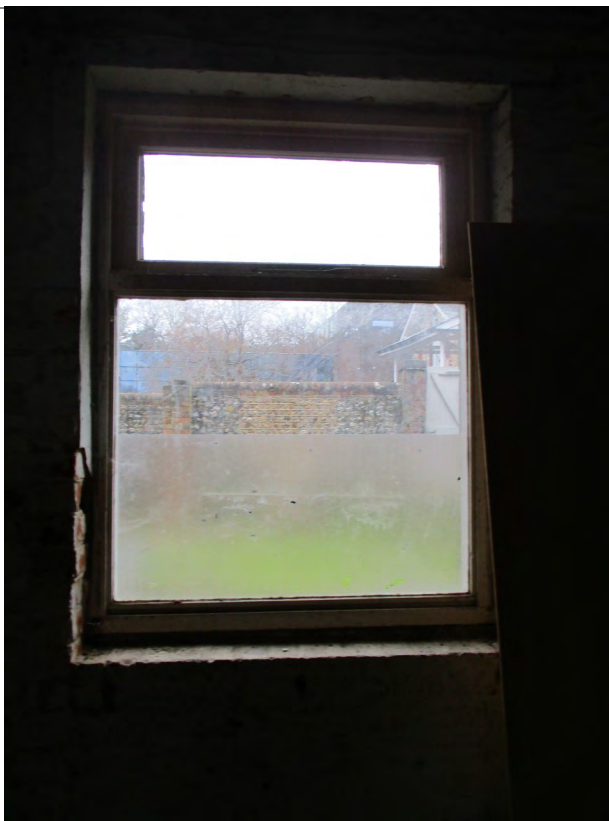
| Reference | Wg.22 | | |

| Location | Ground floor, west wing | | |
| Type | Softwood fixed timber window with toplight. 1no. pane to fixed and 1no. Pane to toplight. Glazing film on bottom half of fixed pane | | |

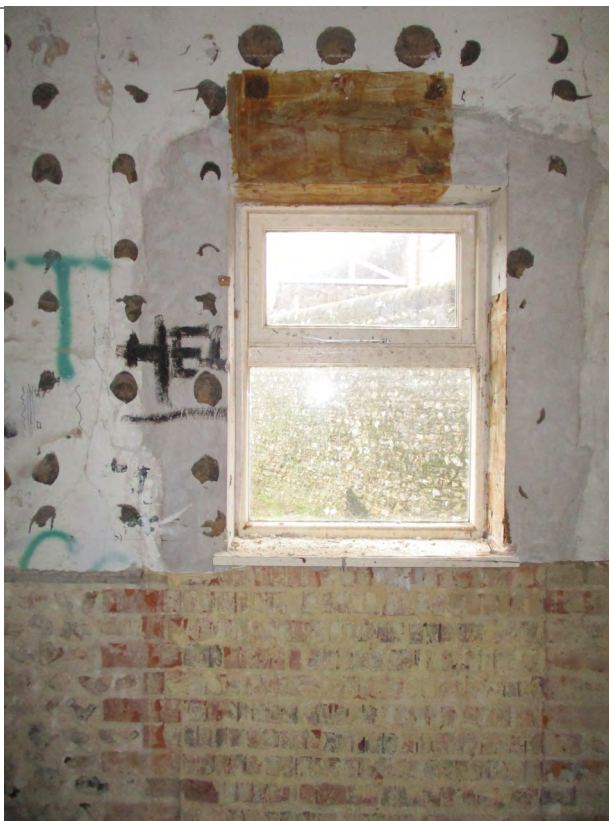
| Reference | Wg.23 | | |

| Location | Ground floor, west wing | | |
| Type | Softwood fixed timber window with toplight. 1no. pane to fixed and 1no. Pane to toplight | | |

| Timber decay | Cut back and replace base of both vertical stiles | | |
| Loose elements | Reattach the exterior horizontal stop bar of the fixed pane | | |

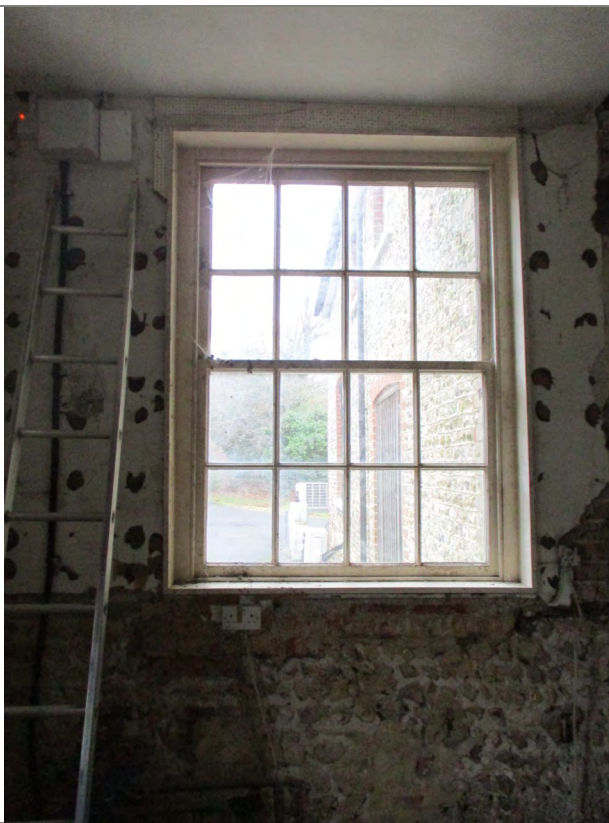
| Reference | Wg.24 | | |

| Location | Ground floor, west wing | | |
| Type | Timber '8 over 8' vertical sliding sash with cords and sliding sash lock | | |

| Furniture | Replace sliding sash lock | | |

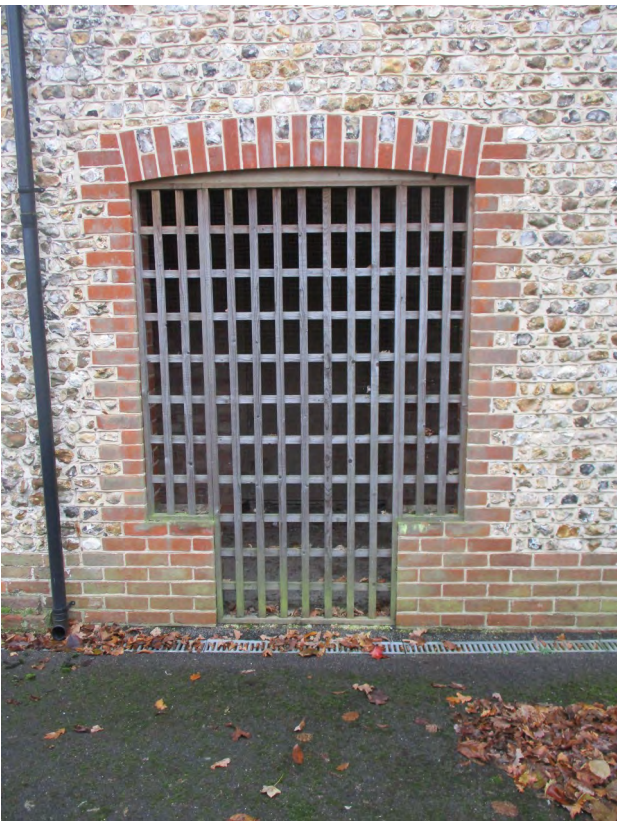
| <b>Reference</b> | Wg.25 | | |

| <b>Location</b> | Ground floor | | |
| <b>Type</b> | Timber trellis | | |

| <b>Missing elements</b> | Allow for new door | | |

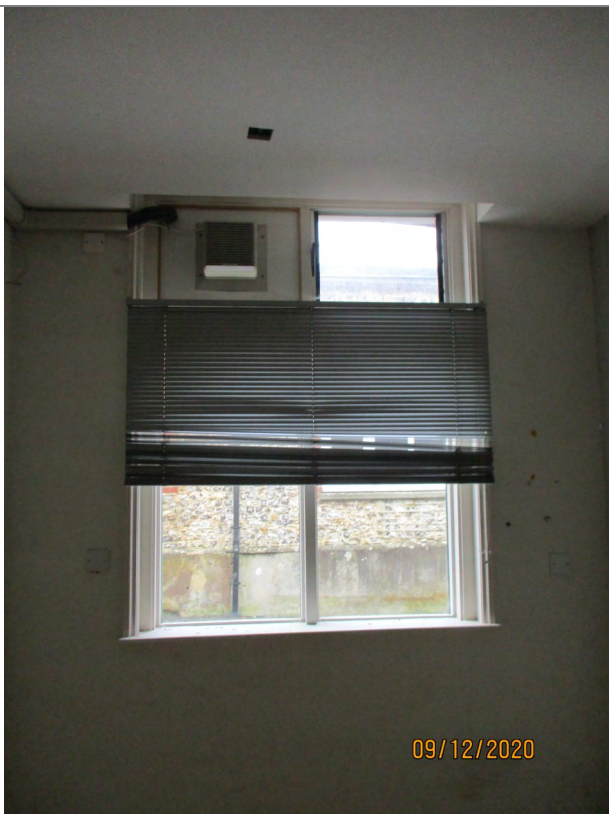
| Reference | Wg.26 | | |

| Location | G.05 R&D Lab, Ground floor | | |
| Type | Fixed softwood timber window with central mullion and toplights above. The left toplight had no glazing pane just a service fan and the right fanlight was louvred glass | | |

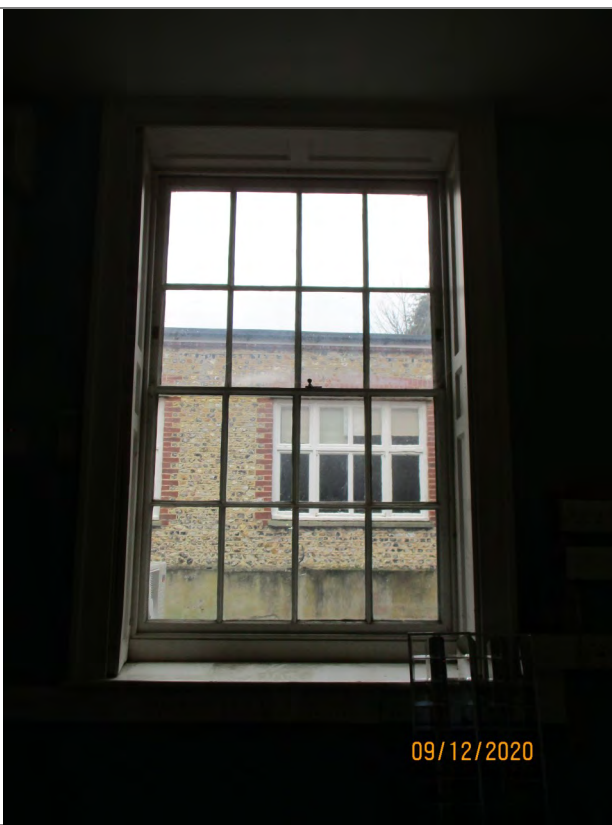
| Reference | Wg.27 | | |

| Location | G.06 IT Workshop | | |
| Type | Softwood timber '8 over 8' vertical sliding sash with brass lock on meeting rails and pulley cords | | |

| Operation | Allow to replace sash balances<br>Allow to ease both sashes | | |

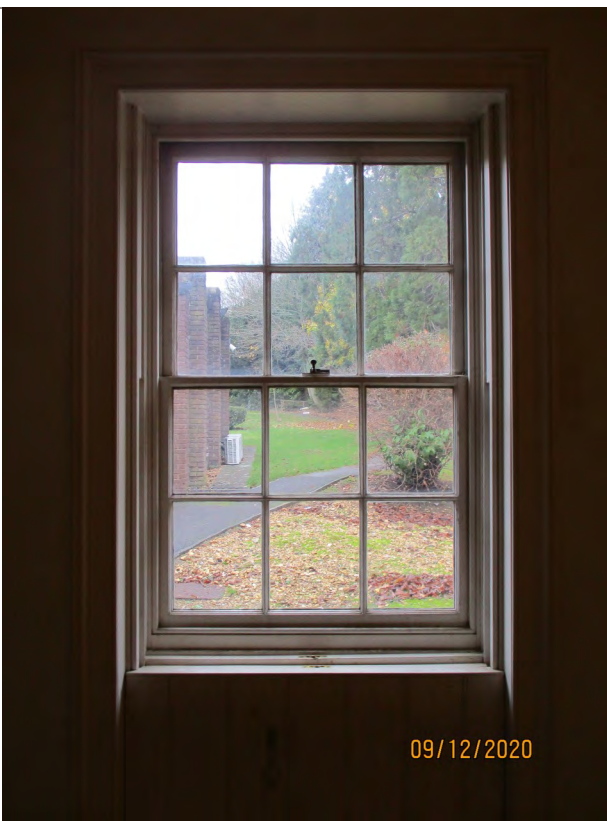
| Reference | Wg.29 | | |

| Location | G.07 IT Office | | |
| Type | Softwood timber '6 over 6' vertical sliding sash with lock on meeting rails | | |

| Operation | Allow to replace sash balances<br>Allow to ease both sashes | | |

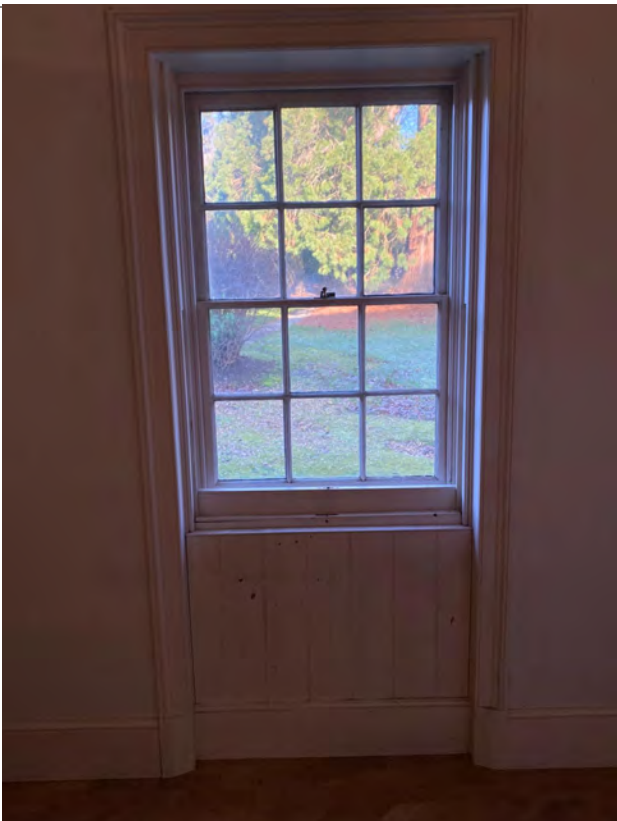
| Reference | Wg.30 | | |

| Location | G.07 IT Office | | |
| Type | Softwood timber '6 over 6' vertical sliding sash with lock on meeting rails | | |

| Operation | Allow to replace sash balances<br>Allow to ease both sashes | | |
| Glazing | Allow to replace bottom left pane on bottom sash | | |
| Loose elements | Reattach sliding shutter where loose at base | | |

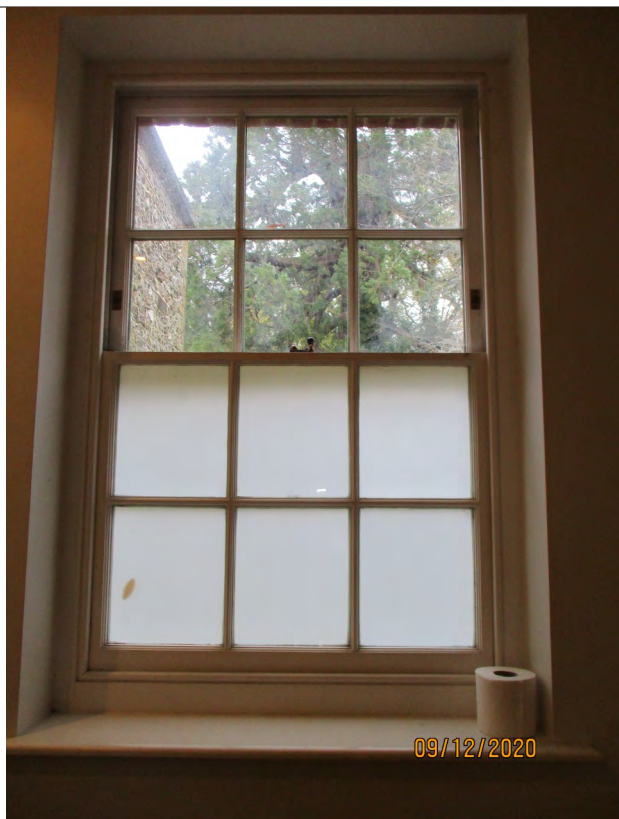
| Reference | Wg.31 | | |

| Location | G.10 Toilets | | |
| Type | Softwood timber '6 over 6' vertical sliding sash with lock on meeting rails. The bottom sash glazing had frosted film applied | | |

| Operation | Allow to replace sash balances<br>Allow to ease both sashes | | |

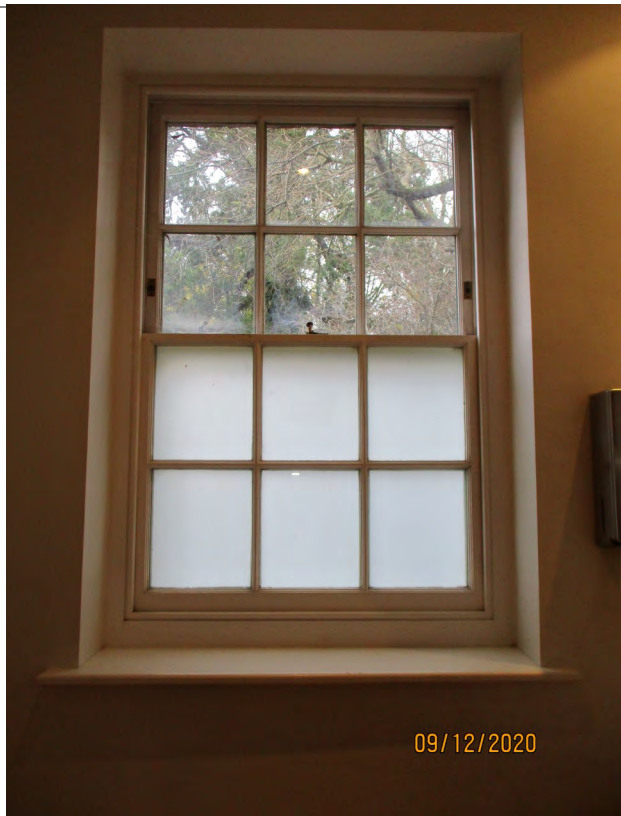
| Reference | Wg.32 | | |

| Location | G.10 Toilets | | |
| Type | Softwood timber '6 over 6' vertical sliding sash with lock on meeting rails. The bottom sash glazing had frosted film applied | | |

| Operation | Allow to replace sash balances<br>Allow to ease both sashes | | |

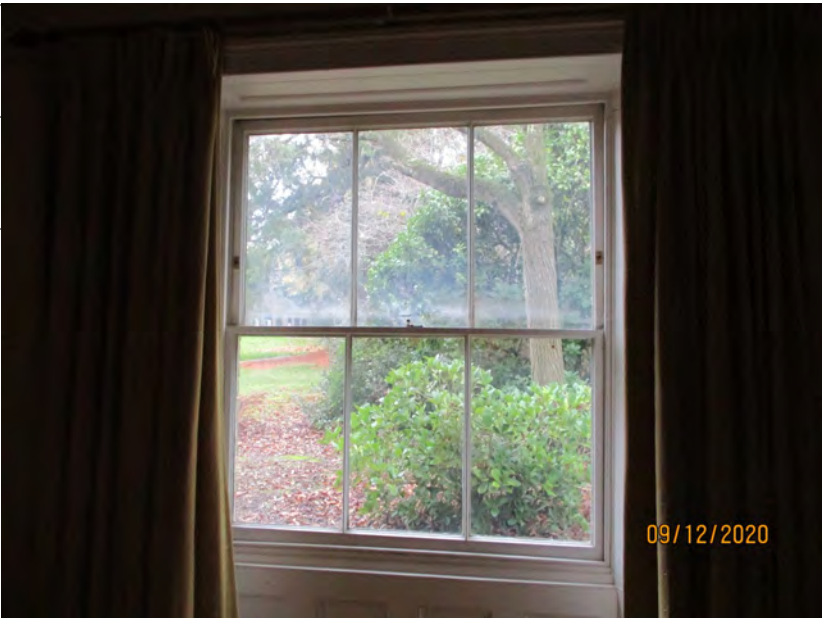
| <b>Reference</b> | Wg.33 | | |

| <b>Location</b> | G.11 Office (former morning room) | | |
| <b>Type</b> | Softwood timber '3 over 3' vertical sliding sash with lock on meeting rails | | |

| <b>Operation</b> | Allow to replace sash balances<br>Allow to ease both sashes | | |

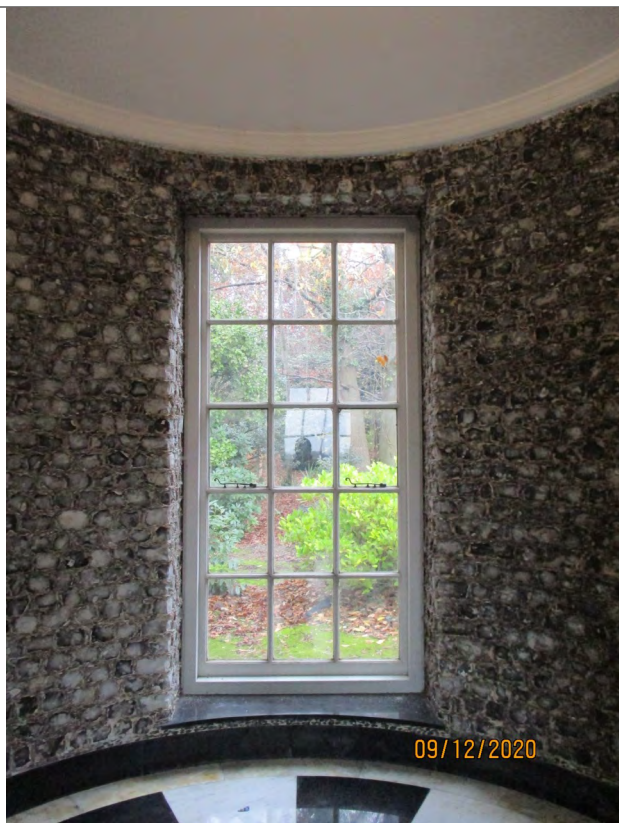
| Reference | Wg.34 | | |

| Location | Main Entrance | | |
| Type | Timber fixed window with 15no. panes with UV film applied. The centre left and right panes were both metal framed side hung case-ments | | |

| Loose elements | Remove loose or damaged putty, apply new putty and smooth | | |

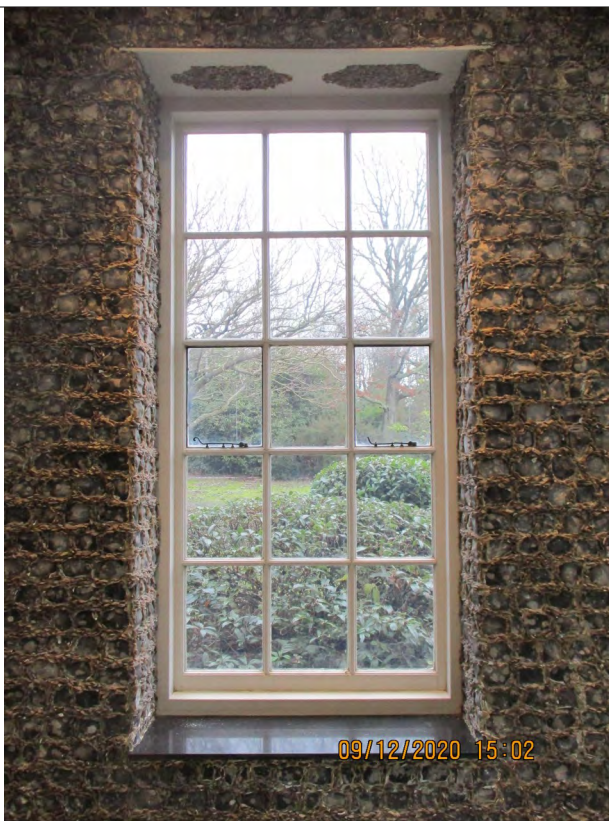
| Reference | Wg.35 | | |

| Location | G.12 Reception | | |
| Type | Timber fixed window with 15no. panes with UV film applied. The centre left and right panes were both metal framed side hung case-ments | | |

| Furniture | Right say bay should be repaired or if not possible then it should be replaced by a similarly detailed stay bar | | |
| Timber decay | Both (2no.) bottom joints in the bottom sash should be dressed-back to sound timber and resin-repaired | | |
| Loose elements | Remove loose or damaged putty, apply new putty and smooth | | |

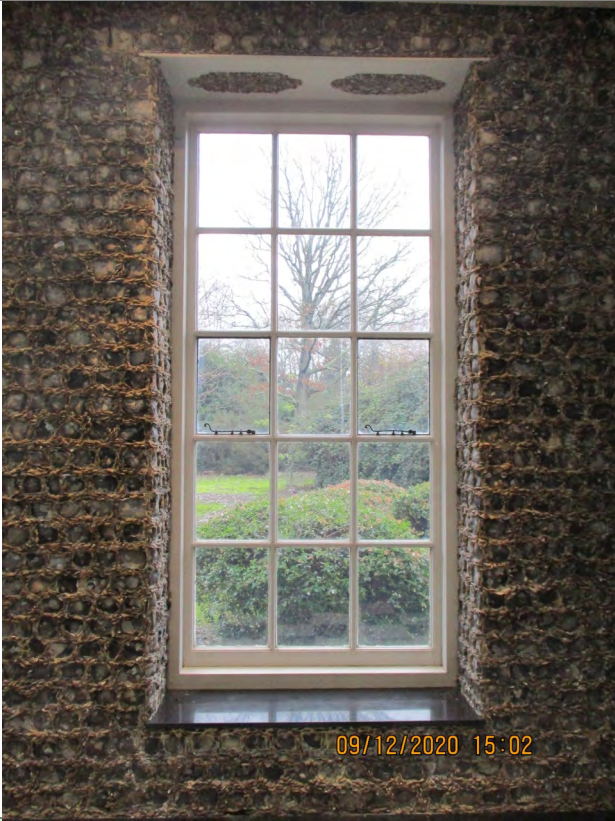
| <b>Reference</b> | Wg.36 | | |

| <b>Location</b> | G.12 Reception | | |
| <b>Type</b> | Timber fixed window with 15no. panes with UV film applied. The centre left and right panes were both metal framed side hung case-ments | | |

| <b>Timber decay</b> | Both (2no.) bottom joints in the bottom sash should be dressed-back to sound timber and resin-repaired | | |
| <b>Loose elements</b> | Remove loose or damaged putty, apply new putty and smooth | | |
