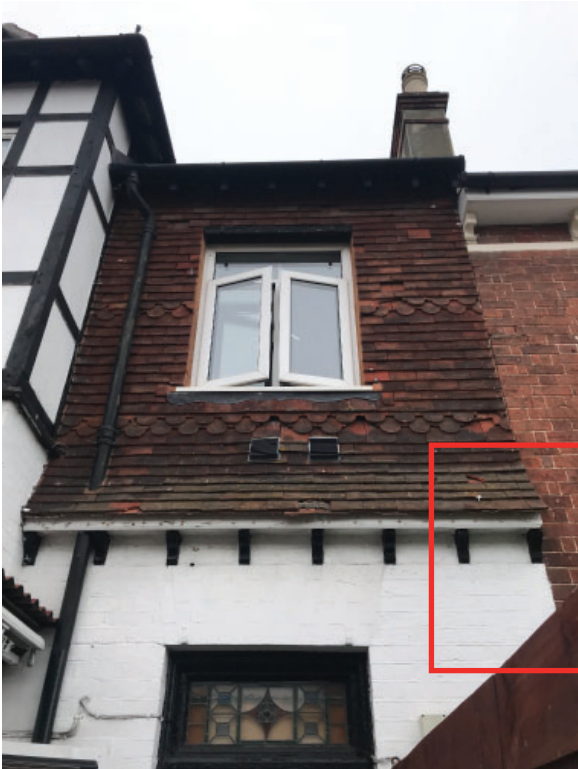
Photograph 1

View of property from North Street at line of junction between the Railway Inn and the adjoining terraced house

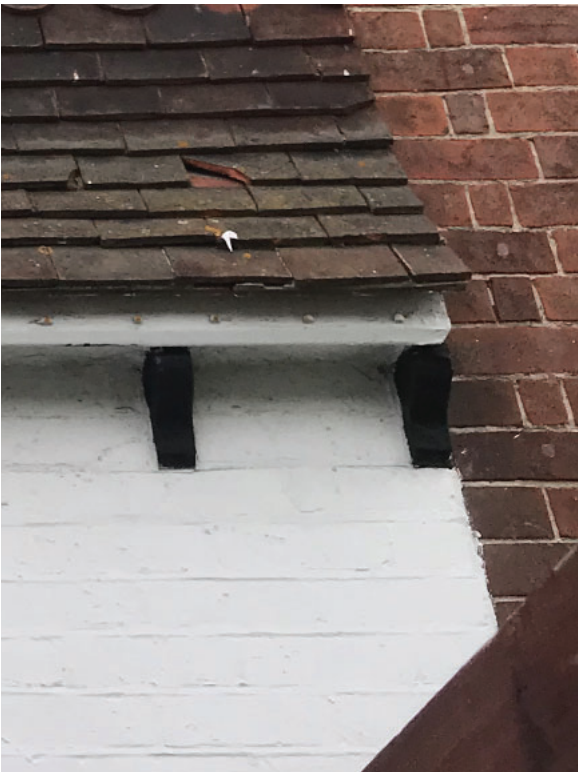
Detail 1

Brickwork not coursing on either side of boundary and return headers indicate separate walls built on line of boundary

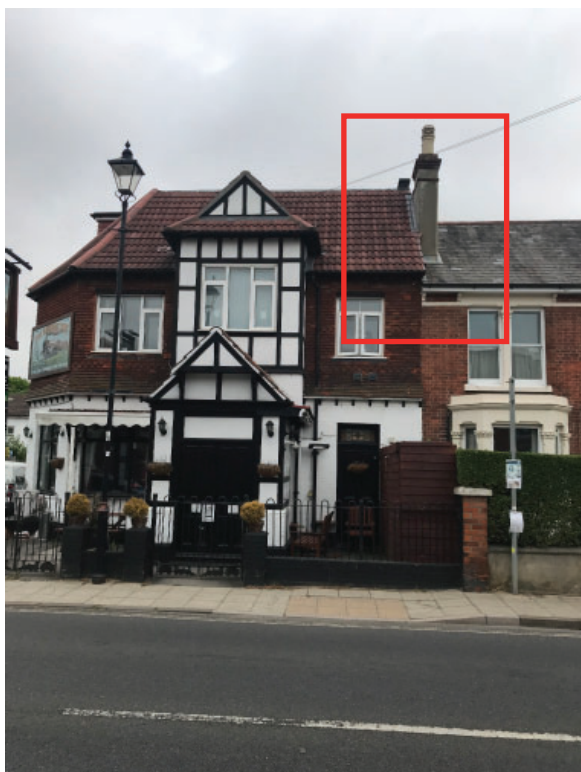
Photograph 2

View of property from North Street at line of junction between the Railway Inn and the adjoining terraced house

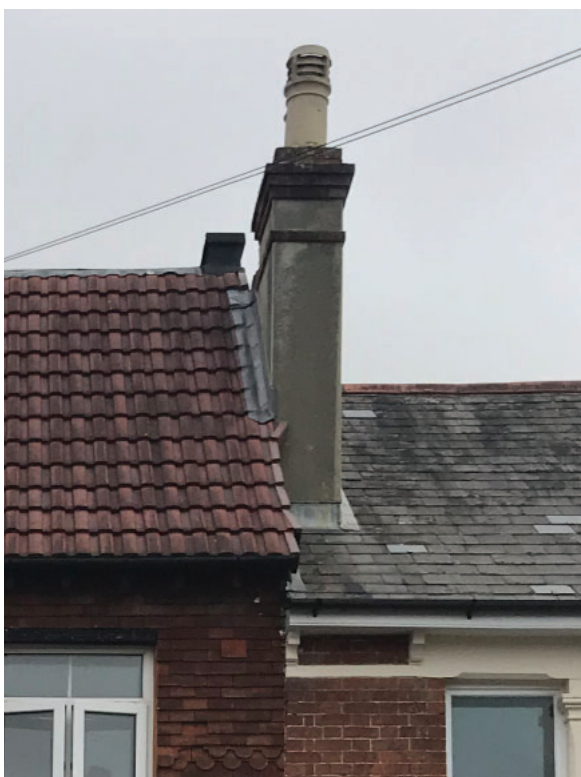
Detail 2

Chimney Brickwork to adjoining property built on line of boundary with no encroachment onto the boundary wall of The Railway Inn

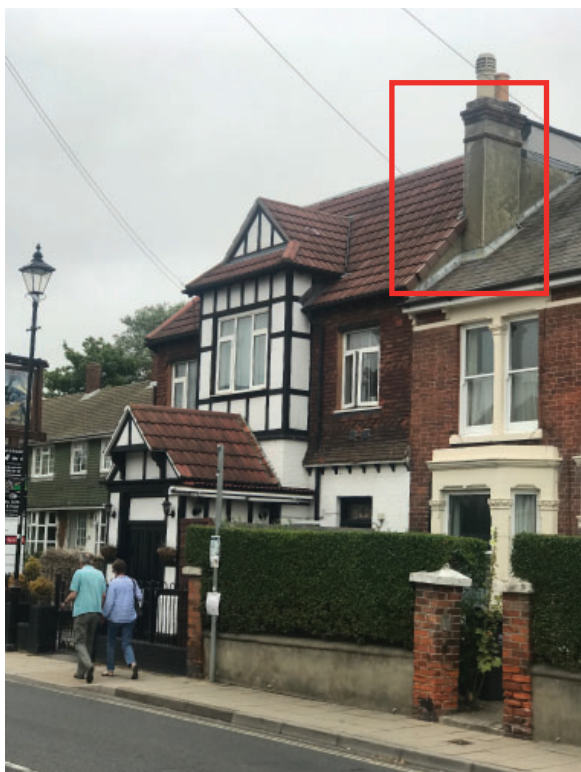
Photograph 3

Oblique view of The Railway Inn viewed from North Street and the adjoining terraced house

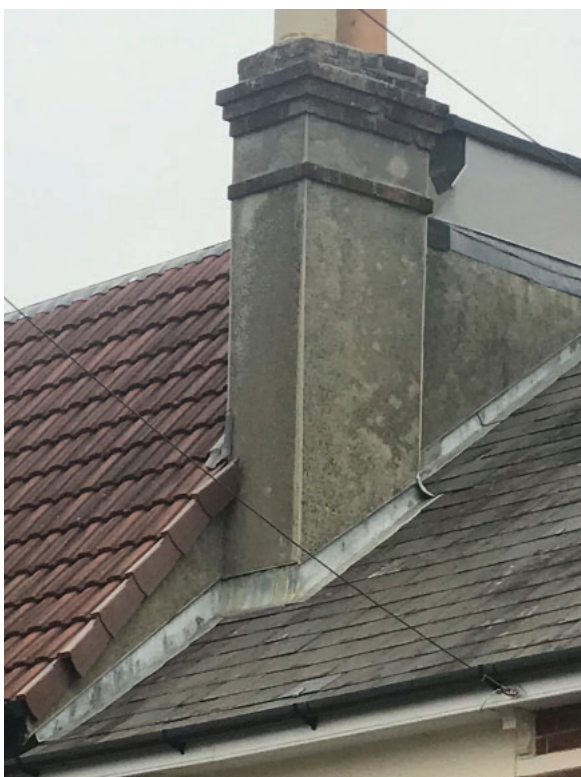
Detail 3

Lead flashings at junction between properties and showing boundary wall of the Railway Inn extending above the roof level of the adjacent terraced house

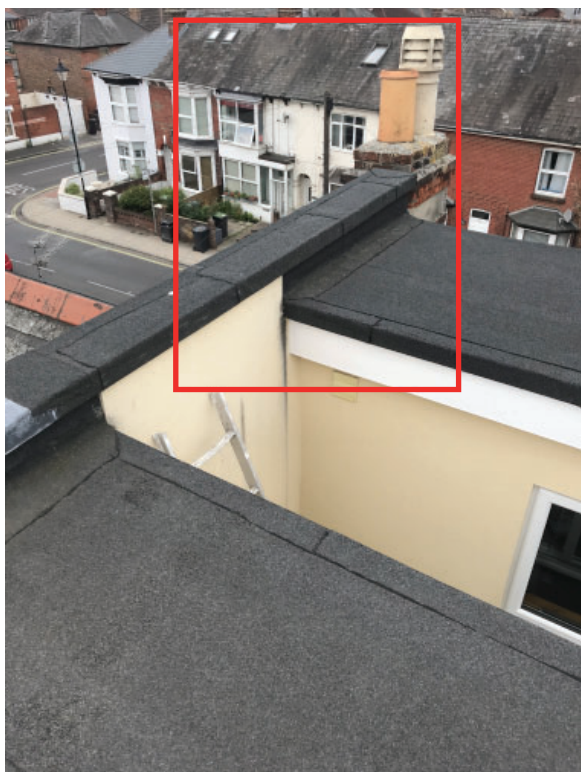
Photograph 4

View from above at roof level showing the boundary wall to The Railway Inn forming enclosure to the rooms at second floor level separate to the adjacent property

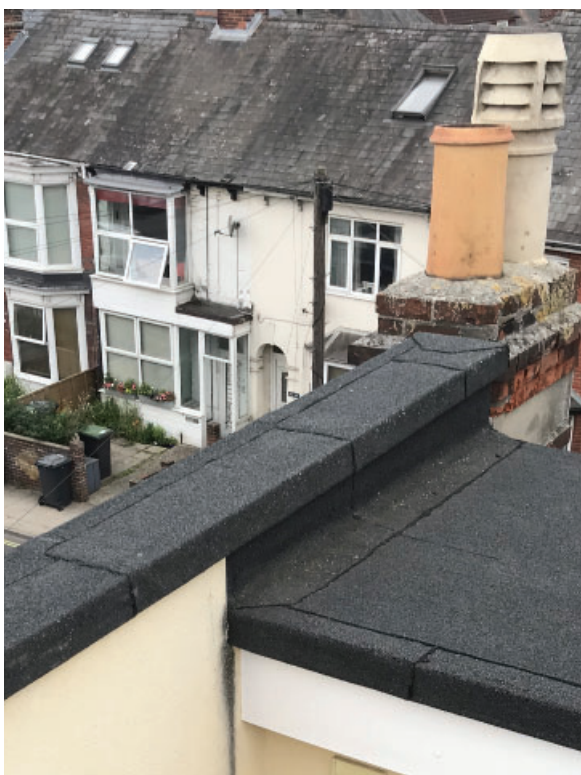
Detail 4

Independent wall on line of boundary between properties

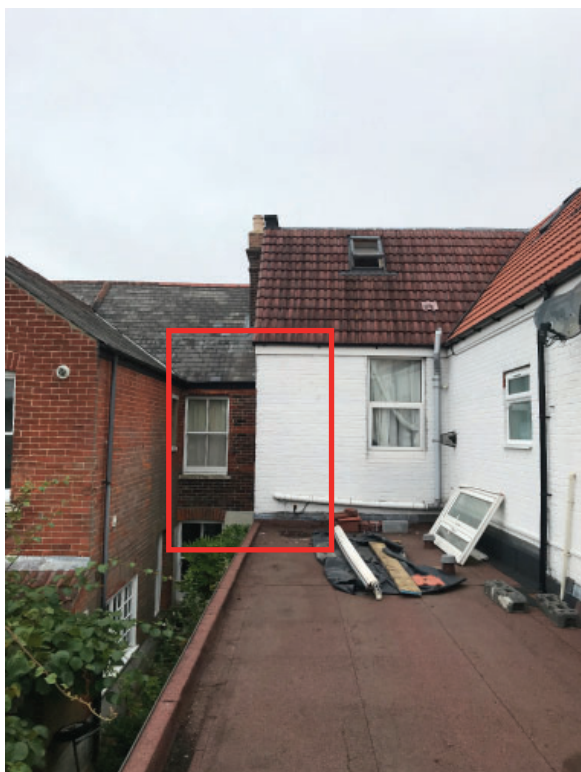
Photograph 5

Rear of the property viewed from the existing flat roof at line of junction between the Railway Inn and the adjoining terraced house

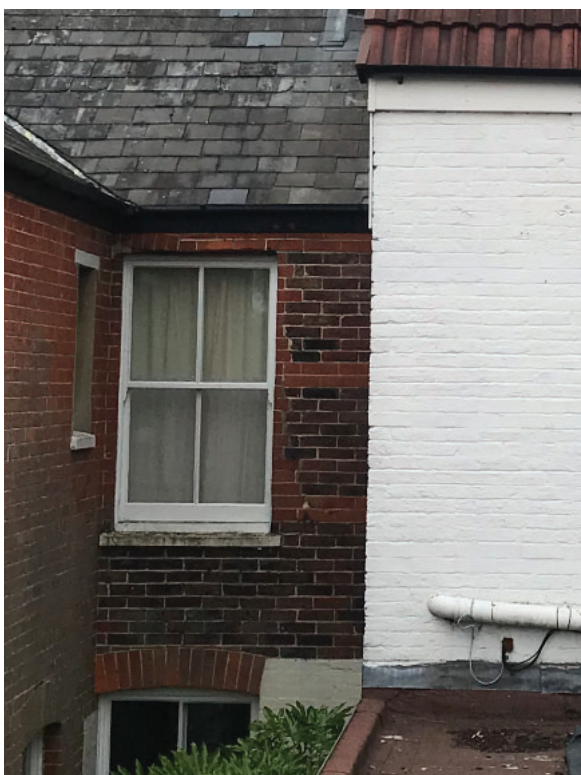
Detail 5

Line of boundary wall clearly within the property boundary with a position consistent with the same boundary line visible elsewhere
