## Measures taken at 178A West Street - APP/23/00356

We are keen to work with our neighbours and Havant Council and whilst undertaking the clearing of this site and creating a compound for vehicle storage we have taken time and effort to ensure everything we do has a limited impact on the adjoining houses and the environment. These extra measures are listed below with photographs in the inventory to demonstrate the lengths we have gone to.

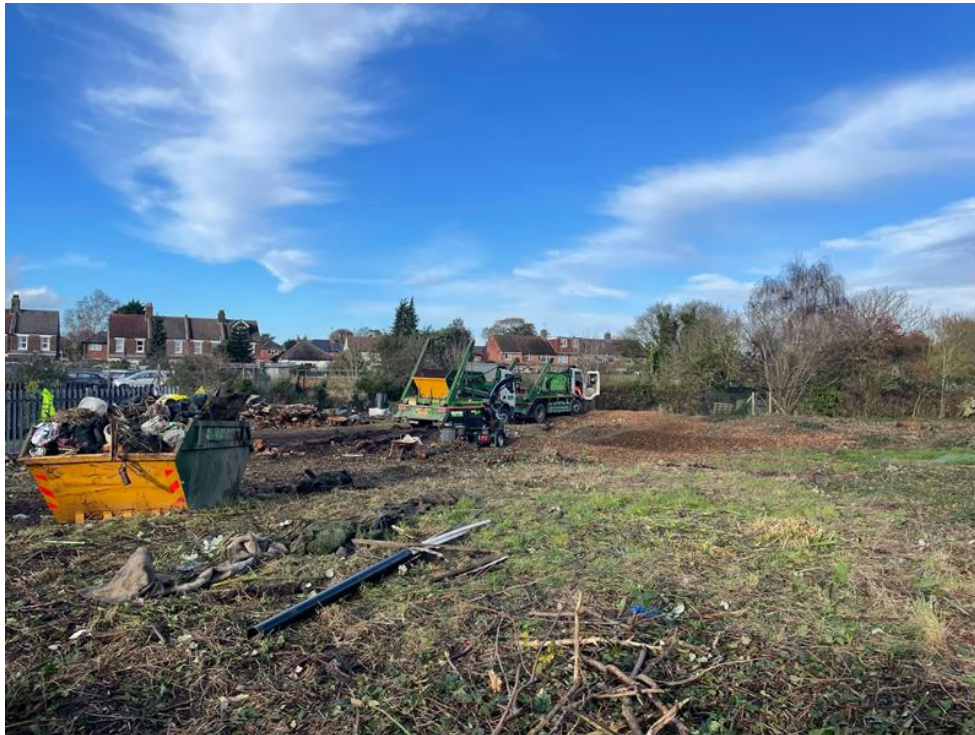
**Clearing the site, multiple skips to dispose of rubbish from fly tipping.**

Whilst our contractor was clearing the site he was disposing of beds, mattresses, sofas, fridges and lots of broken glass from old green houses as well as other general waste. The land was a health hazard and infested with rodents.

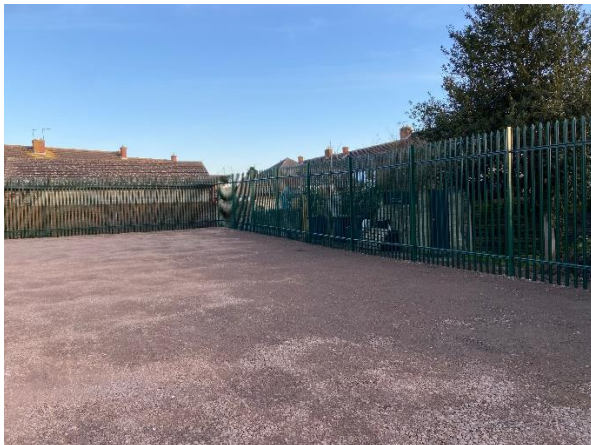
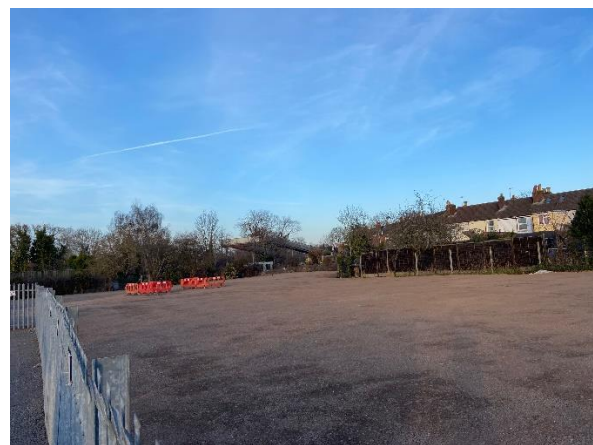
**Compound After completion with subtle fencing blending into the local environment:**

We chose to dig down dispose of all the contaminated soil and use Drintex Geo Textile Fabric followed by 100 mm of type one MOT and 50mm limestone topping over (pictures attached). This material is Permeable and Porous allowing rainwater to soak away and not runaway to other properties. This has proven to be very effective over a number of recent storms and, even with the heavy rain, there is very little if no standing water.

We chose to use Palisade fencing for its security attributes, but again consciously chose to spend more money and buy the fence in powder coated dark green to blend into the environment. Initially we erected a 10-foot fence but when we were contacted by Havant Council about the height of the fence, we cut it down to the agreed height immediately to comply with council regulations.

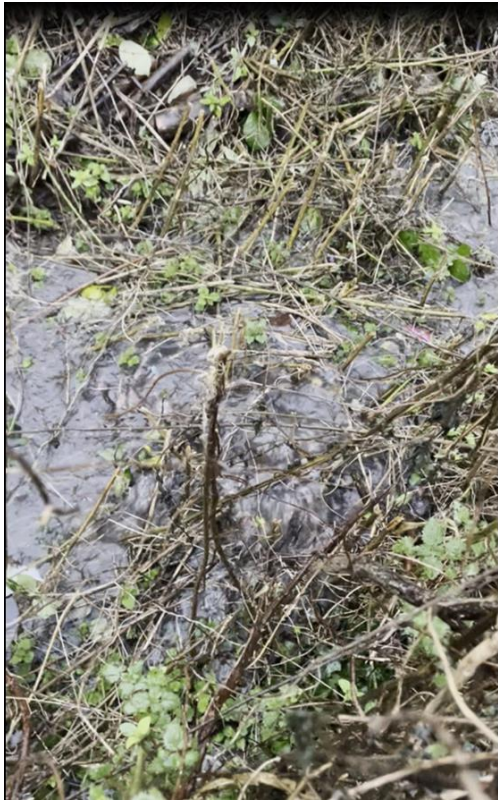
**Ditch Overflowing on Network Rail Property alongside 26 Staunton Rd Garden: :**

We have been monitoring this with the owner and, when it rains, the water comes from multiple directions stops and pools when it gets to the concrete slab. Whilst visiting Number 26, we also identified a blocked drainage ditch at the bottom of the railway embankment which is on Network Rail property. This is not being maintained by Network Rail, so rainwater is not draining away and instead overflowing into the garden of Number 26 and pooling at the bottom of the garden by the workshop.

Southern Water have been asked to investigate the drainage issues on the property and this blocked ditch is something that they have noted as a cause of the flooding. We are assisting the owner and talking to Network Rail about the drainage ditch and getting this cleared, even though it is not on our property or our responsibility to do so.

We sympathise with the owner of 26 Staunton Road; when we get heavy rain the bottom half of his garden does flood but as detailed above, this is more likely now down to other factors. We are working with the owner and Network Rail to get the blocked ditch cleared which we believe is the major cause of the flooding in his garden. A copy of the latest correspondence with Network Rail is included for reference.

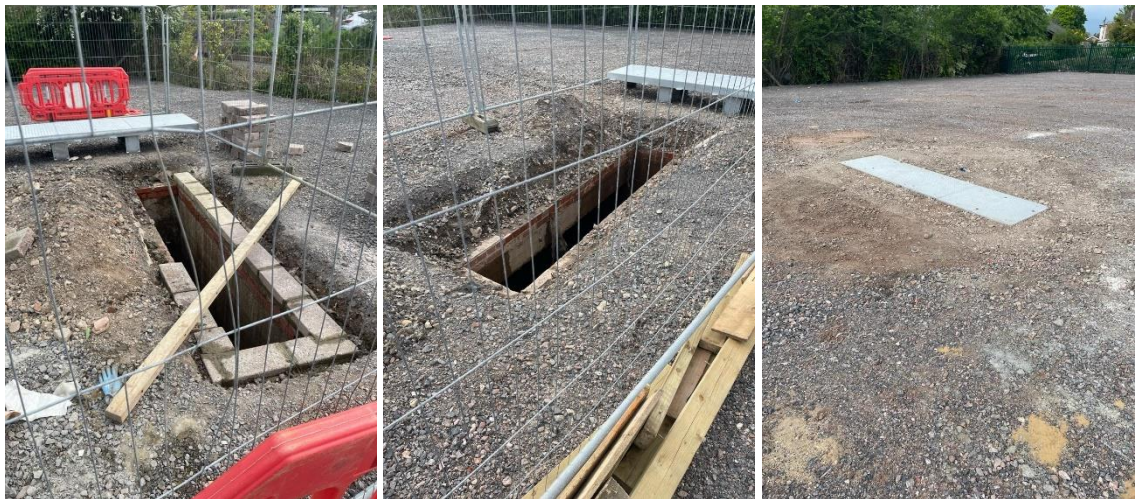
**3 Sewage Tanks being rebuilt and repaired with new steel lids:**

In addition to this there are three large sewage tanks on site that Southern Water require access to as they need pumping out every six months. Due to the overgrown nature of the land, access for Southern Water was simply not possible, this was confirmed by Southern Waters' contractor when they came to site in March 2023 to pump out the tanks for the first time in many years. These three tanks have large concrete lids for access these had completely collapsed in and the tanks were blocked with roots and other material. (Pictures of the old covers are attached in the inventory) Local residents also advised us that they had a raw sewage leak from these tanks on a couple of occasions causing the whole area to flood with waste.

All three tanks have now been repaired and have new lids and surrounds these have also been serviced twice in the last twelve months. The work that we have done has made it very easy for Southern Water to access and no flooding of raw sewage has occurred since.
