Downley Road, HAVANT, PO9 2JD

## **Annex C: Site Photographs**

# Detailed Unexploded Ordnance (UXO) Risk Assessment

| Project Name | Downley Road, Havant |

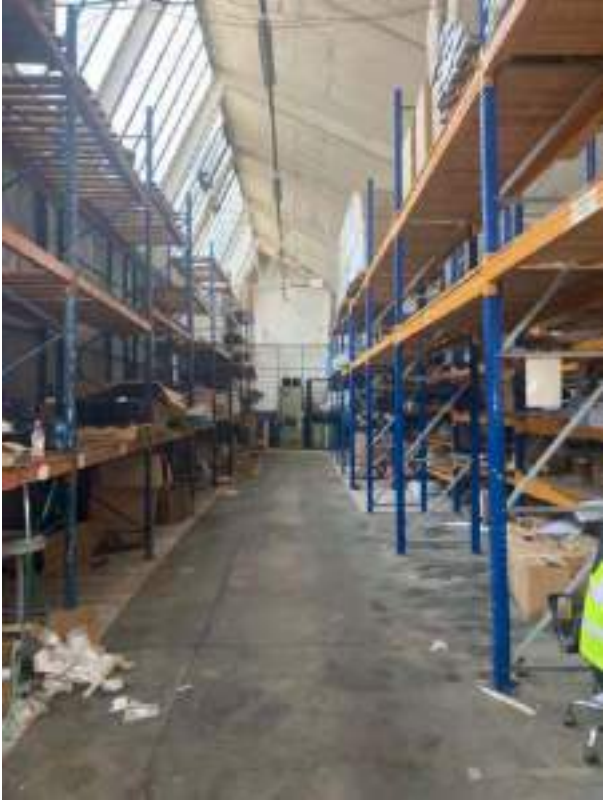
| Client: | | Site Location: | Project No.: |
|---|---|---|---|
| 1 | 09/10/23<br>- | | |

| Client: | | Site Location: | Project No.: |
|---|---|---|---|
| <b>Description</b><br>Ground floor of the Site building | | | |

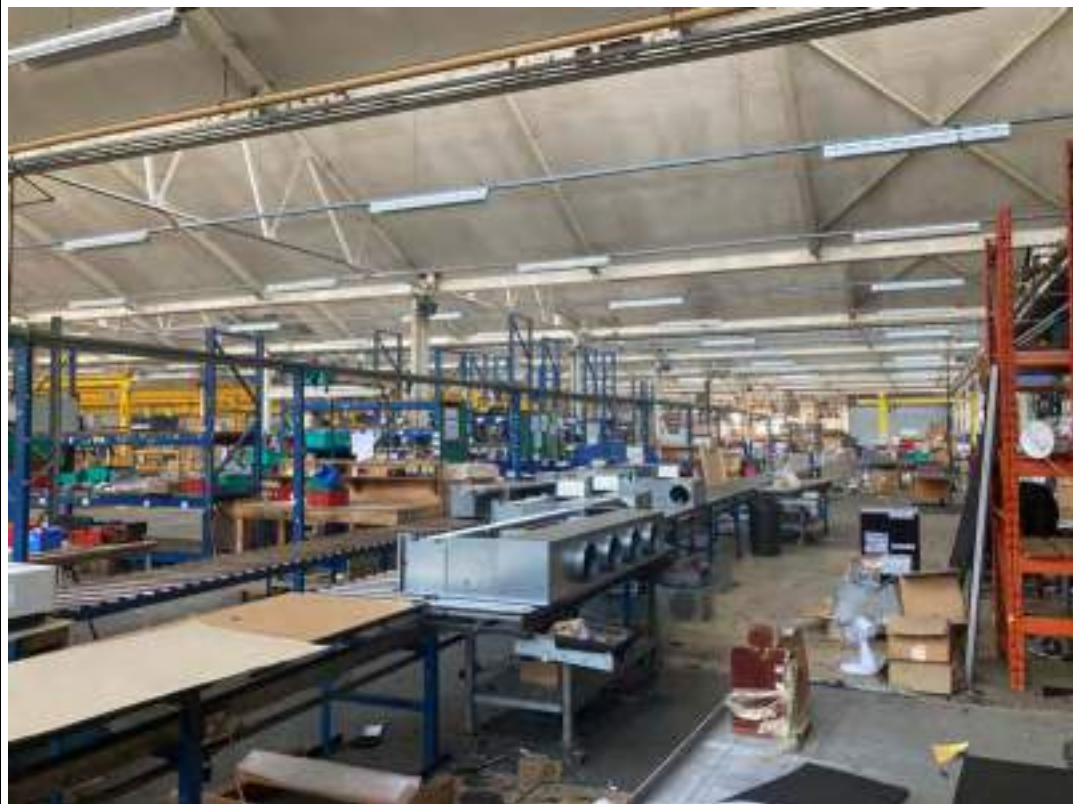
| <b>Photo No.</b><br>3 | <b>Date</b><br>09/10/23<br>- | | |

| <b>Description</b><br>Ground floor of Site building | | | |

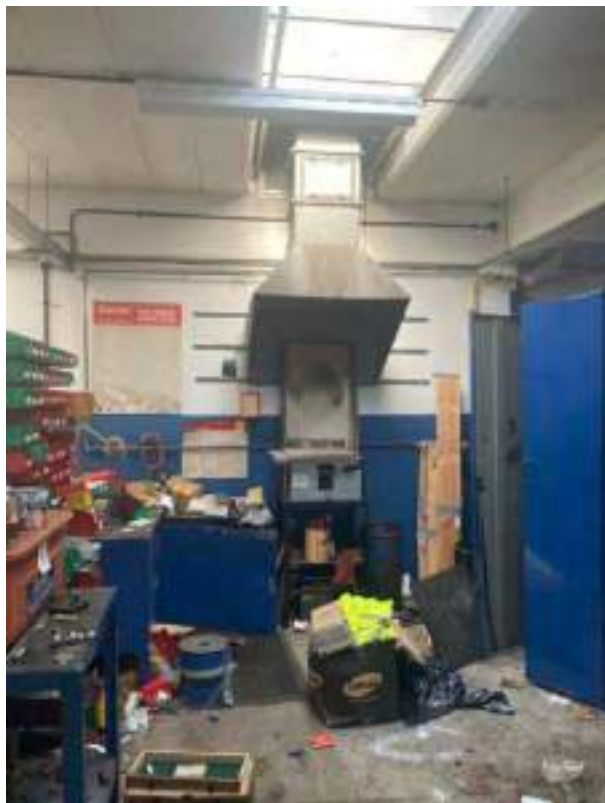
| 4 | 09/10/23<br>- | |

| <b>Description</b><br>Ground floor of Site building | | |

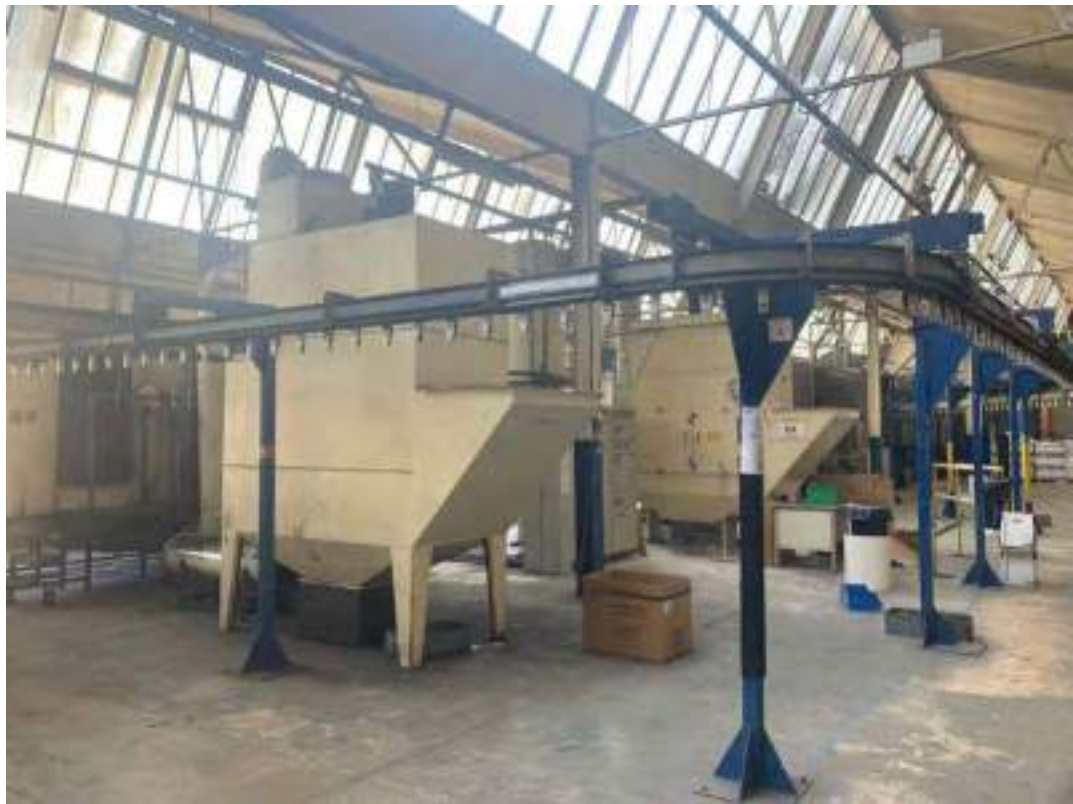
| <b>Photo No.</b><br>5 | <b>Date</b><br>09/10/23<br>- | | |

| <b>Description</b><br>Ground floor of Site building | | | |

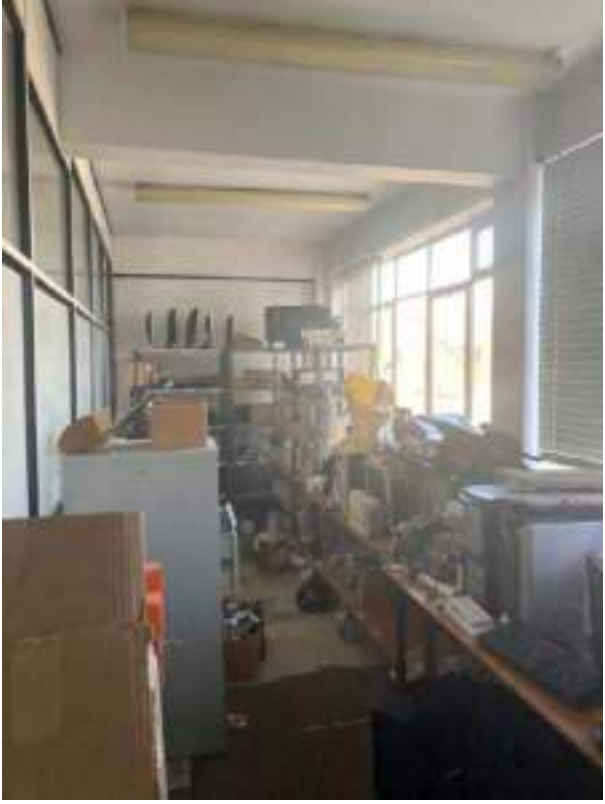
| Client: | | Site Location: | Project No.: |
|---|---|---|---|
| 7 | 09/10/23<br>- | | |

| Client: | | Site Location: | Project No.: |
|---|---|---|---|
| First floor office space | | | |

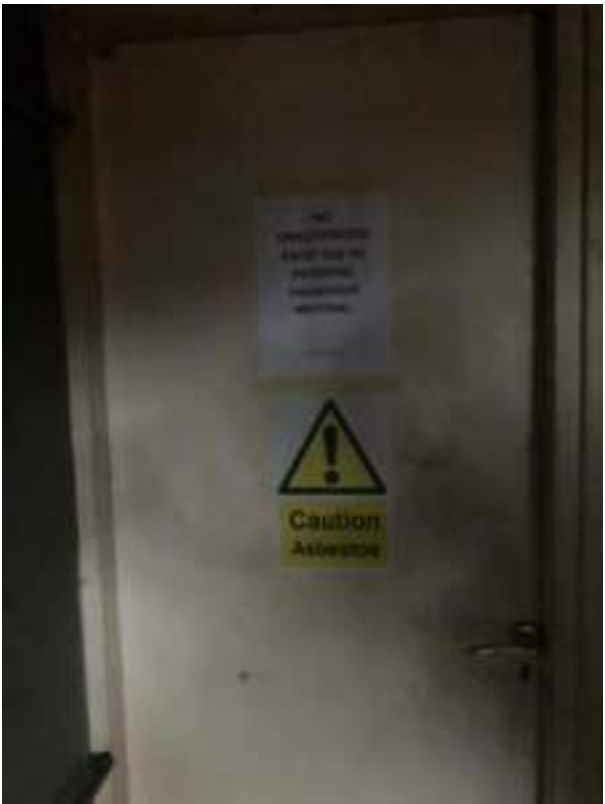
| Client: | | Site Location: | Project No.: |
|---|---|---|---|
| 9 | 09/10/23<br>- | | |

| Client: | | Site Location: | Project No.: |
|---|---|---|---|
| <b>Description</b><br>Possible asbestos on ground floor | | | |

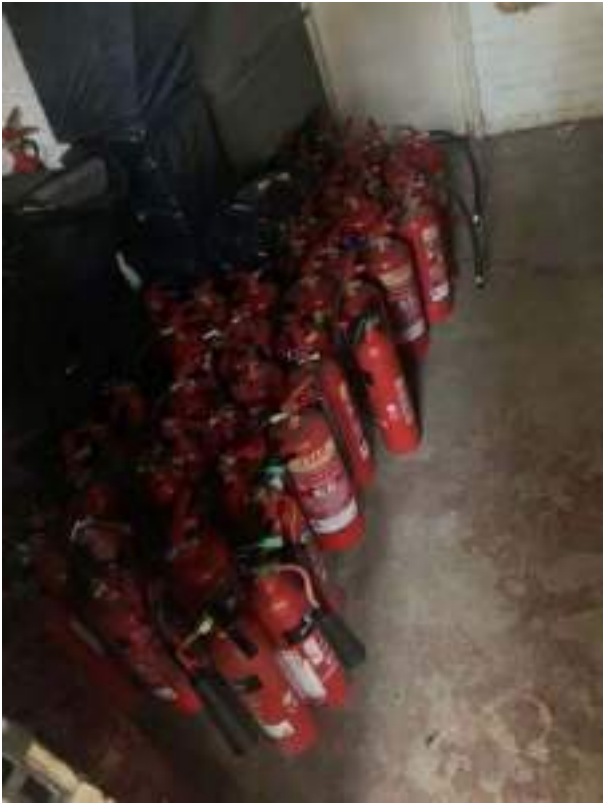
| Client: | | Site Location: | Project No.: |
|---|---|---|---|
| 10 | 09/10/23<br>- | | |

| Client: | | Site Location: | Project No.: |
|---|---|---|---|
| <b>Description</b><br>Fire extinguishers | | | |

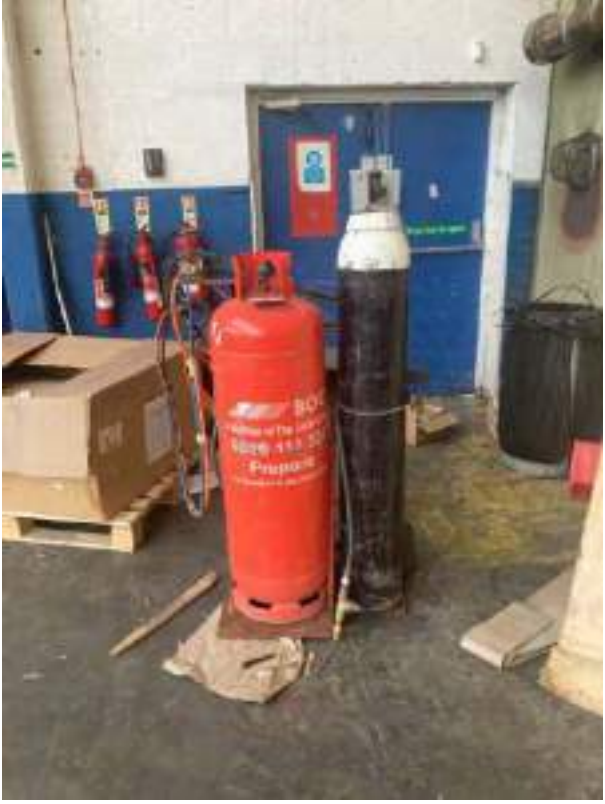
| Client: | | Site Location: | Project No.: |
|---|---|---|---|
| 13 | 09/10/23<br>- | | |

| Client: | | Site Location: | Project No.: |
|---|---|---|---|
| <b>Description</b><br>Propane tanks | | | |

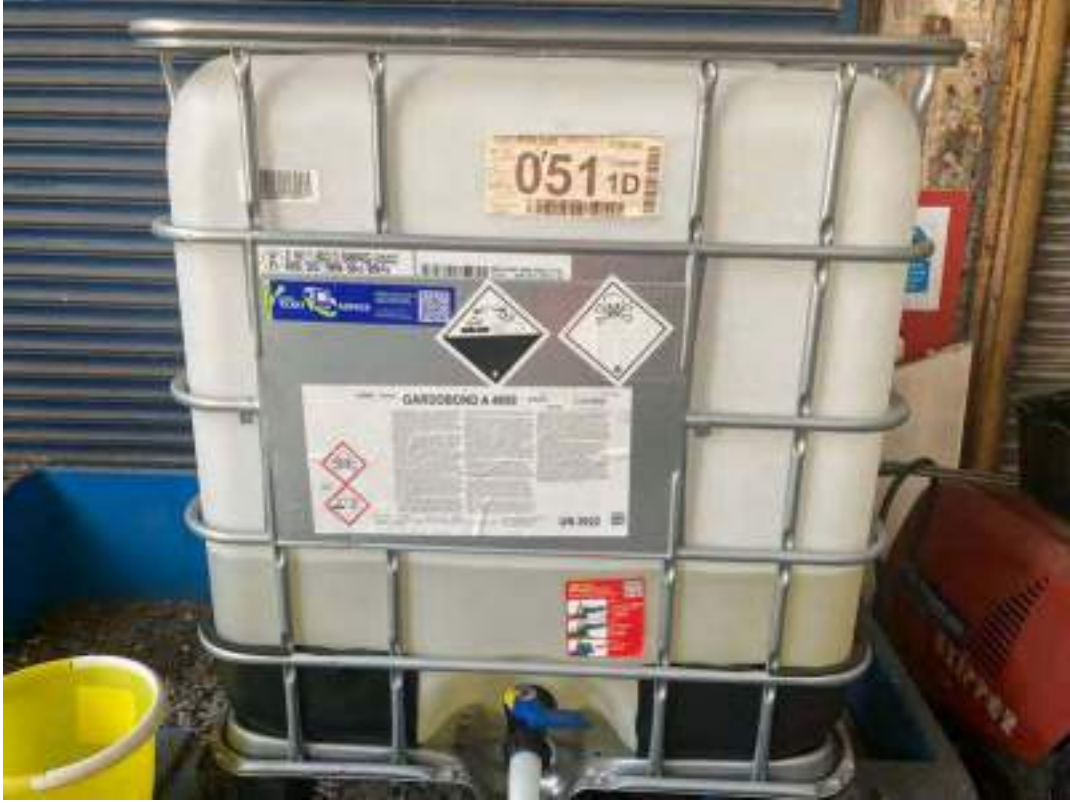
| Photo No. | Date | |
|---|---|---|
| 14 | 09/10/23<br>- | |

| Photo No. | Date | |
|---|---|---|
| <b>Description</b><br>Intermediate Bulk Containers | | |

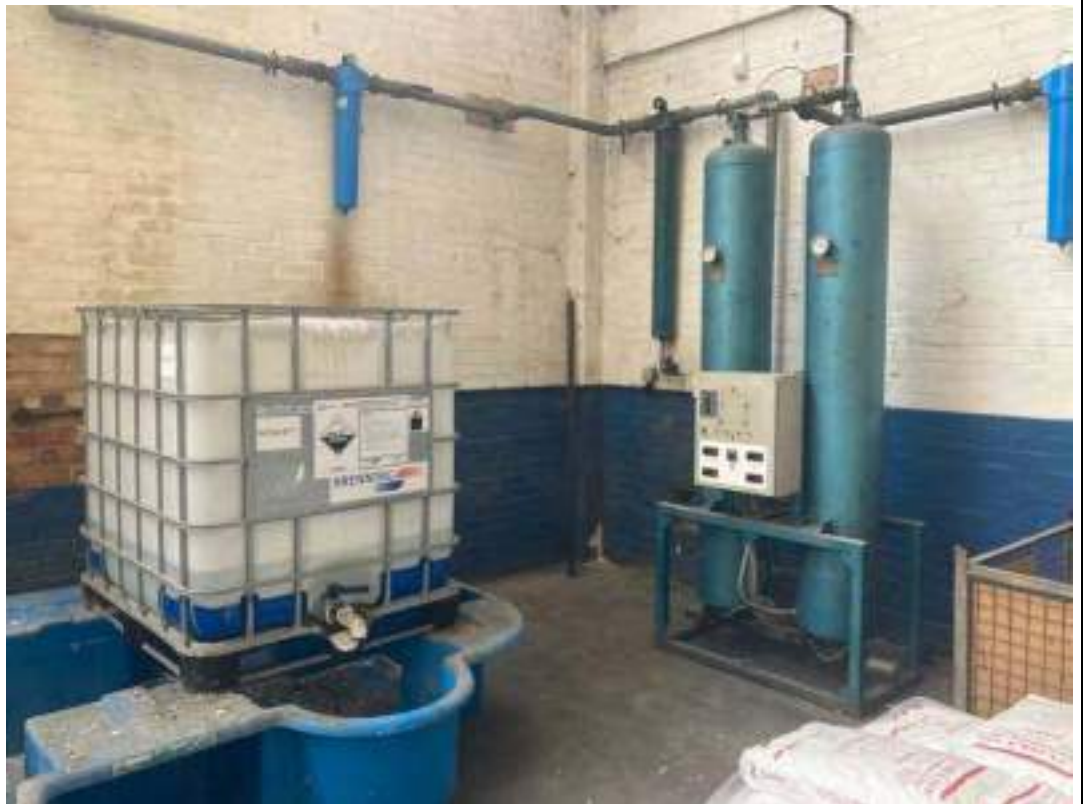
| Client: | | Site Location: | Project No.: |
|---|---|---|---|
| 15 | 09/10/23<br>- | | |

| Client: | | Site Location: | Project No.: |
|---|---|---|---|
| <b>Description</b><br>Intermediate Bulk Containers | | | |

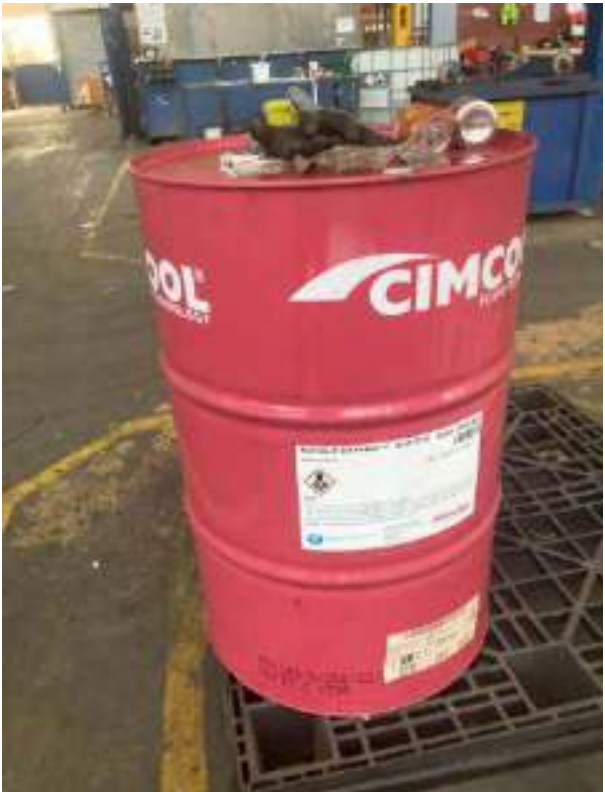
| Photo No. | Date | | |
|---|---|---|--|
| 16 | 09/10/23<br>- | | |

| Photo No. | Date | | |
|---|---|---|--|
| <b>Description</b><br>Drums | | | |

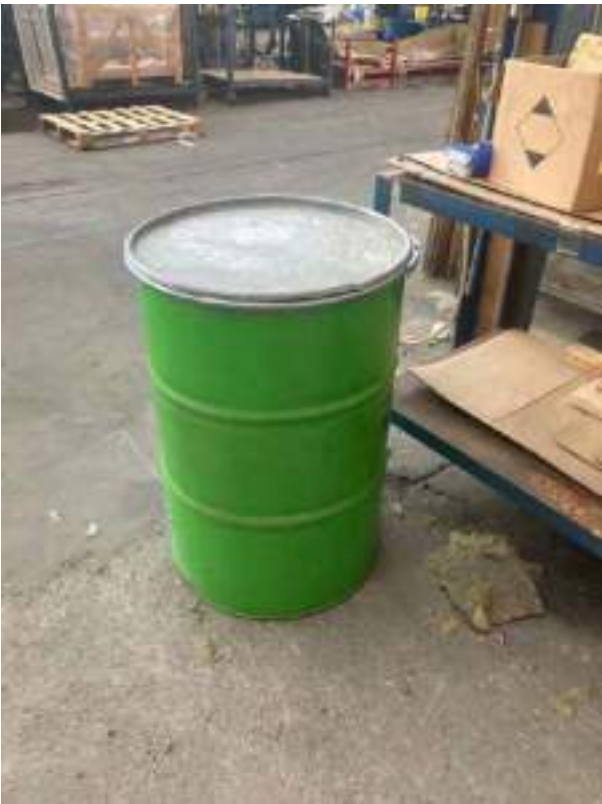
| Photo No.<br>17 | Date<br>09/10/23<br>- | | |

| Description<br>Drum | | | |

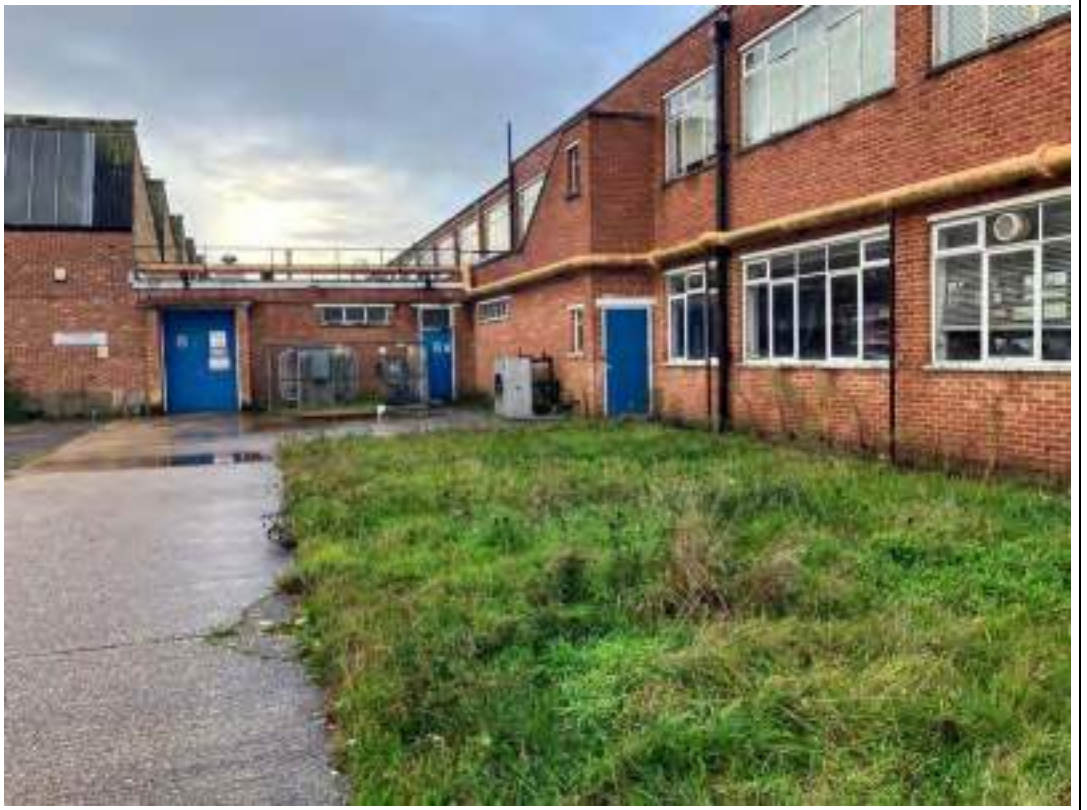
| Client: | | Site Location: | Project No.: |
|---|---|---|---|
| 19 | 09/10/23<br>- | | |

| Client: | | Site Location: | Project No.: |
|---|---|---|---|
| <b>Description</b><br>Electricity Substation | | | |

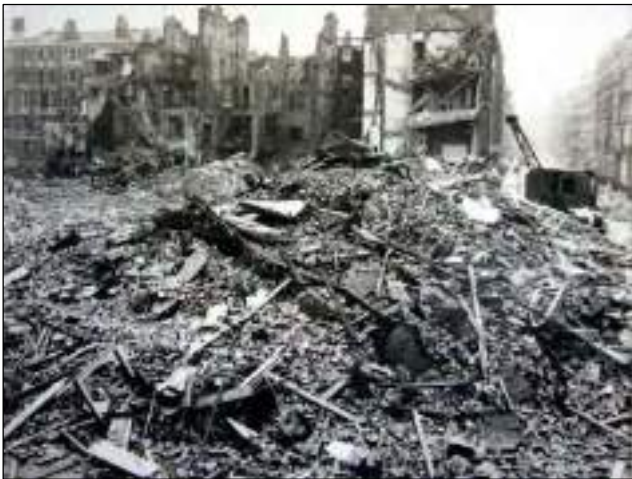
**Top:** J-curve Effect - Due to angle of entry, unexploded bombs would often end their trajectory at a lateral offset from point of entry, often ending up beneath adjacent extant structures/sites.

The photograph **above** shows a 250kg unexploded bomb found in Bermondsey in 2015, pointing upwards, demonstrating 'J-curve'.

J-curve is the term used to describe the characteristic curve commonly followed by an air delivered bomb dropped from height after it penetrates the ground. Typically, as the bomb is slowed by its passage through underlying soils, its trajectory curves towards the surface. Many UXBs are found with their nose cone pointing upwards as a result of this effect. More importantly, however, is the resulting horizontal offset from the point of entry. This is typically a distance of about one third of the bomb's penetration depth, but can be higher in certain conditions (see **Annex E**).

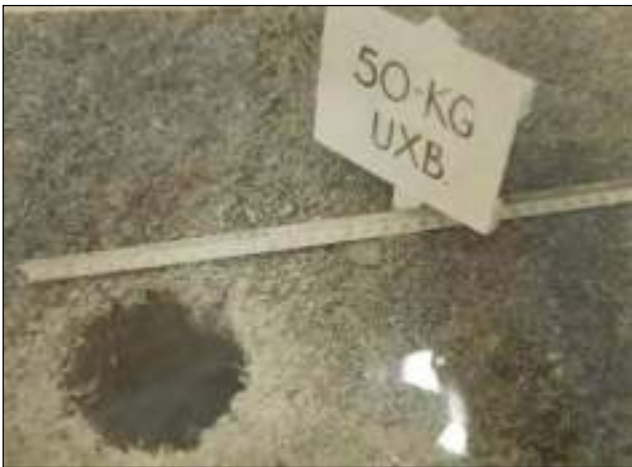
One of the most common scenarios for UXO going unnoticed was when a UXB fell into a 'bomb site' (such as the area shown **Top Left**), the entry hole of the bomb obscured by any debris and rubble present. Note that the entry hole of a 50kg UXB could be as little as 20cm in diameter (**Left**).

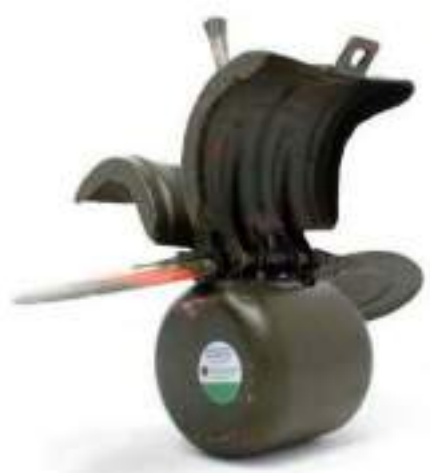
Parachute Mine (Luftmine B / LMB)

| Bomb Weight | Approx. 990kg (2176lb) |

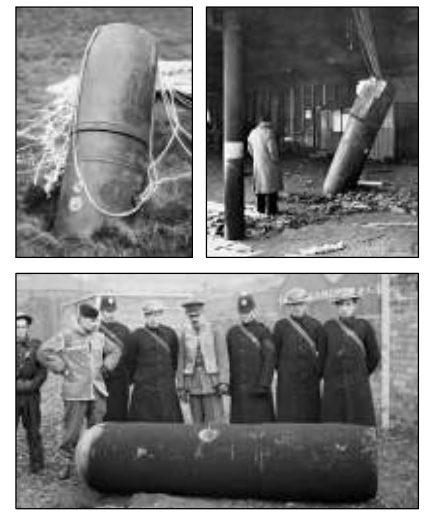
SC 1000kg High Explosive Bomb

| Bomb Weight | Approx. 993-1027kg (2,189-2,264lb) |
| Body Diameter | 654mm (18.5in) |
| Use | SC-type bombs were General Purpose Bombs used primarily for general demolition work. Constructed of parallel walls with comparatively heavy noses, they are usually of three-piece welded construction. |

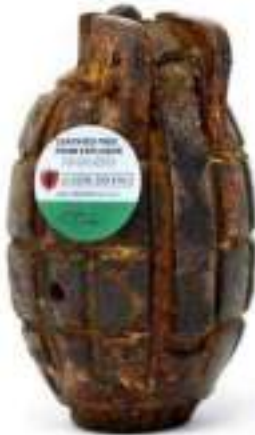
| No. 36 'Mills' Grenade | | | |
|---|---|---|--|
| Weight | Approx. 765g filled (1lb 11.25oz) | | |
| Explosive Weight | 71g (2oz) filling. | | |
| Fuze Type | 4-7 second delay hand-throwing fuze. No. 6 Detonator | | |
| Use | Fragmentation explosive at approx. 30m range 100m range of damage. | | |

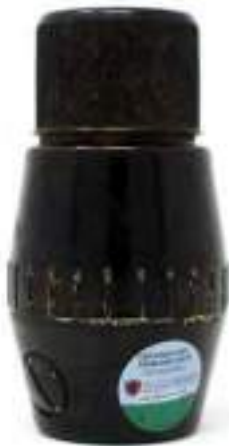
| No. 69 Grenade | | |
|---|---|---|
| Weight | Approx. 383g ( 13.5oz) | |
| Fill Weight | 93g (3.25 oz) of either Amatol, Baratol or Lyddite | |
| Fuze Type | 'All-ways' fuze. Comprised of a safety cap, a weighted streamer attached to a steel ball bearing and a safety bolt designed to detonate from any point of impact. | |

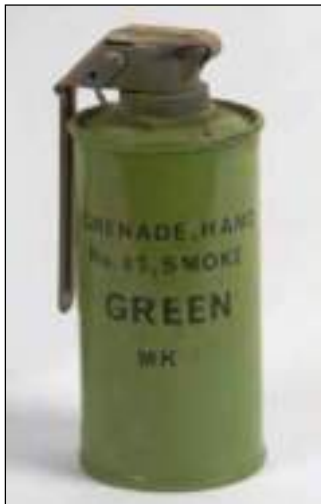
| No. 83 Smoke Grenade | | | |

| No. 83 Smoke Grenade | | | |
|---|---|---|--|
| Weight | Approx. 680g ( 1.5lb) | | |
| Explosive Weight | Approx. 170-200g. (6-7 oz) | | |
| Fuze Type | Originally used a friction system using a match head composition. Later developed to a striker lever ignition system. | | |

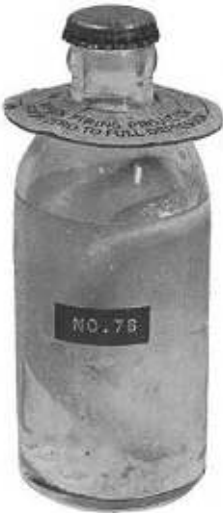
| No. 76 Self Igniting Phosphorous (SIP) Grenade | | | |
|---|---|---|---|
| Weight | Approx. 1lb 3oz | | |
| Filling | White Phosphorous and Benzene | | |
| Design | The filling was contained in a ½ pint sized glass bottle with water and a strip of rubber. Over time the rubber dissolved to create a sticky which would self ignite when the bottle broke. | | |
| Remarks | The Home Guard hid caches of these grenades during the war. Not all locations were officially recorded and some caches were lost and encountered post-war. In all cases, the grenades are still found to be dangerous. | | |

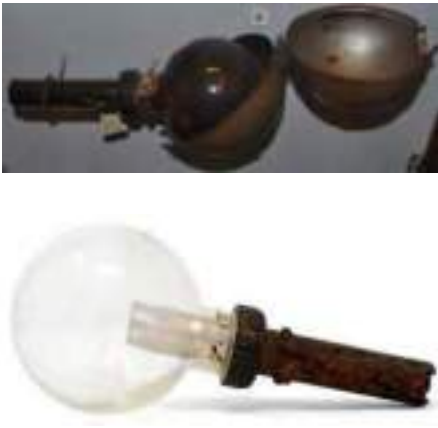
| No. 74 Grenade ("Sticky Bomb") Mk1 | | | |
|---|---|---|---|
| Weight | Approx. 1.1kg (2.25lb) | | |
| Filling | Approx. 600g Nobel's No.283 (Nitro-glycerine) (1.33lb) | | |
| Design | A glass ball on the end of a Bakelite (plastic) handle. The inside of the ball would contain the explosive filling and the outside a very sticky adhesive coating. | | |
| Remarks | Timer fuze was located in the handle. This would explode after 3-6 secs. | | |

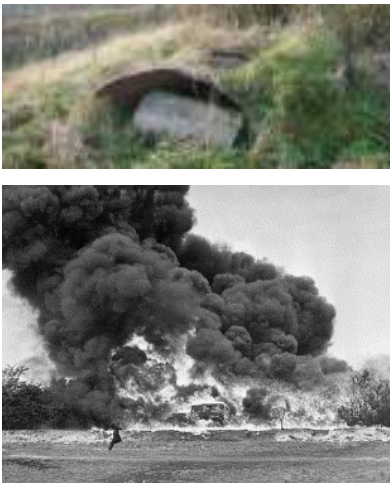
| Flame Fougasse Bomb | | | |
|---|---|---|---|
| Weight | Various | | |
| Filling | Initially a mixture of 40% petrol and 60% gas. Ammonal provided the propellant charge. | | |
| Design | Usually constructed from a 40-gallon drum dug into a roadside and camouflaged. | | |
| Use | As an improvised anti-tank bomb. When triggered the Fougasse could project a beam of burning sticky fuel in a fixed direction from up to 3m (10ft) wide and 27m (30yards) long. | | |
