**VERIFICATION REPORT**

**PLOTS 161-165**

**WOODCROFT FARM, WOODCROFT LANE,**

**VISTRY SOUTHERN**

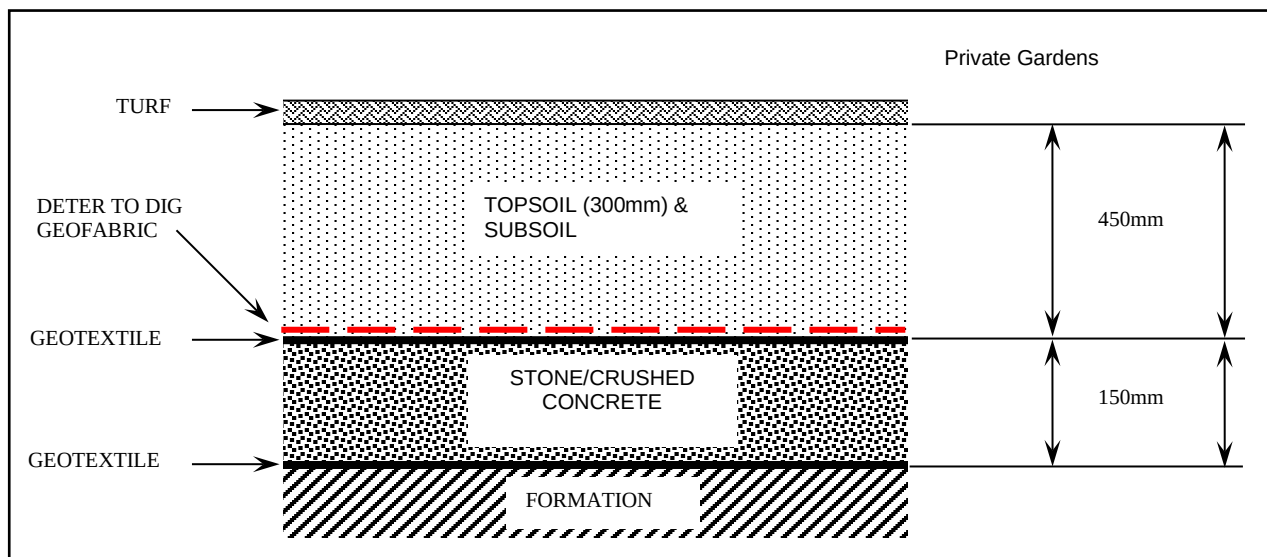
A soil cover system was derived based on Soil Cover Systems for Land Regeneration by BRE, which indicated that a soil cover system of 450mm would be required within areas of private gardens areas within the horse arena area. Due to the possible presence of impacted material beneath the proposed soil cover system the cover system should also incorporate a capillary break layer comprising 150mm depth of stone or crushed concrete, between two layers of geotextile. A high visibility deter to dig geofabric shall be laid over the upper geotextile to provide a visible deterrent to excavation. The cover system should include a minimum thickness of 300mm of Topsoil.

An example of the recommended cover system for use in gardens in the Horse Arena area is provided below:

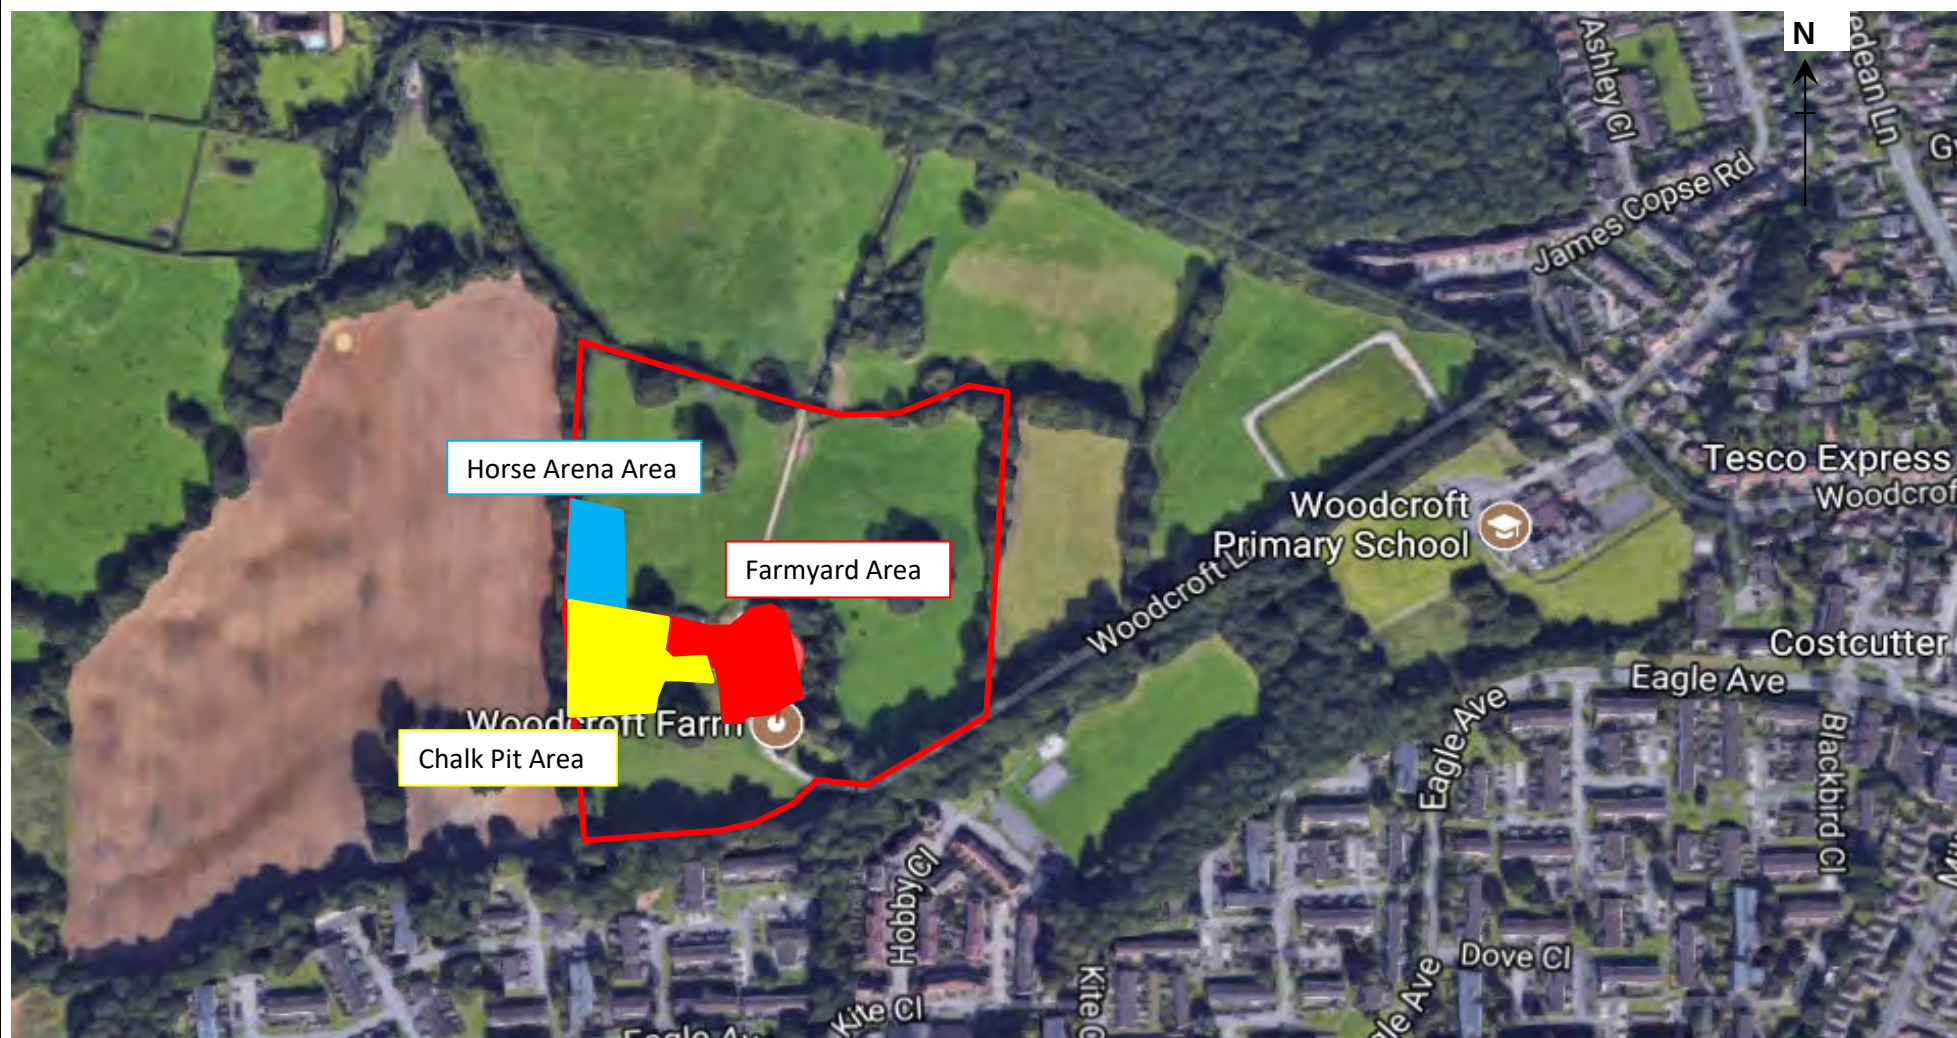
The wider site's previous uses included use as a farm with associated barns and buildings, scrapyard, horse arena and a former chalk pit which was subsequently infilled as an inert landfill. The portion of the site considered specifically herein comprised the former horse arena area, as shown in Figure 2.

| <b>Project:</b> | Woodcroft Farm, Lovedean, PO8 9QA | | | <b>Title</b> | Areas Requiring Remediation | |

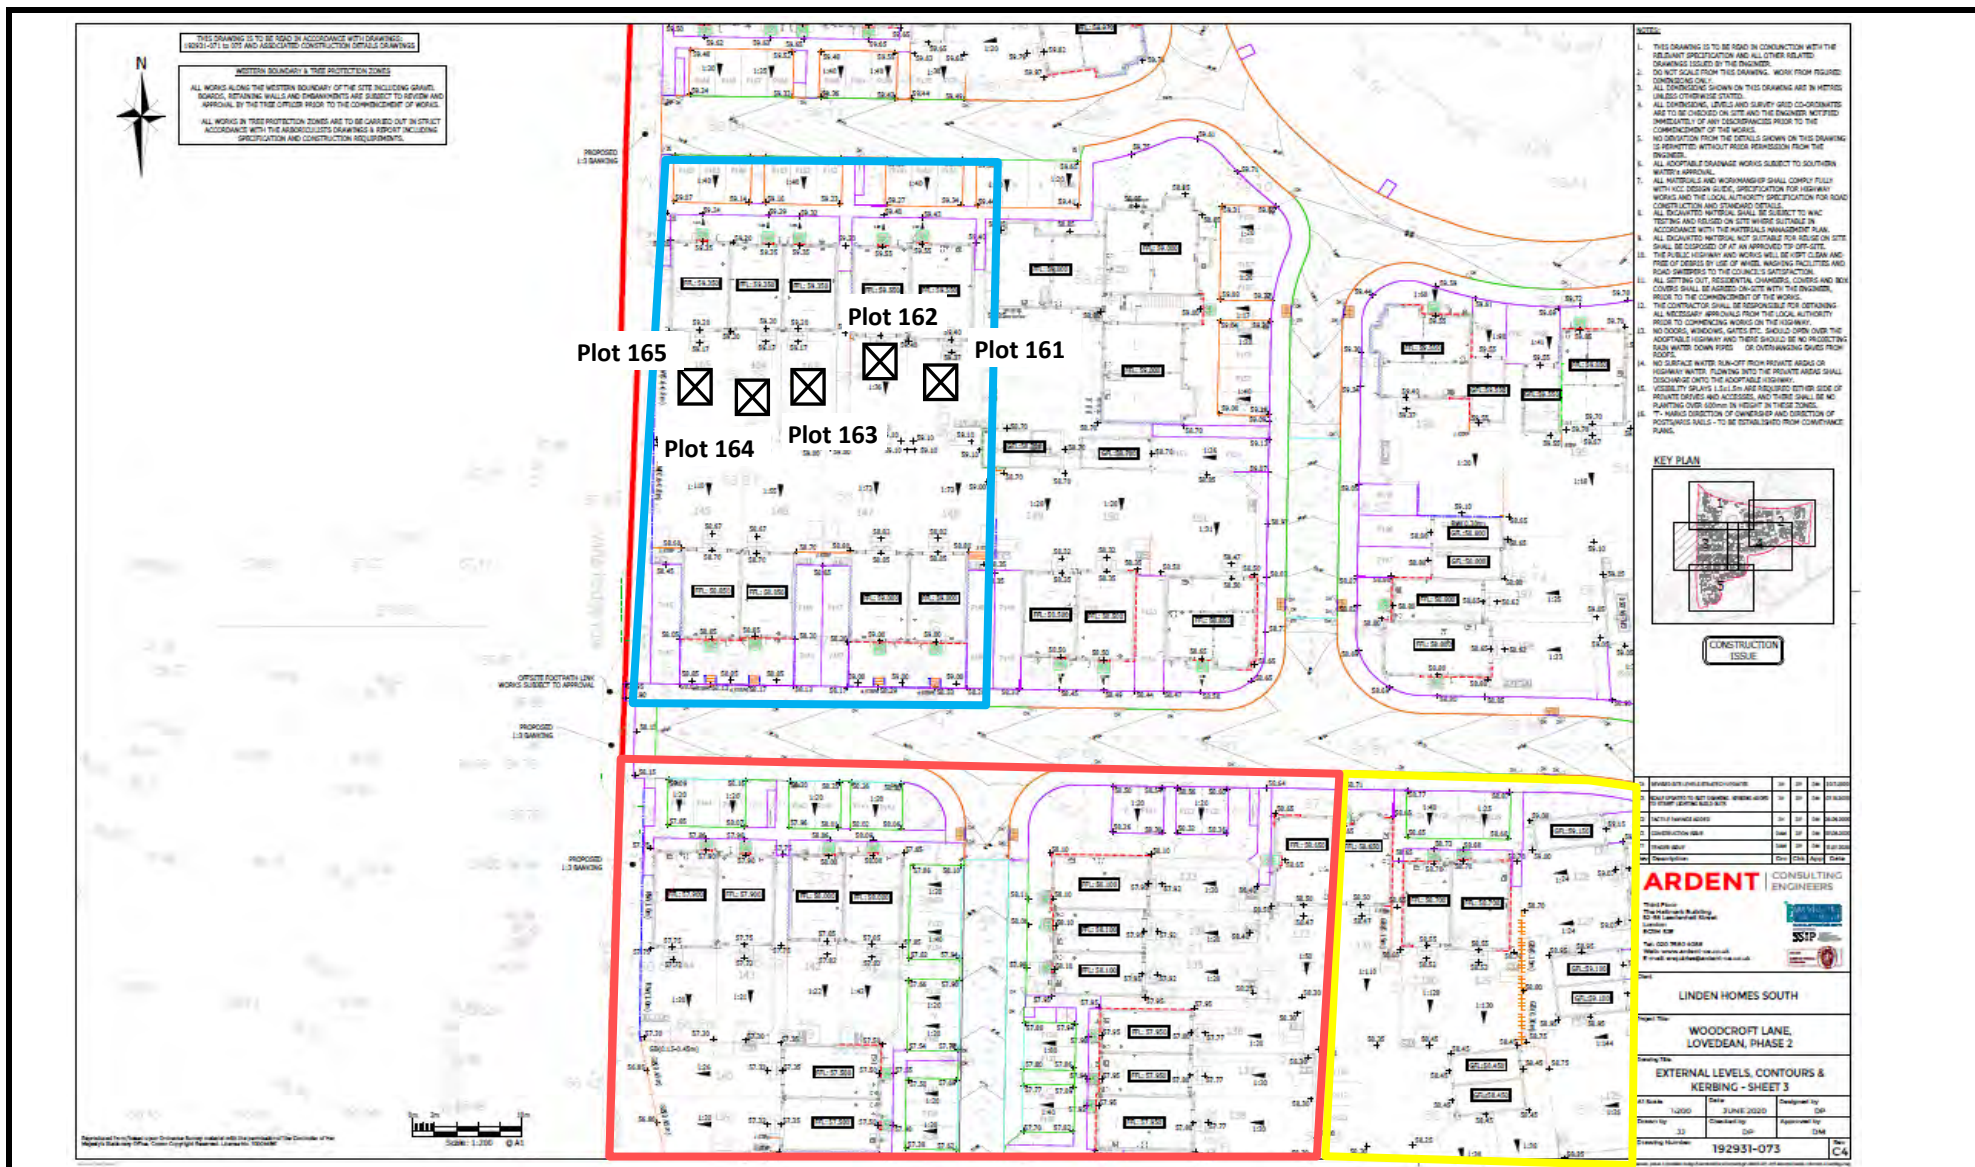
| <b>Project:</b> | Woodcroft Farm Lovedean PO8 9QA | <b>Title:</b> | Validation Location Plan |

The collected samples were referenced Plot 161 at 0.10m bgl, Plot 162 at 0.15m bgl, Plot 164 at 0.60m bgl and Plot 165 at 0.10m bgl. The laboratory test results are presented within Appendix C.

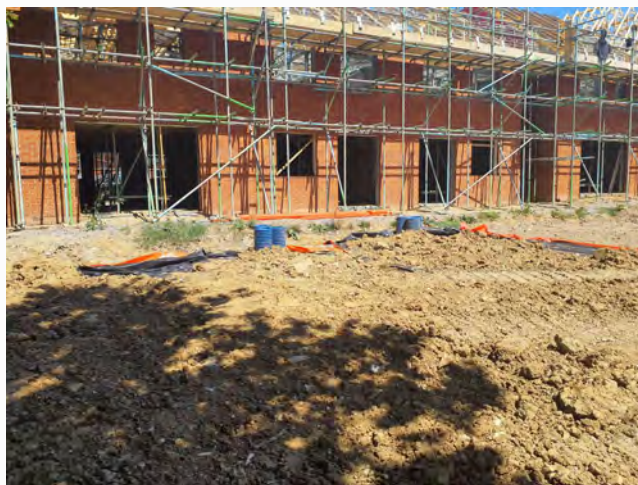
At the time of the visit the crushed concrete layer had been installed within Plots 161-165 and was visible within Plots 163-165. An orange geotextile and a black geotextile had been laid above the crushed concrete layer within Plots 161-162, with a thin layer of subsoil above. It should be noted that no soft landscaping was evident to the front of these plots, nor is it understood to be proposed.

| Description | Plots 161-165 in progress |

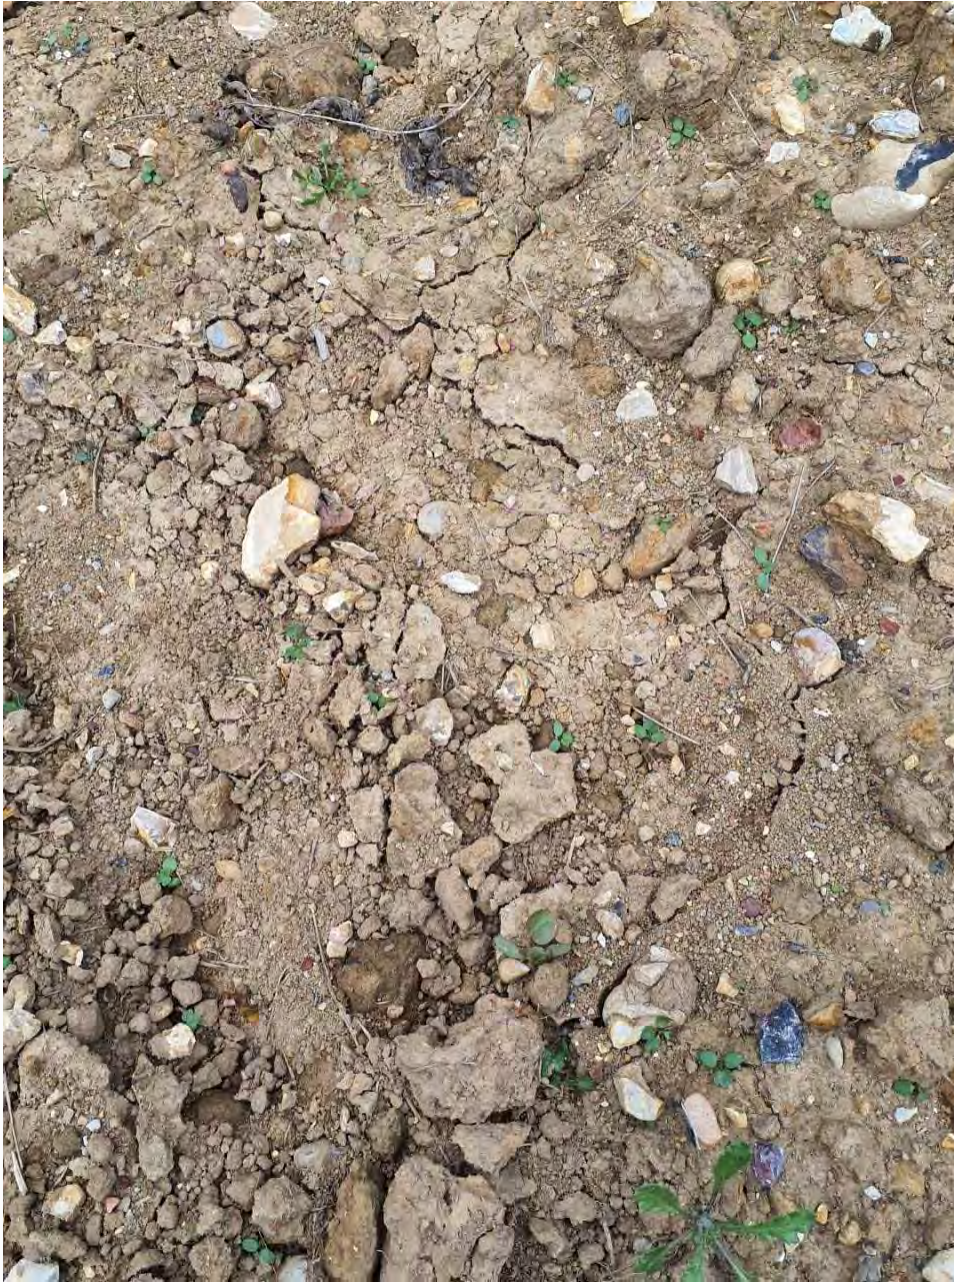
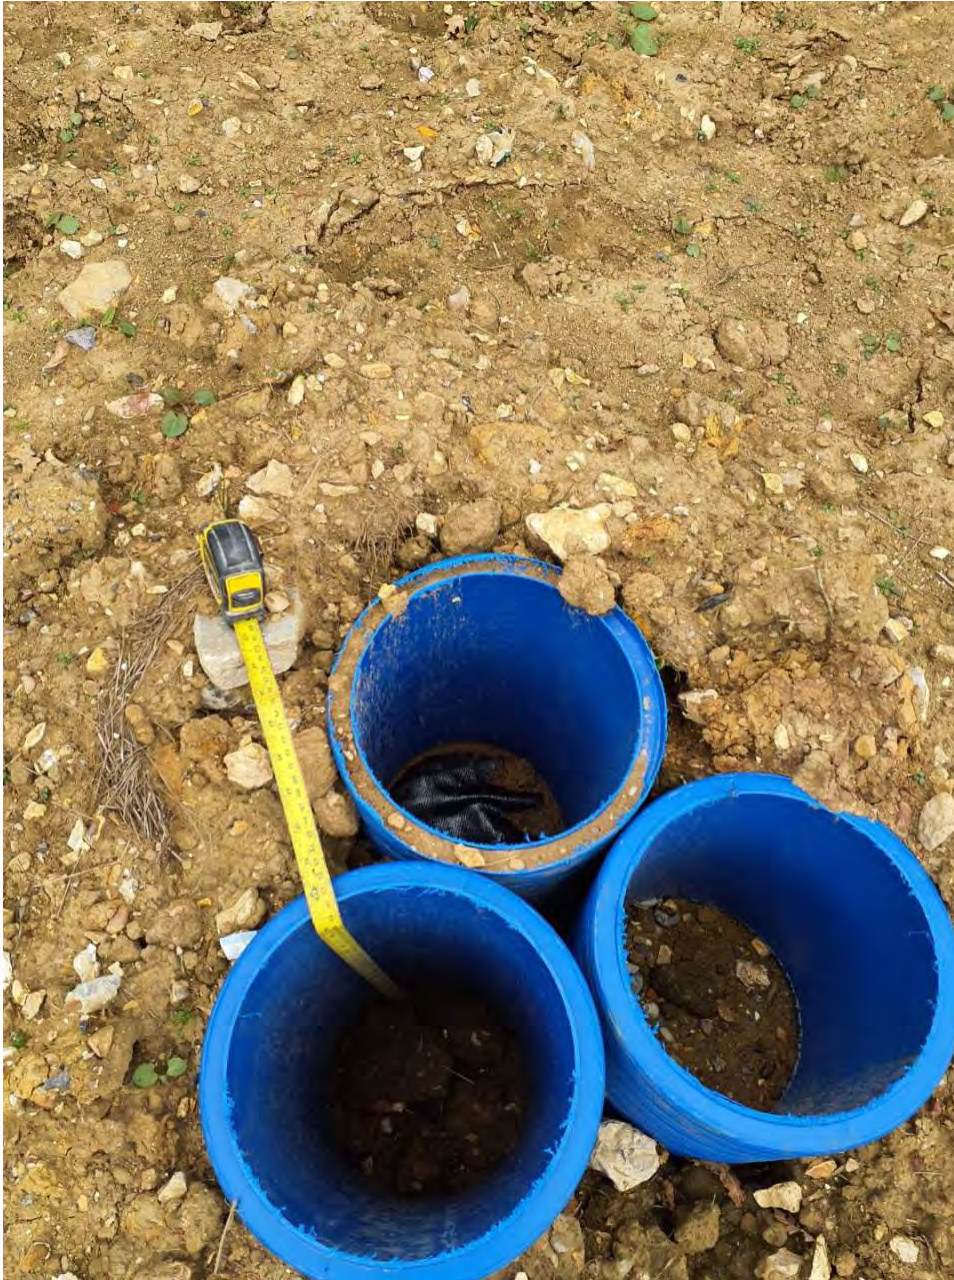
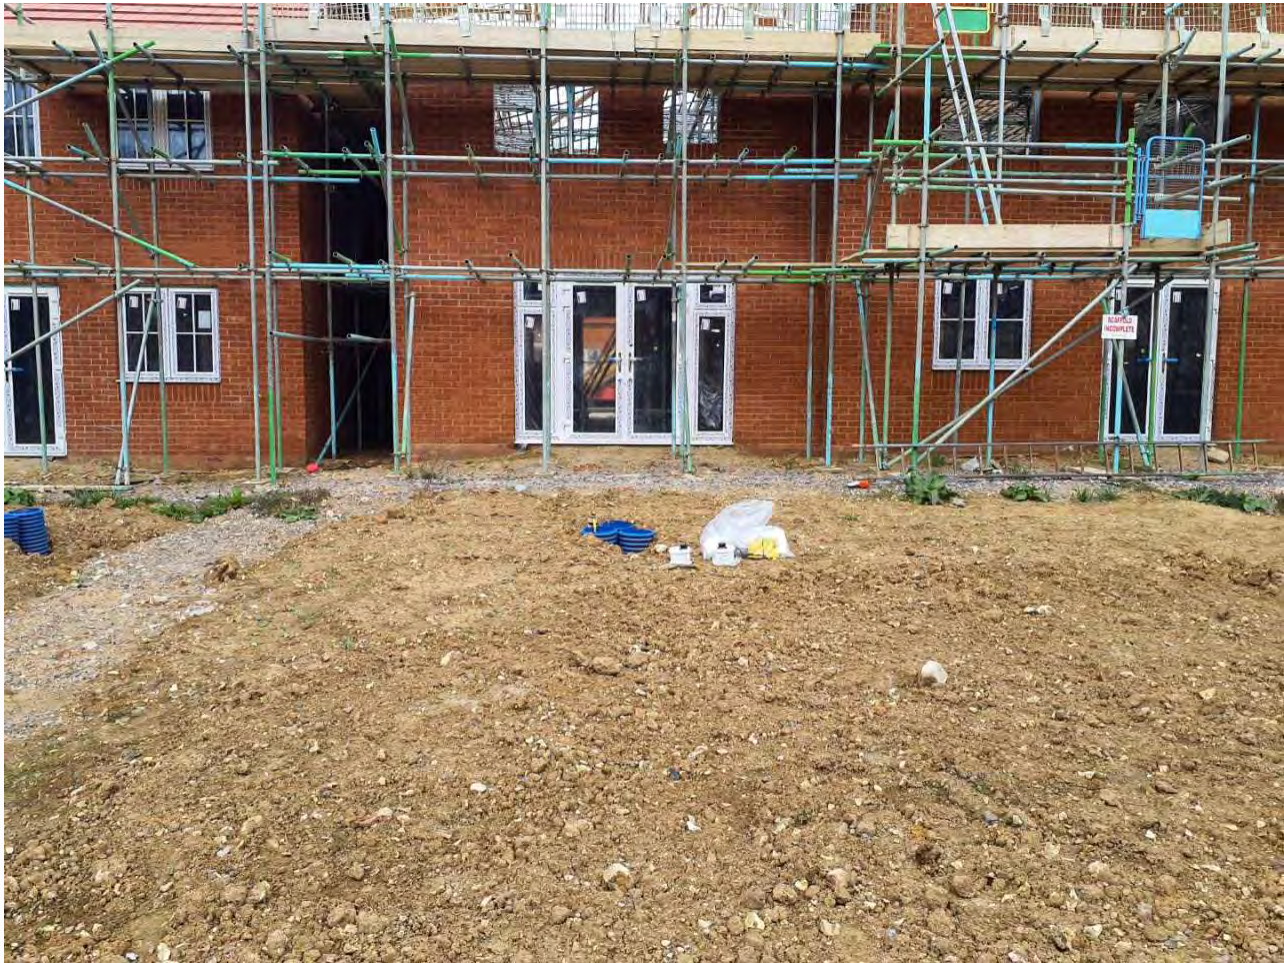
Plot 162

Inspection comprised four inspection pit locations excavated within four plots (Plots 162-165). Vertical plastic pipe had been installed by the groundworkers prior to the installation of the Topsoil within Plots 162-165. This was to confirm the thickness of the soil cover system. The location of all the inspection pits excavated is presented on Figure 4, photographs and site inspection records taken during this inspection visit are presented in Appendix B, which confirm the depth of the installed Topsoil within the cover system installed, along with soil logs of the material encountered. It should be noted that at the point of inspection the turf and the soil likely associated with the turf placement had not been laid within any of the areas of soft landscaping at the time of the inspection.

The inspection confirmed that within the inspection pits, Topsoil was found to be between 590mm and 620mm in thickness within all the inspected areas. It should be noted that the soil cover system comprised Topsoil only and this Topsoil utilised within Plots 162-165 comprised site-won soils which had previously been deemed suitable for re-use, as reported in the RSVP for the horse arena area (GE16943/RSVP-HA-V6.0/FEB21).

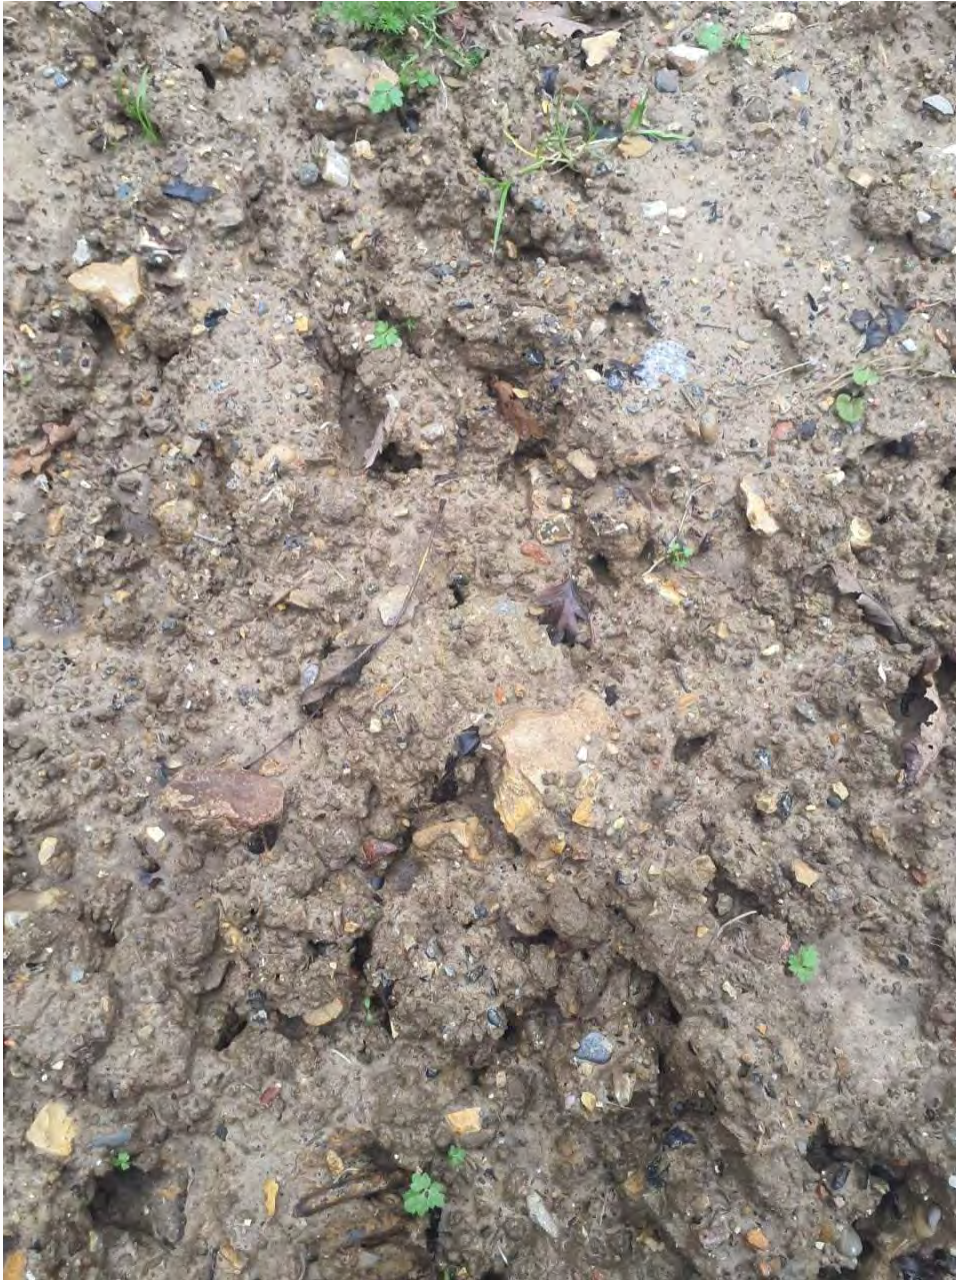
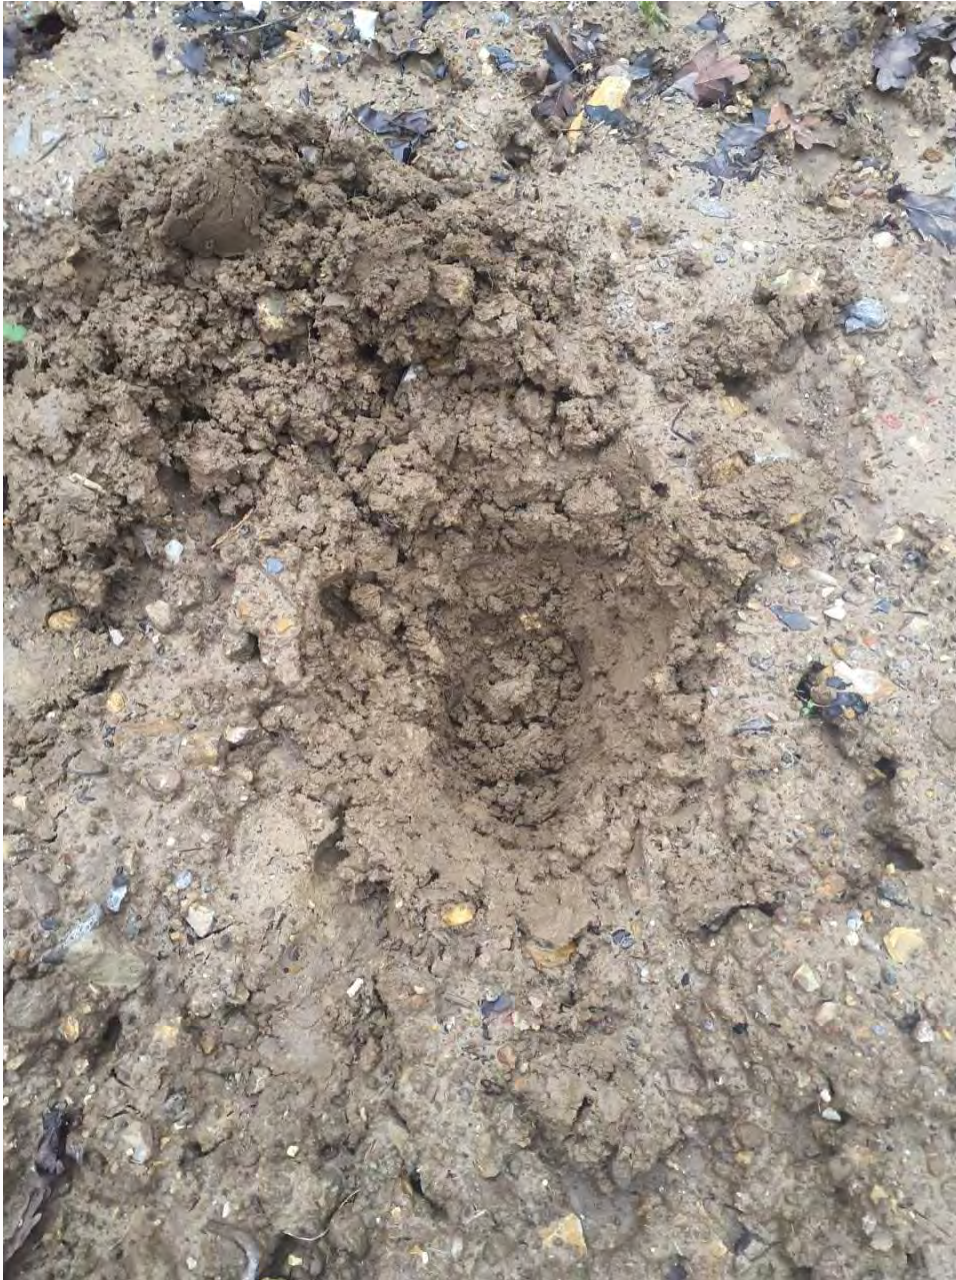
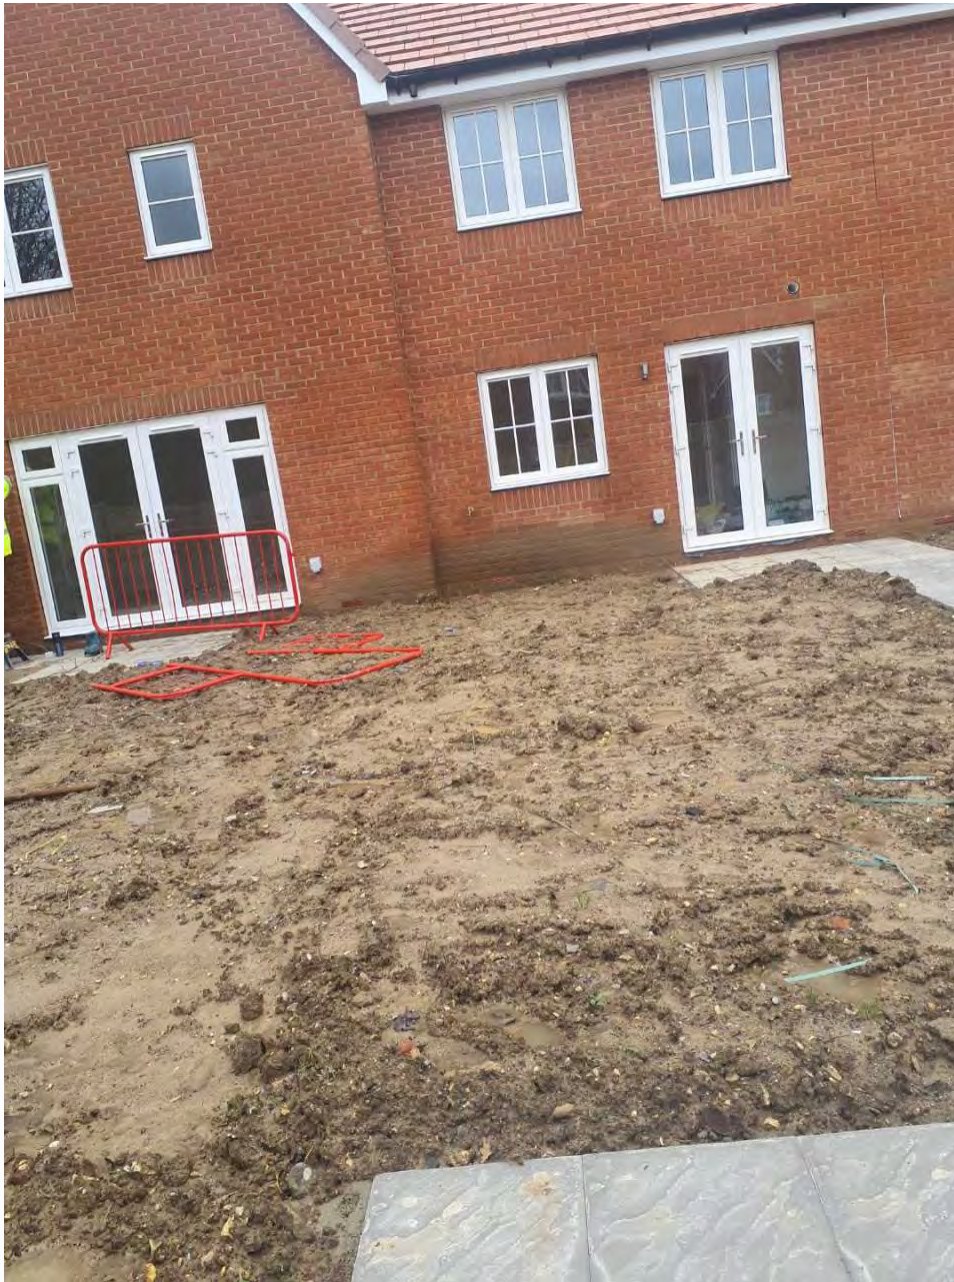
Plot 161 &amp; 162

Inspection comprised three inspection pits located within Plots 161, 163 and 165 which were excavated by the Engineer from Geo-Environmental. This was to confirm that works to install the soil cover system were complete at the point of inspection. The location of all the inspection pits excavated is presented on Figure 4, photographs and site inspection records taken during this inspection visit are presented in Appendix B, which confirms the installation of Topsoil within the cover system installed, along with soil logs of the material encountered. It should

The inspection included two inspection pits within previously inspected area as the groundworkers had confirmed that these areas had been re-laid due to activity in this area. It should be noted that the soil cover system comprised Topsoil only and this Topsoil utilised within Plots 161-165 comprised site-won soils which had previously been deemed suitable for re-use, as reported in the RSVP for the horse arena area (GE16943/RSVP-HA-V6.0/FEB21).
