## **UXO & UXB ASSESSMENT**

**APP/17/00863 – CONDITION 16**

**SOUTHLEIGH PARK HOUSE**

## Detailed Unexploded Ordnance (UXO) Risk Assessment

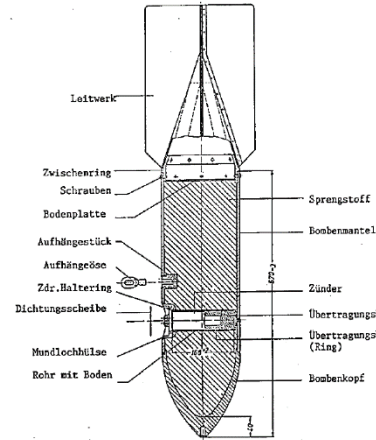
SC 250kg High Explosive Bomb

| Remarks | It could be carried by almost all German bomber aircraft, and was used to notable effect by the Junkers Ju-87 Stuka (Sturzkampfflugzeug or dive-bomber). |

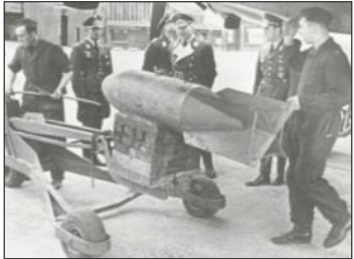
SC250 bomb being loaded onto German bomber

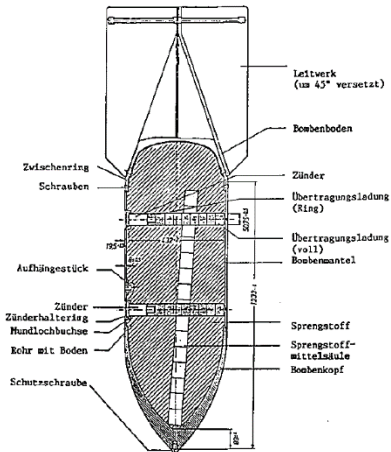
| Use | Against fixed airfield installations, hangars, assembly halls, flyovers, underpasses, high-rise buildings and below-ground installations. |
| Remarks | 40/60 or 50/50 Amatol TNT, trialene. Bombs recovered with Trialen filling have cylindrical paper wrapped pellets 1-15/16 in. in length and diameter forming |

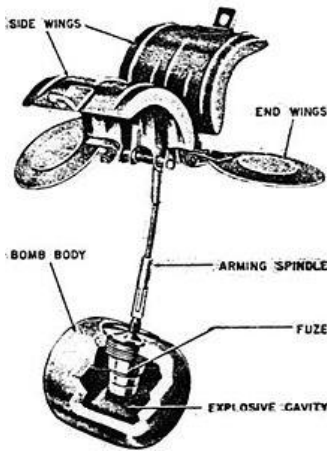
Parachute Mine (Luftmine B / LMB)

| Remarks | Deployed a parachute when dropped in order to control its descent. Had the potential to cause extensive damage in a 100m radius. |

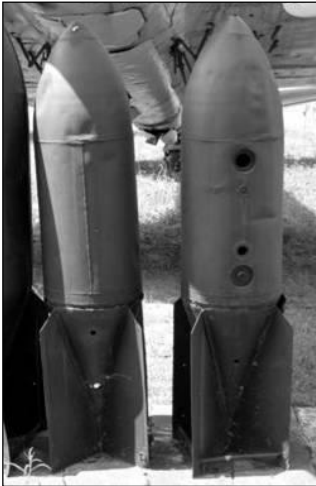
Flam C-250 Oil Bomb

| Bomb Weight | Approx. 125kg (276lb) |
| Body Diameter | 368mm (14.5in) |
| Use | Often used for surprise attacks on ground troops, against troop barracks and industrial installations. Thin casing – not designed for ground penetration |

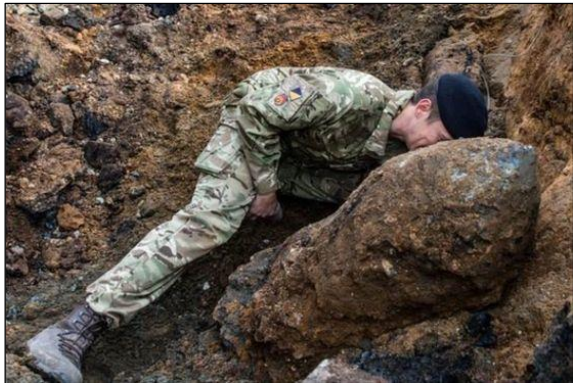
**Top:** J-curve Effect - Due to angle of entry, unexploded bombs would often end their trajectory at a lateral offset from point of entry, often ending up beneath adjacent extant structures/sites. The photograph above shows 250kg bomb found in Bermondsey pointing upwards, demonstrating 'J-curve'

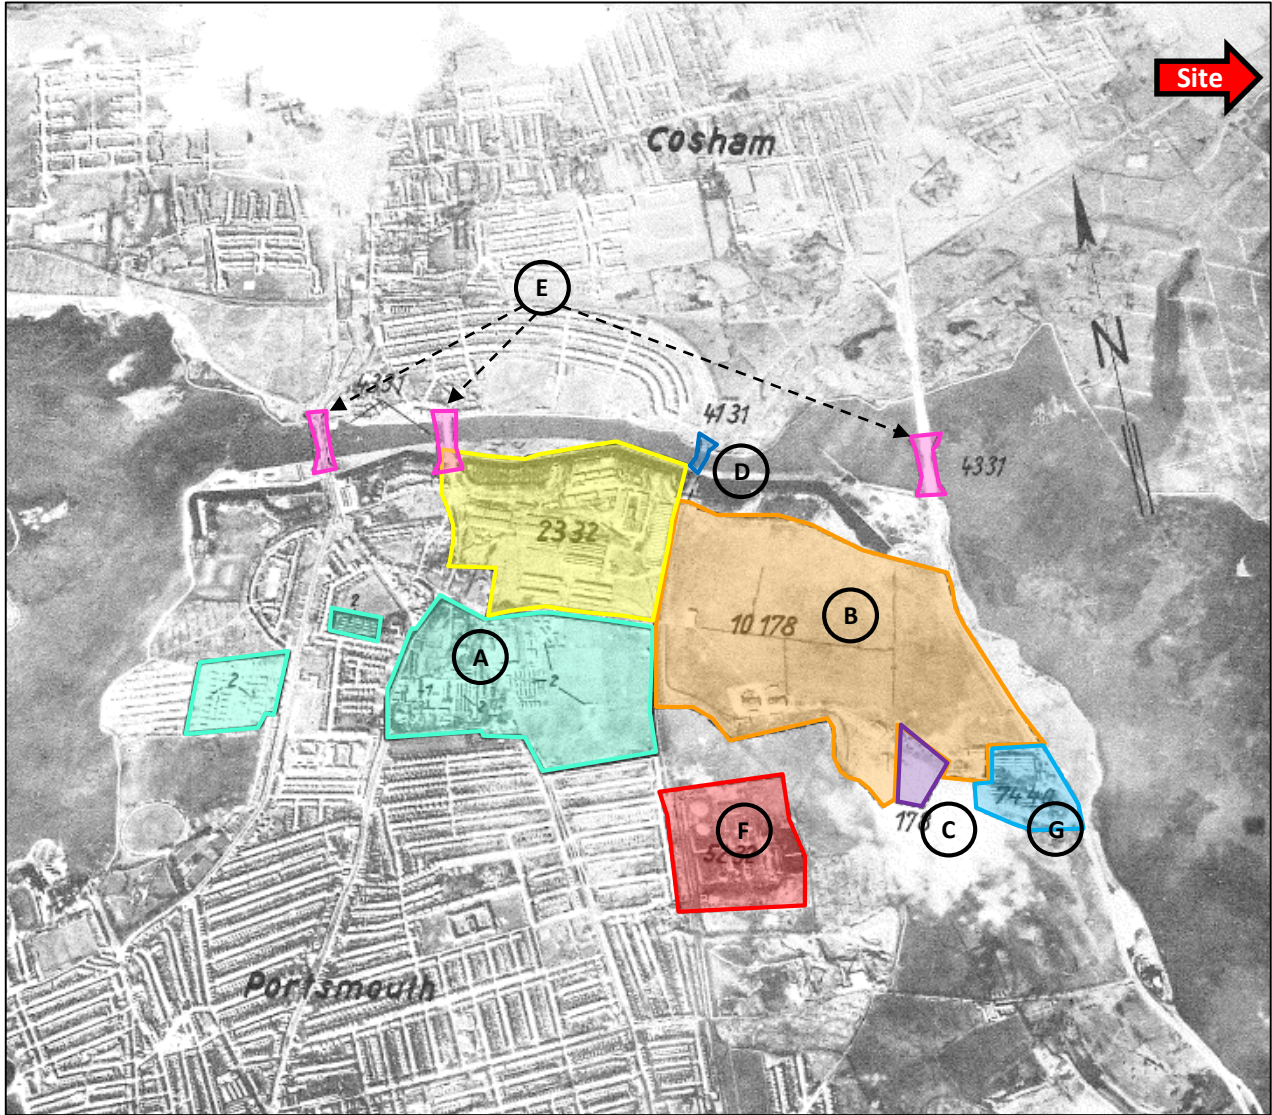
Luftwaffe Photograph, 3<sup>rd</sup> September 1941

Hampshire – Portsmouth, Hilsea and Cosham

- A. GB 138 – Barracks building & total flat area
- B. GB 10 178 – Portsmouth airport
- C. GB 17 8 – Bearing system
- D. GB 41 31 – Railway bump
- E. GB 43 31 – 2 Road bridges & 1 Street embankment
- F. GB 52 32 – Hilsea Gasworks
- G. GB 74 40 – Airframe factory

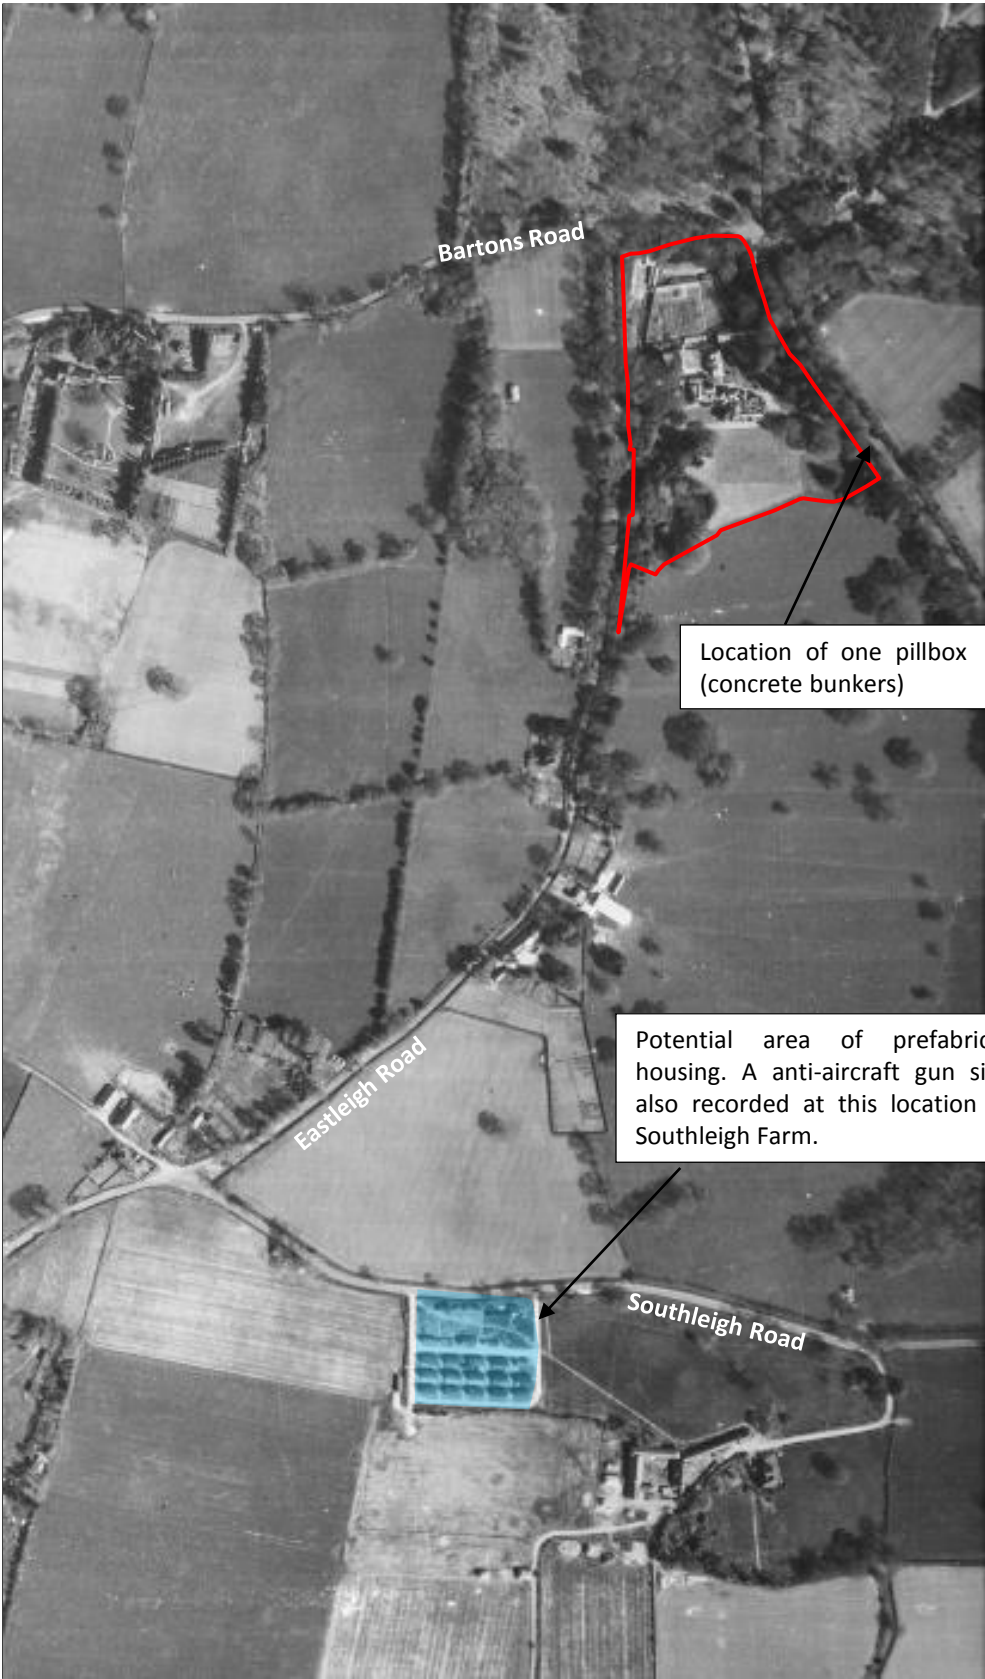
Location of one pillbox  
(concrete bunkers)

Potential area of prefabricated  
housing. A anti-aircraft gun site is  
also recorded at this location near  
Southleigh Farm.

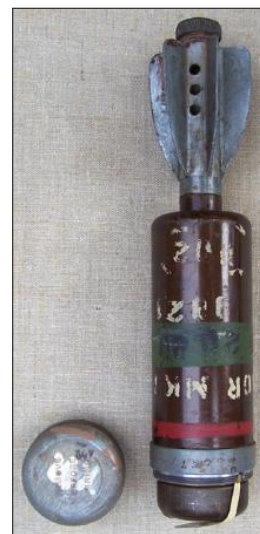
**2 inch Mortar Smoke**

| Weight | Approx. 910g (2lb) |
| Identification | Smoke mortars have a recess and emission holes. May still see light green body paint. Look for stained ground around munition. |
| Use | As a screening devices for unit movement or to impair enemy field of vision. |

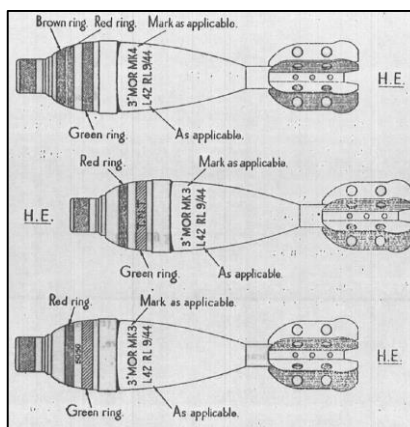
**3 inch Mortar High Explosive**

| Weight | Approx. 4.5kg (10lb) |
| Remarks | Fin-stabilised bomb fired by means of a charge consisting of a primary cartridge in the tail and four secondary cartridges |
| Identification | An old style mortar. No way of telling if HE or practice so treat as HE |

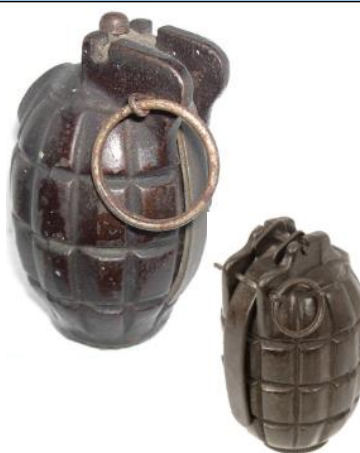
| Use | Fragmentation explosive at approx. 30m range 100m range of damage. |
| Remarks | First introduced in 1915 its classic grooved, cast-iron 'pineapple' design was designed to provide uniform fragmentation. The detonator is inserted before use after removing the base plug. |

Left: baseplate and detonator removed

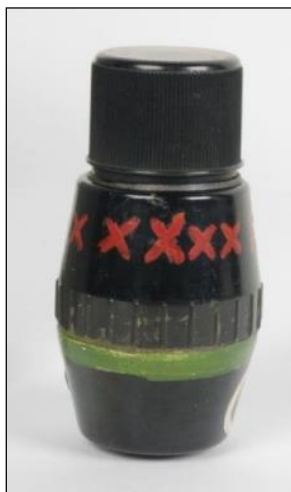
## No. 69 Grenade

| Use | A blast grenade for use as an offensive weapon. Detonator was inserted before use. |
| Remarks | Introduced December 1940 and made from the plastic Bakelite as opposed to conventional metals. Detection is difficult due to this low metal content. |

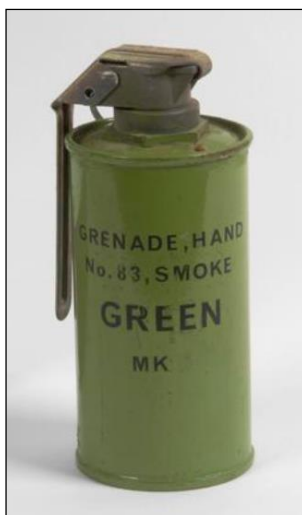
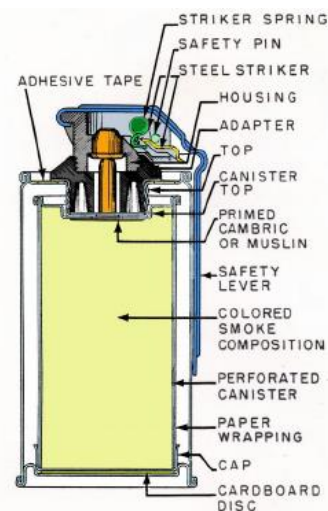
## No. 83 Smoke Grenade

| Weight | Approx. 680g ( 1.5lb) |
| Use | Use as a target or landing zone marking device and as a screening method for troop / unit movement. |
| Remarks | This basic design stayed relatively unchanged up to the 1980's. The letters CCC were often etched into the body of the grenade in the colour of the smoke. |

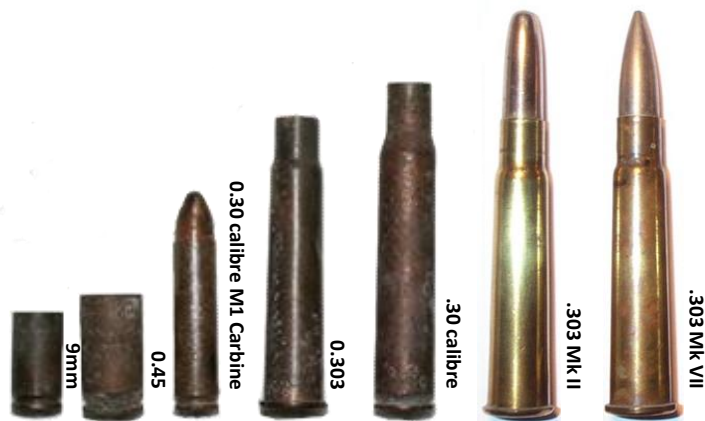
Examples of British Small Arms Ammunition

.303 Rifle

| Bullet Diameter | 7.92mm |

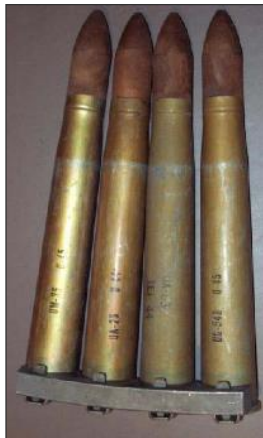
40mm Bofors Projectile

| Projectile Weight | 1.96lb (0.86kg) |
| Ceiling | 23,000ft (7000m ) |
| Remarks | Light quick fire high explosive anti-aircraft projectile. Each projectile fitted with small tracer element. If no target hit, shell would explode when tracer burnt out. Designed to engage aircraft flying below 2,000ft |

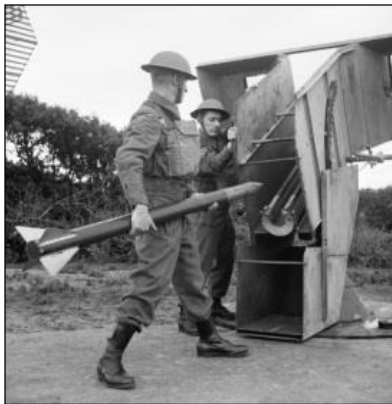
3in Unrotated Projectile (UP) Anti-Aircraft Rocket ("Z" Battery)

| HE Projectile Weight | 3.4kg (7.6lb) |
| Dimensions of projectile | 236 x 83mm (9.29 x 3.25in) |
| Remarks | As a short range rocket-firing anti-aircraft weapon developed for the Royal Navy. It was used extensively by British ships during the early days of World War II. The UP was also used in ground-based single and 128-round launchers known as Z Batteries. Shell consists of a steel cylinder reduced in diameter at the base and threaded externally to screw into the shell ring of the rocket motor |

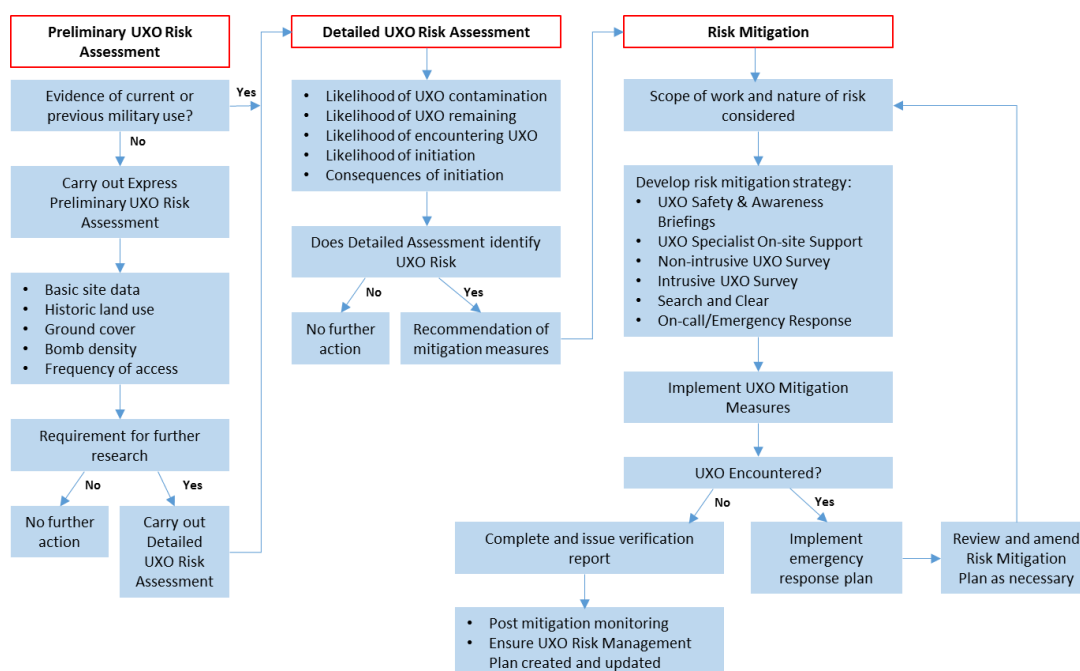
It is important to understand the process by which UXO risk is assessed and mitigated. Documents such as *CIRIA C681 UXO A guide for the Construction Industry* are a useful starting point and provide valuable background information. Key elements of this process are outlined in the guide, but are also summarised for ease in the flowchart below:
