## Intrusive Geoenvironmental and Geotechnical Site Assessment

Downley Road  
Havant  
PO9 2JD

July 2024

**Prepared For:**  
Royal London Property Group

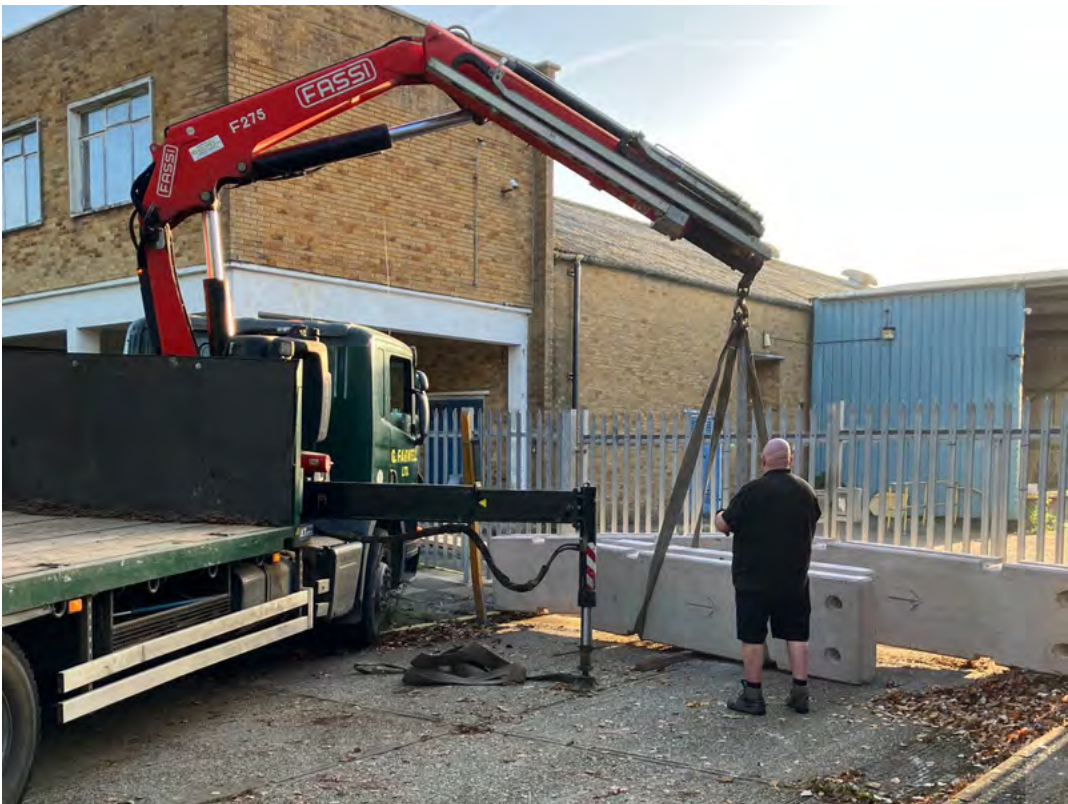
| Client: | | Site Location: | Project No.: |
|---|---|---|---|
| 1 | 09/10/2023 | | |

| Client: | | Site Location: | Project No.: |
|---|---|---|---|
| <b>Description</b><br>Concrete barrier blocking the site access being cleared by lorry | | | |

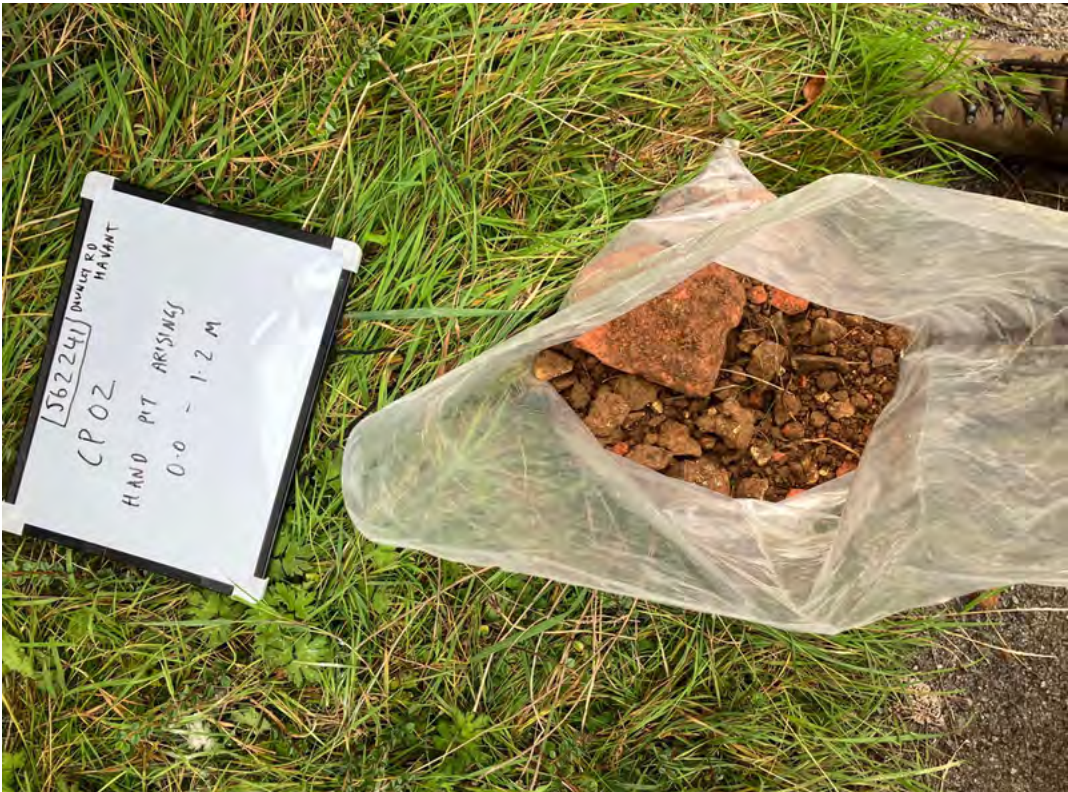
| Photo No. | Date | | |
|---|---|---|--|
| 2 | 09/10/2023 | | |

| Photo No. | Date | | |
|---|---|---|--|
| <b>Description</b><br>CP102 - inspection pit arisings | | | |

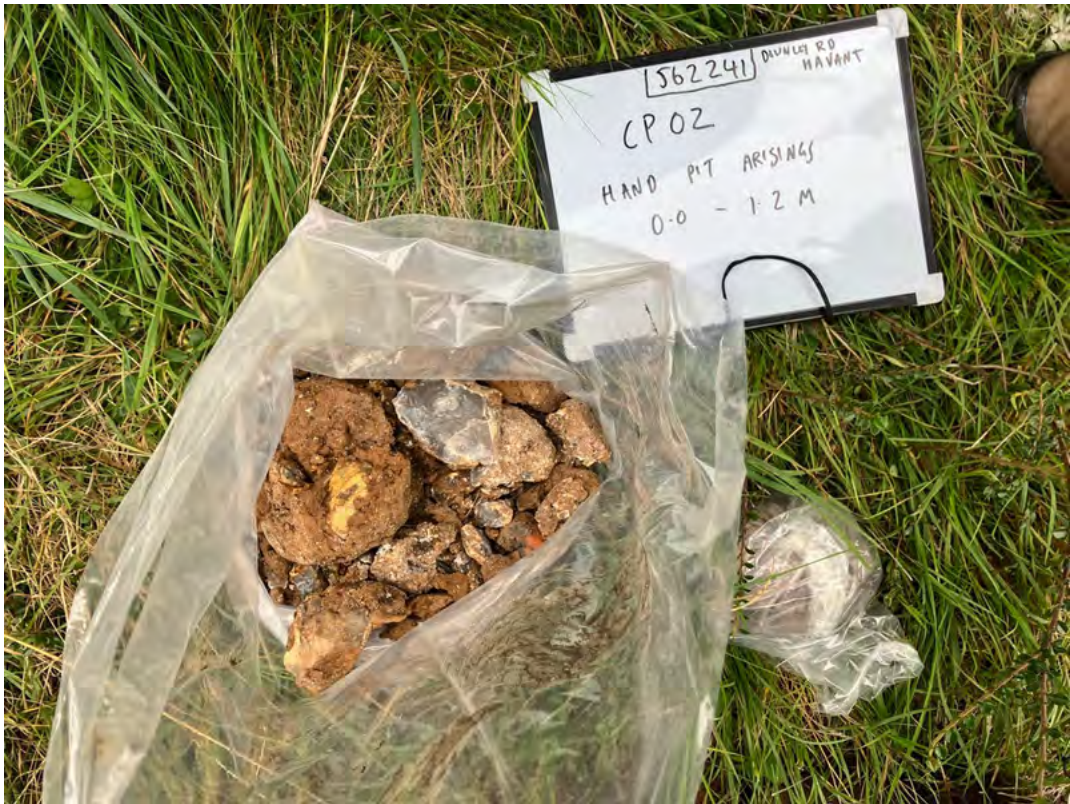
| Client: | | Site Location: | Project No.: |
|---|---|---|---|
| 3 | 09/10/2023 | | |

| Client: | | Site Location: | Project No.: |
|---|---|---|---|
| <b>Description</b><br>CP102 - inspection pit arisings | | | |

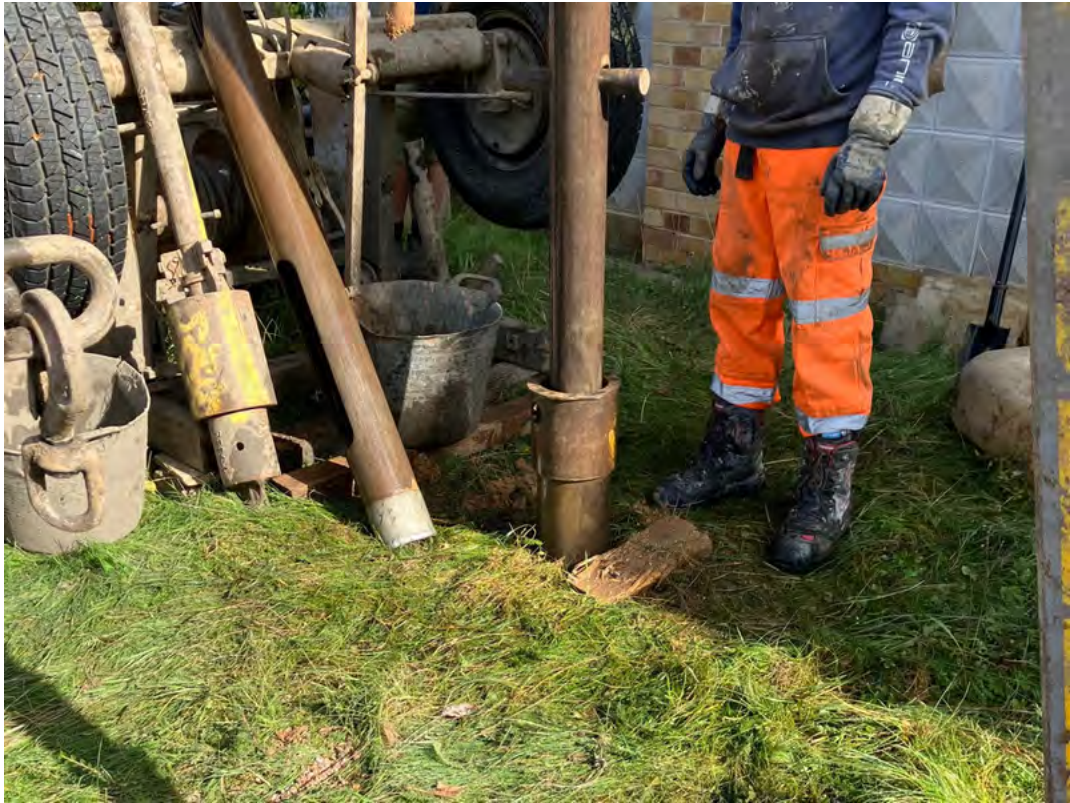
| Photo No. | Date | | |
|---|---|---|--|
| 4 | 09/10/2023 | | |

| Photo No. | Date | | |
|---|---|---|--|
| <b>Description</b><br>CP102 - overview of rig | | | |

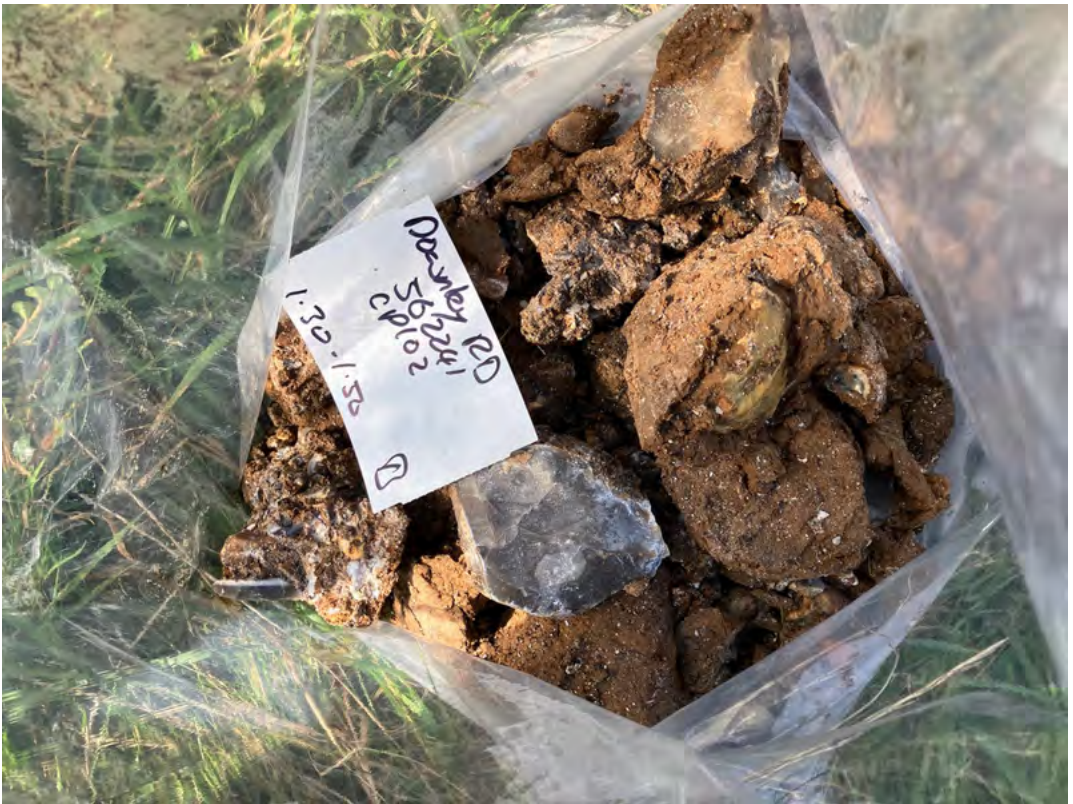
| Client: | | Site Location: | Project No.: |
|---|---|---|---|
| 5 | 09/10/2023 | | |

| Client: | | Site Location: | Project No.: |
|---|---|---|---|
| <b>Description</b><br>CP102 - recovery from 1.30m to 1.50m bgl | | | |

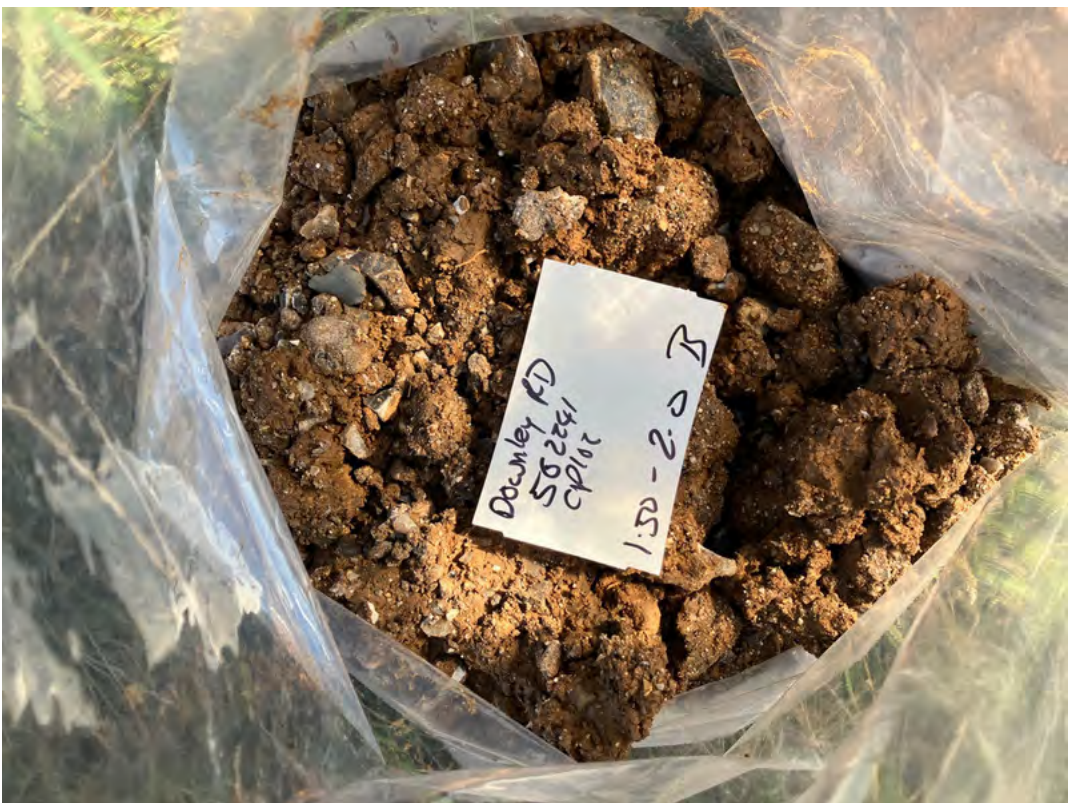
| Photo No. | Date | | |
|---|---|---|--|
| 6 | 09/10/2023 | | |

| Photo No. | Date | | |
|---|---|---|--|
| <b>Description</b><br>CP102 - recovery from 1.5m to 2.0m bgl | | | |

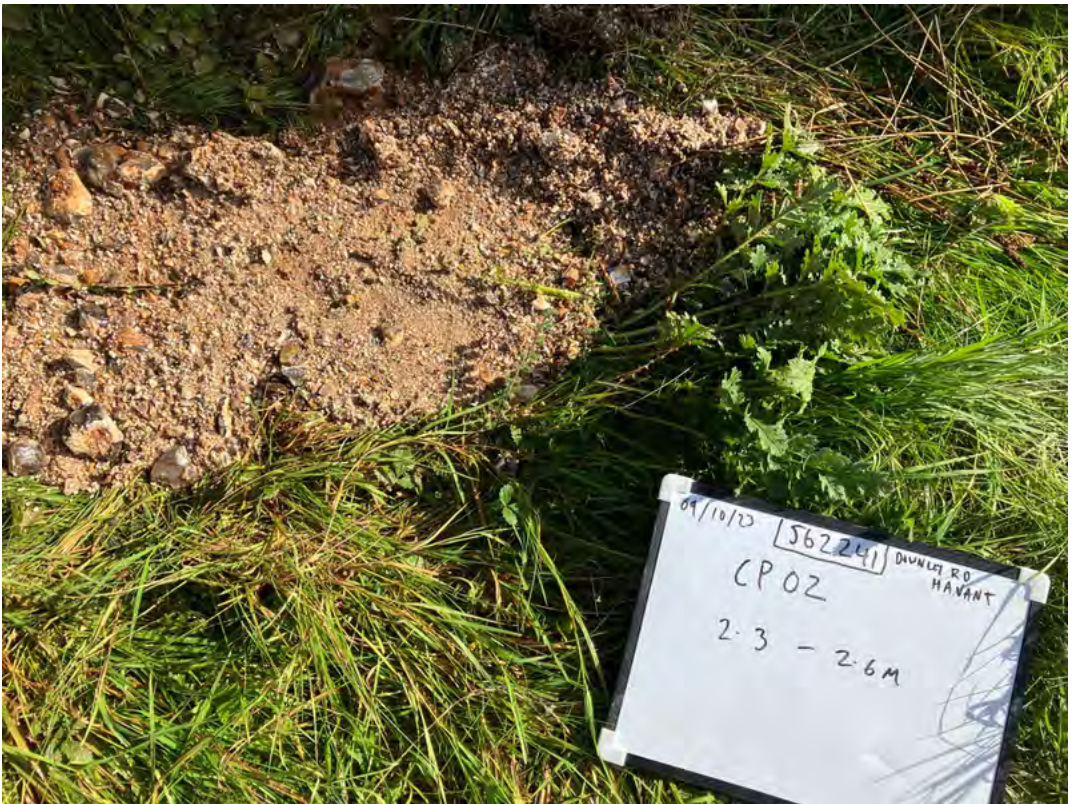
| Client: | | Site Location: | Project No.: |
|---|---|---|---|
| 7 | 09/10/2023 | | |

| Client: | | Site Location: | Project No.: |
|---|---|---|---|
| <b>Description</b><br>CP102 - recovery from 2.3m to 2.6m bgl | | | |

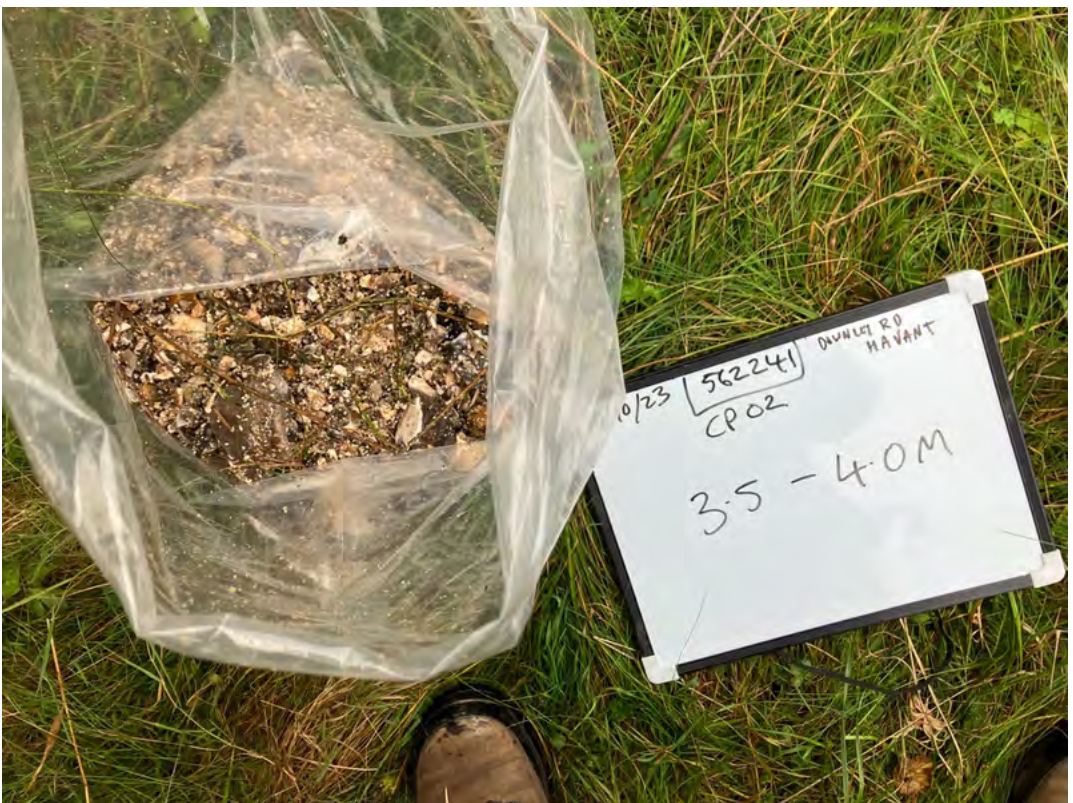
| Photo No. | Date | | |
|---|---|---|--|
| 8 | 09/10/2023 | | |

| Photo No. | Date | | |
|---|---|---|--|
| <b>Description</b><br>CP102 - recovery from 3.5m to 4.0m bgl | | | |

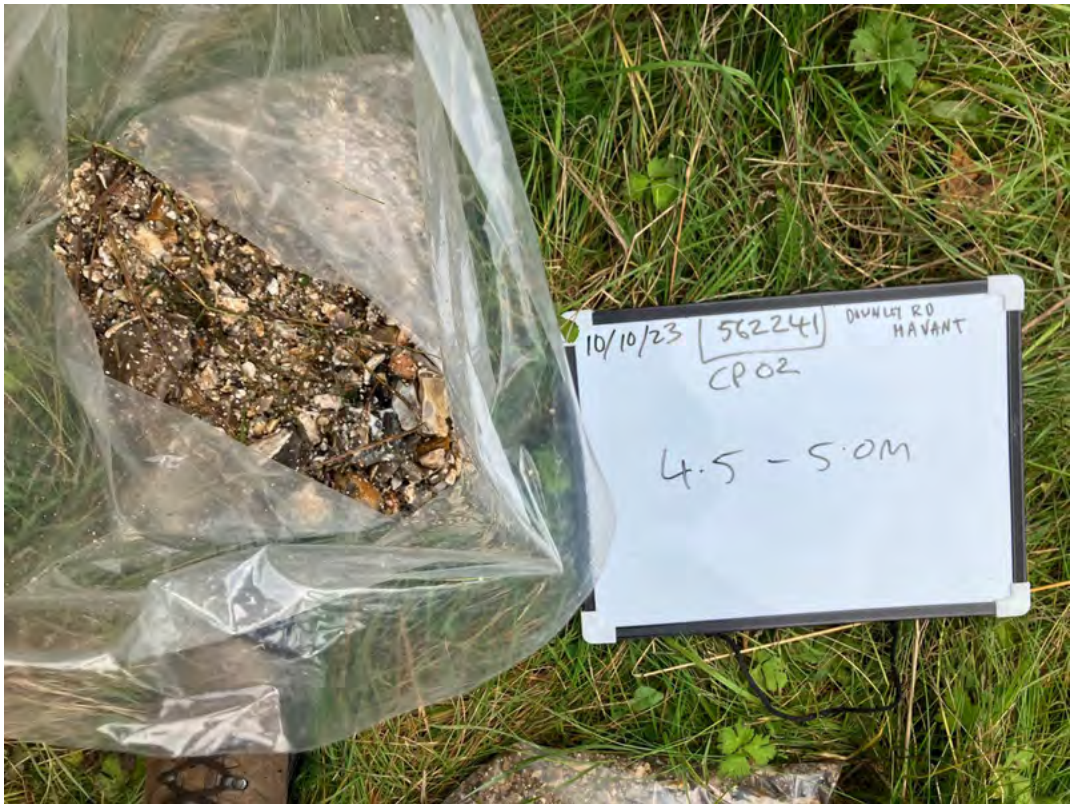
| Client: | | Site Location: | Project No.: |
|---|---|---|---|
| 9 | 09/10/2023 | | |

| Client: | | Site Location: | Project No.: |
|---|---|---|---|
| <b>Description</b><br>CP102 - recovery from 4.5m to 5.0m bgl | | | |

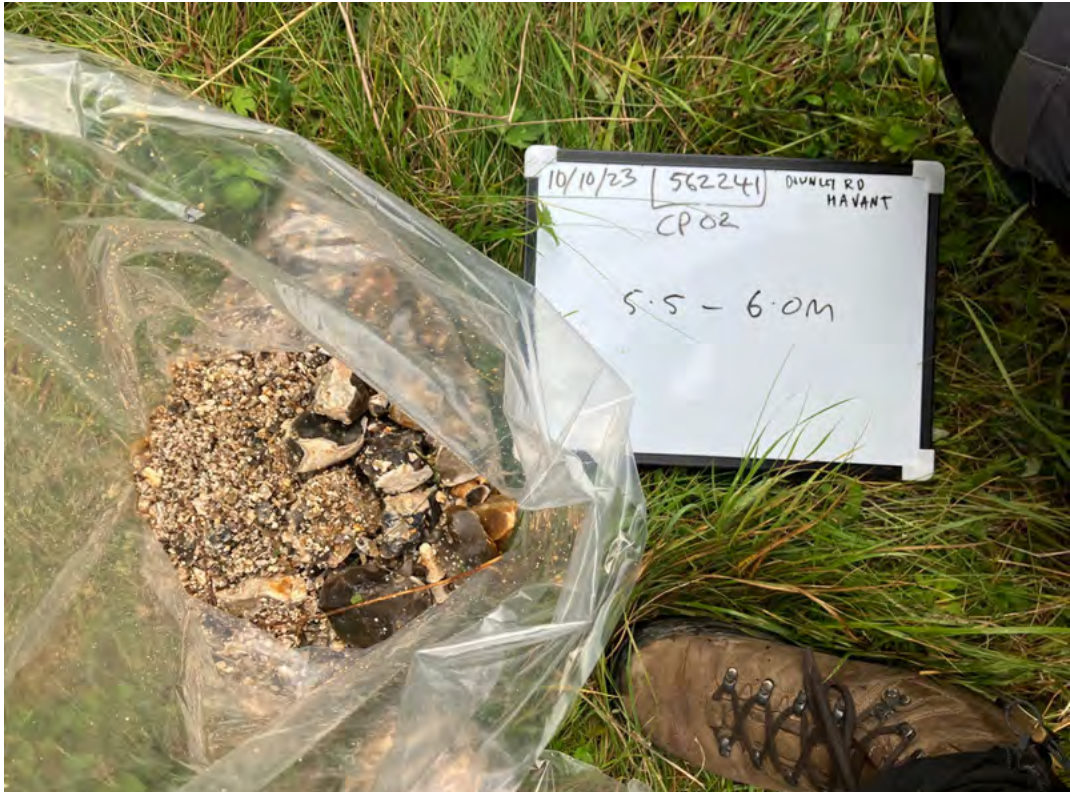
| Photo No. | Date | | |
|---|---|---|--|
| 10 | 09/10/2023 | | |

| Photo No. | Date | | |
|---|---|---|--|
| <b>Description</b><br>CP102 - recovery from 5.5m to 6.5m bgl | | | |

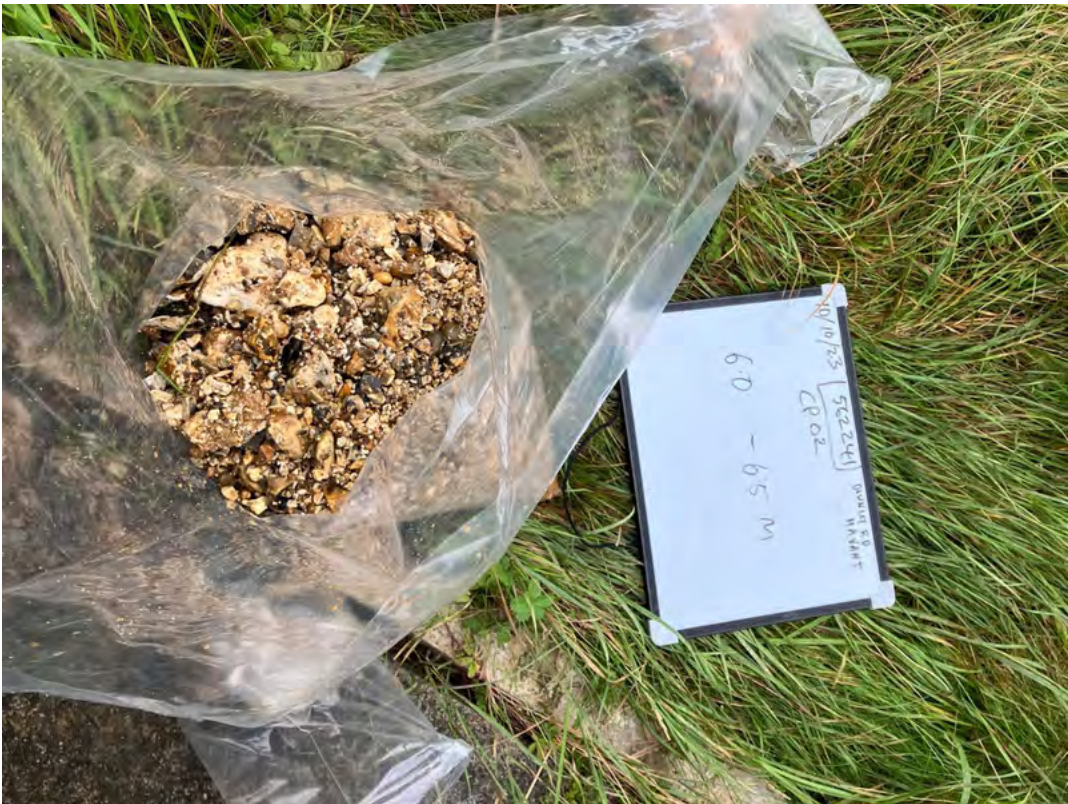
| Client: | | Site Location: | Project No.: |
|---|---|---|---|
| 11 | 09/10/2023 | | |

| Client: | | Site Location: | Project No.: |
|---|---|---|---|
| <b>Description</b><br>CP102 - recovery from 6.0m to 6.5m bgl | | | |

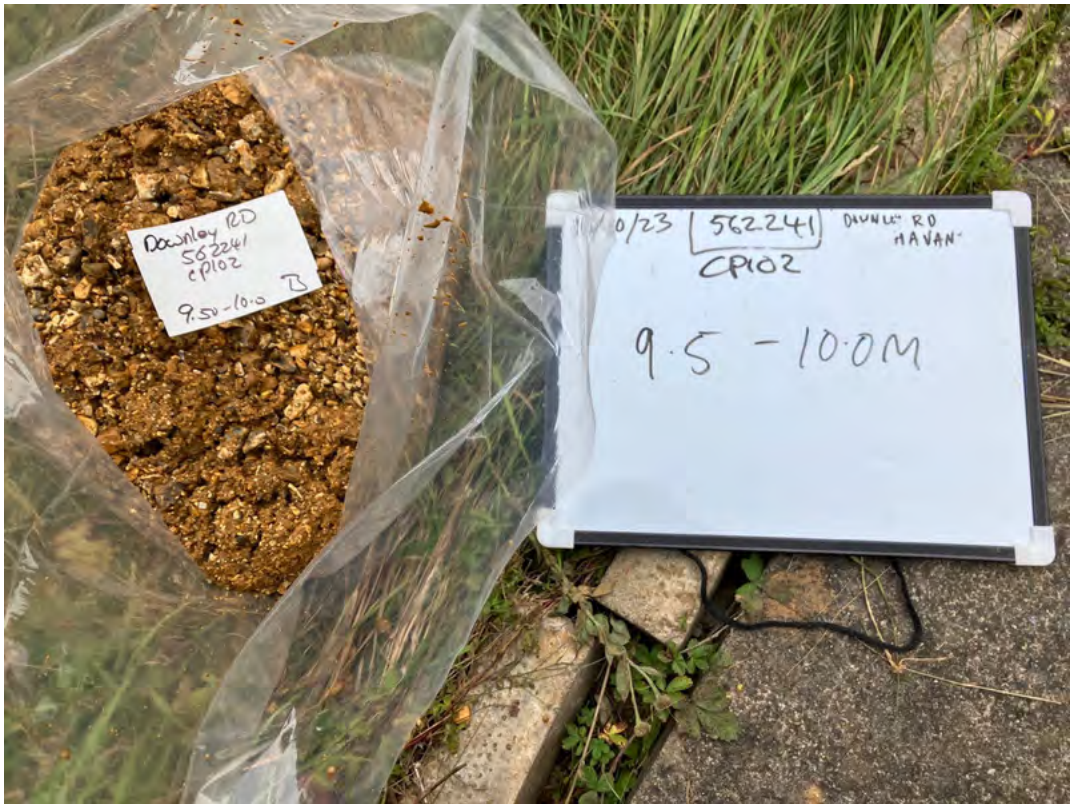
| Client: | | Site Location: | Project No.: |
|---|---|---|---|
| 13 | 09/10/2023 | | |

| Client: | | Site Location: | Project No.: |
|---|---|---|---|
| <b>Description</b><br>CP102 - recovery from 9.5m to 10.0m bgl | | | |

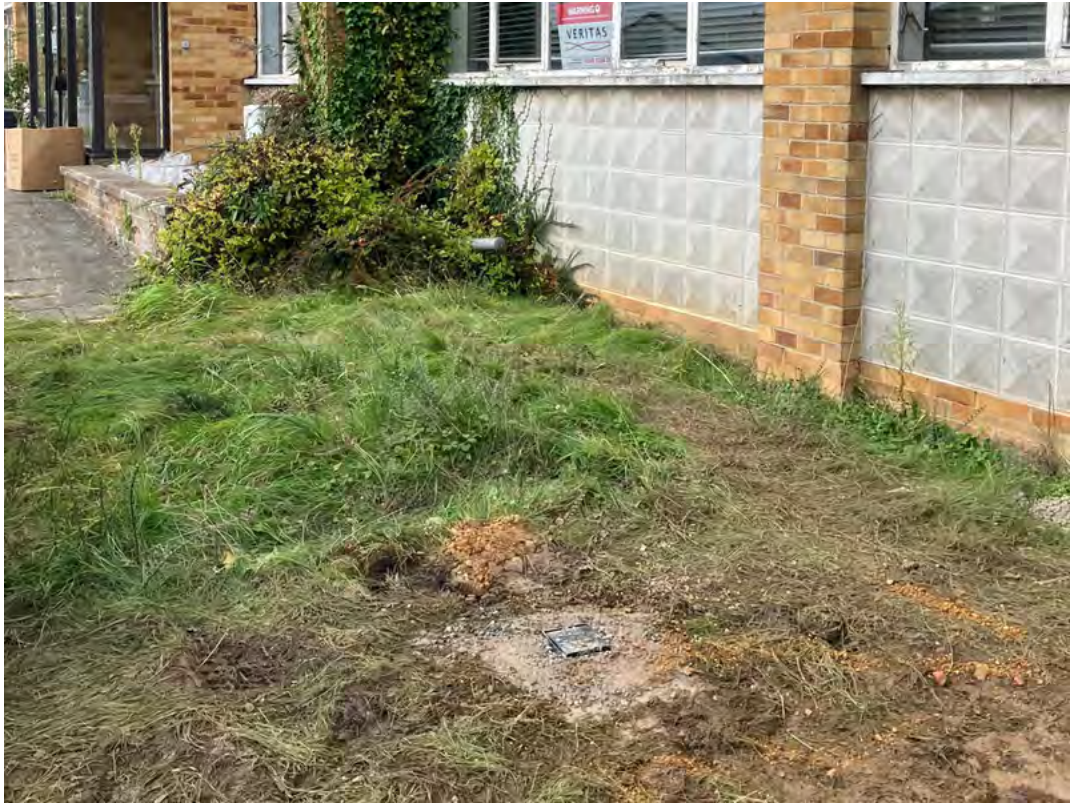
| Photo No. | Date | |
|---|---|---|
| 14 | 09/10/2023 | |

| Photo No. | Date | |
|---|---|---|
| <b>Description</b><br>CP102 - monitoring well install | | |

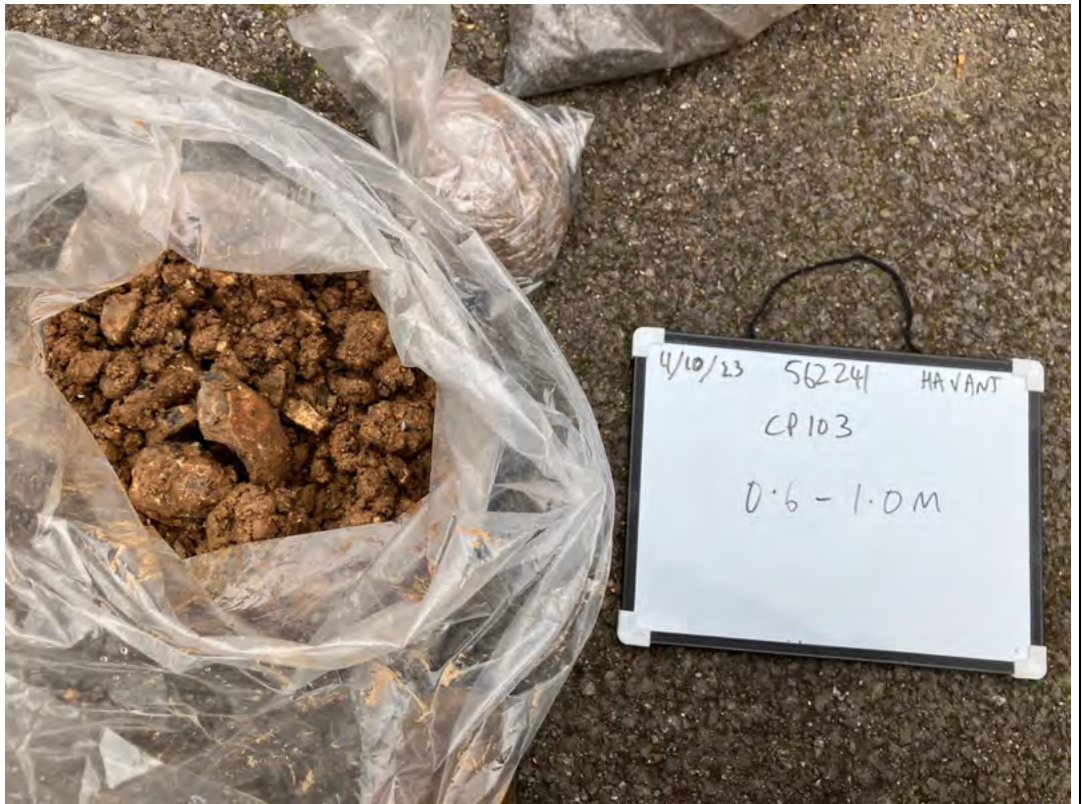
| Client: | | Site Location: | Project No.: |
|---|---|---|---|
| 15 | 09/10/2023 | | |

| Client: | | Site Location: | Project No.: |
|---|---|---|---|
| <b>Description</b><br>CP103 - inspection pit arisings | | | |

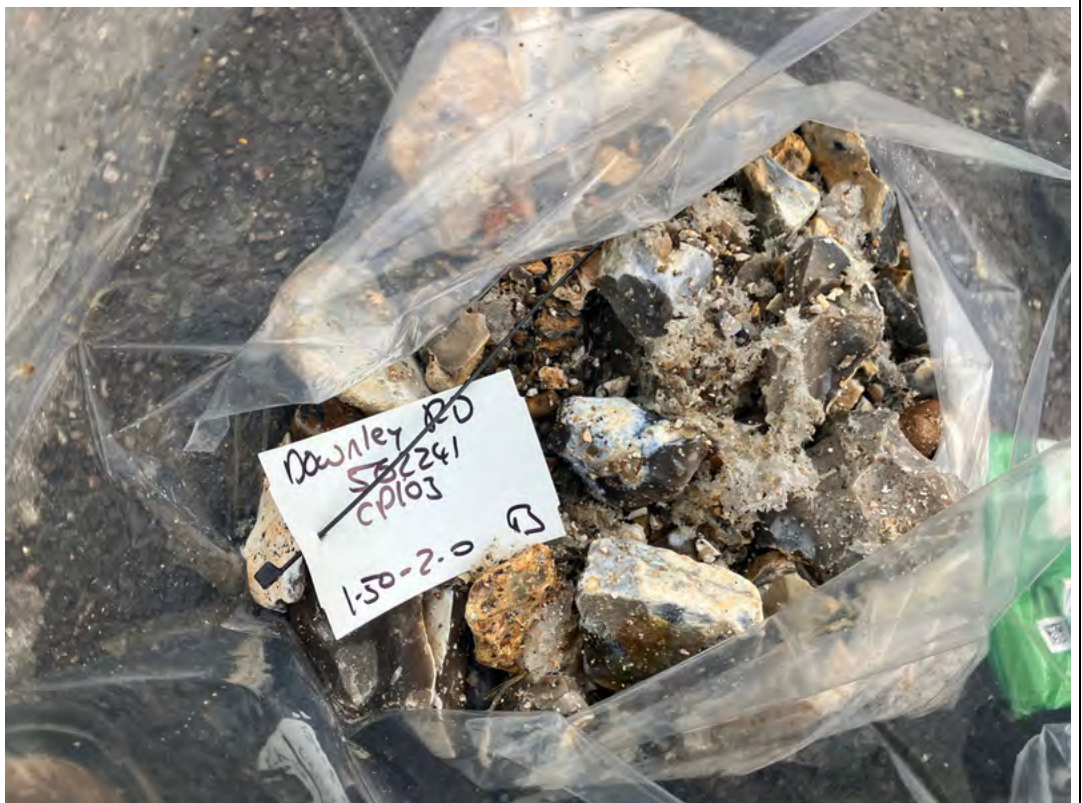
| Photo No. | Date | | |
|---|---|---|--|
| 16 | 09/10/2023 | | |

| Photo No. | Date | | |
|---|---|---|--|
| <b>Description</b><br>CP103 - recovery from 1.5m to 2.0m bgl | | | |

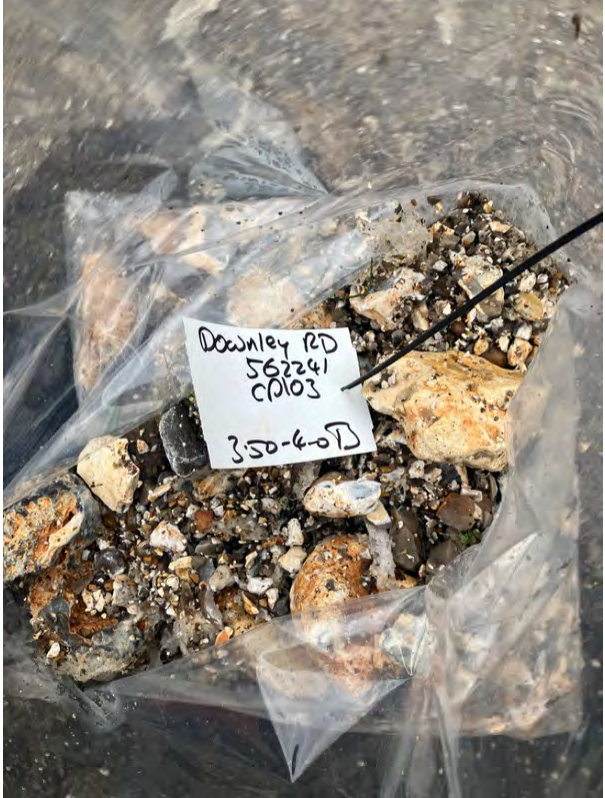
| Client: | | Site Location: | Project No.: |
|---|---|---|---|
| 17 | 09/10/2023 | | |

| Client: | | Site Location: | Project No.: |
|---|---|---|---|
| <b>Description</b><br>CP103 - recovery from 3.5m to 4.0m bgl | | | |

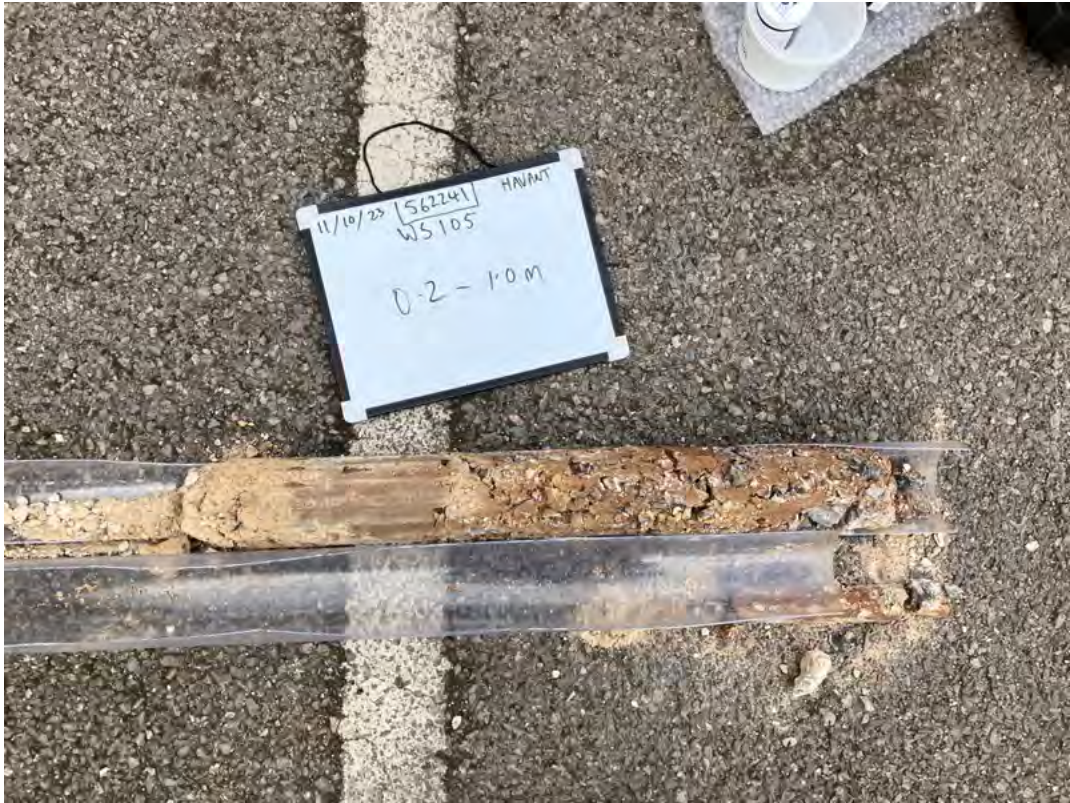
| Photo No. | Date | |
|---|---|---|
| 18 | 09/10/2023 | |

| Photo No. | Date | |
|---|---|---|
| <b>Description</b><br>WS105 - recovery from 0.2m to 1.0m bgl | | |

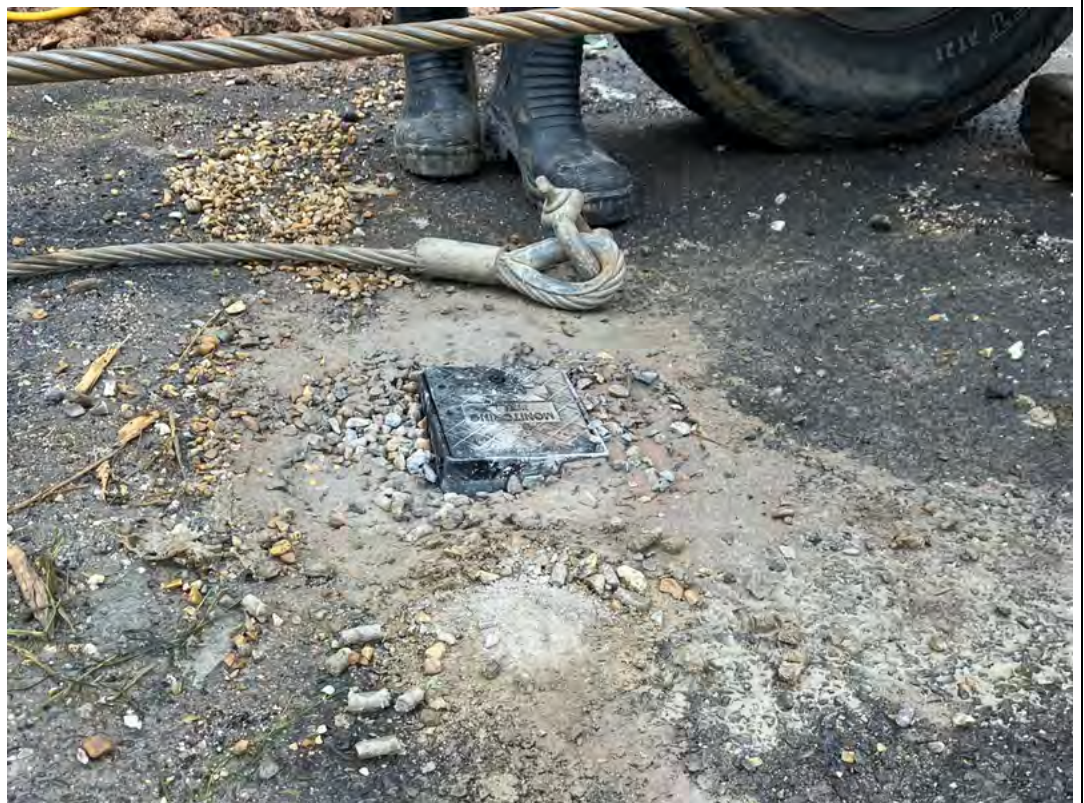
| Photo No. | Date | |
|---|---|---|
| 20 | 09/10/2023 | |

| Photo No. | Date | |
|---|---|---|
| <b>Description</b><br>CP103 - monitoring well install | | |

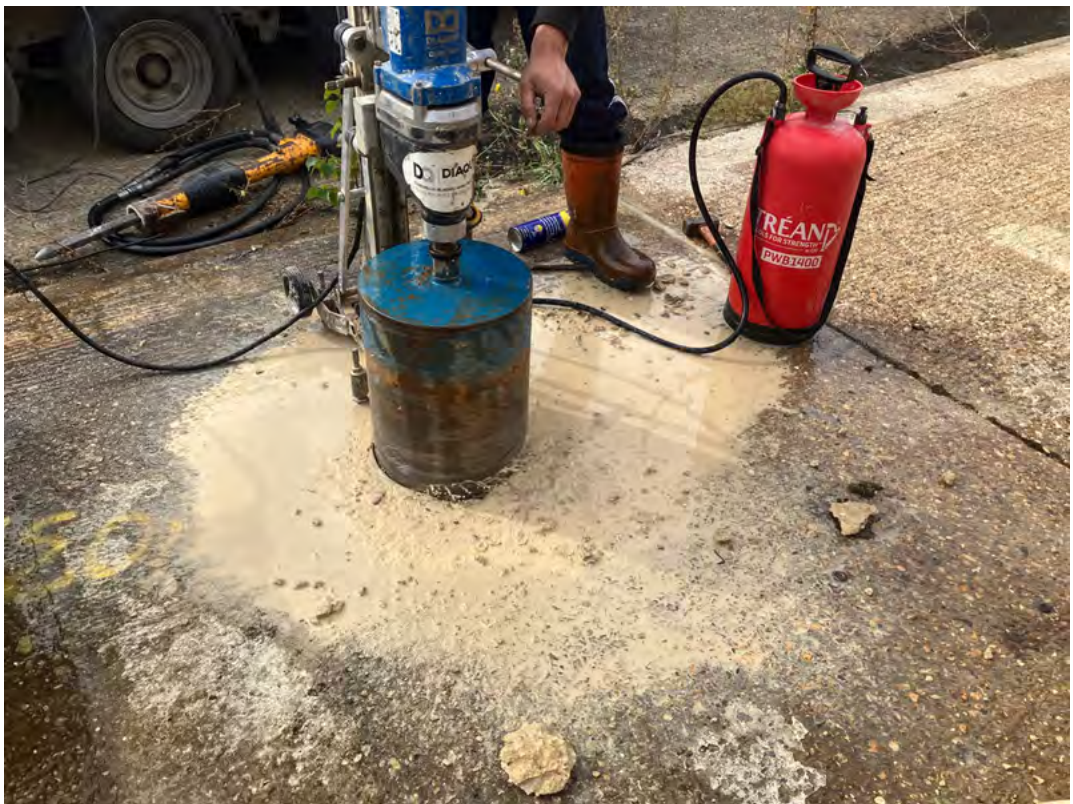
| <b>Description</b><br>Using a concrete corer at WS103A | | | |

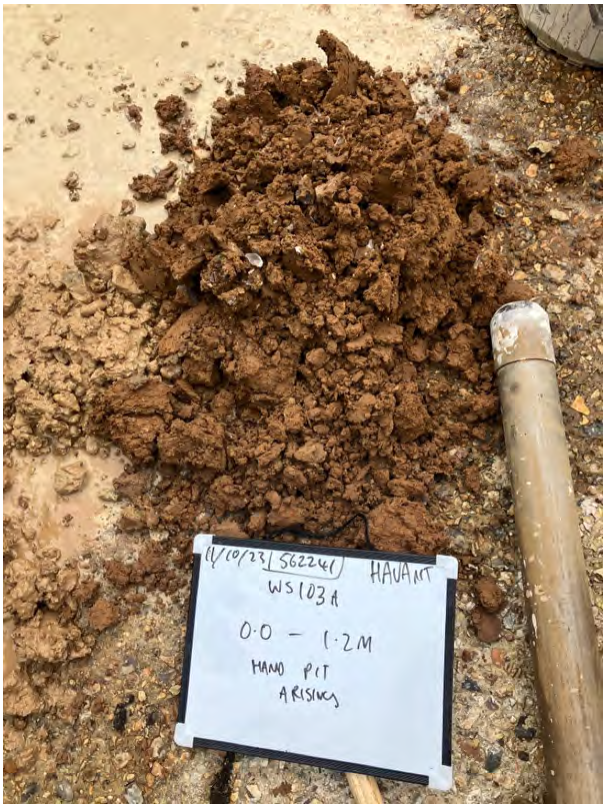
| Client: | | Site Location: | Project No.: |
|---|---|---|---|
| 22 | 09/10/2023 | | |

| Client: | | Site Location: | Project No.: |
|---|---|---|---|
| <b>Description</b><br>WS103A - recovery from 0.3m - 1.2m bgl | | | |

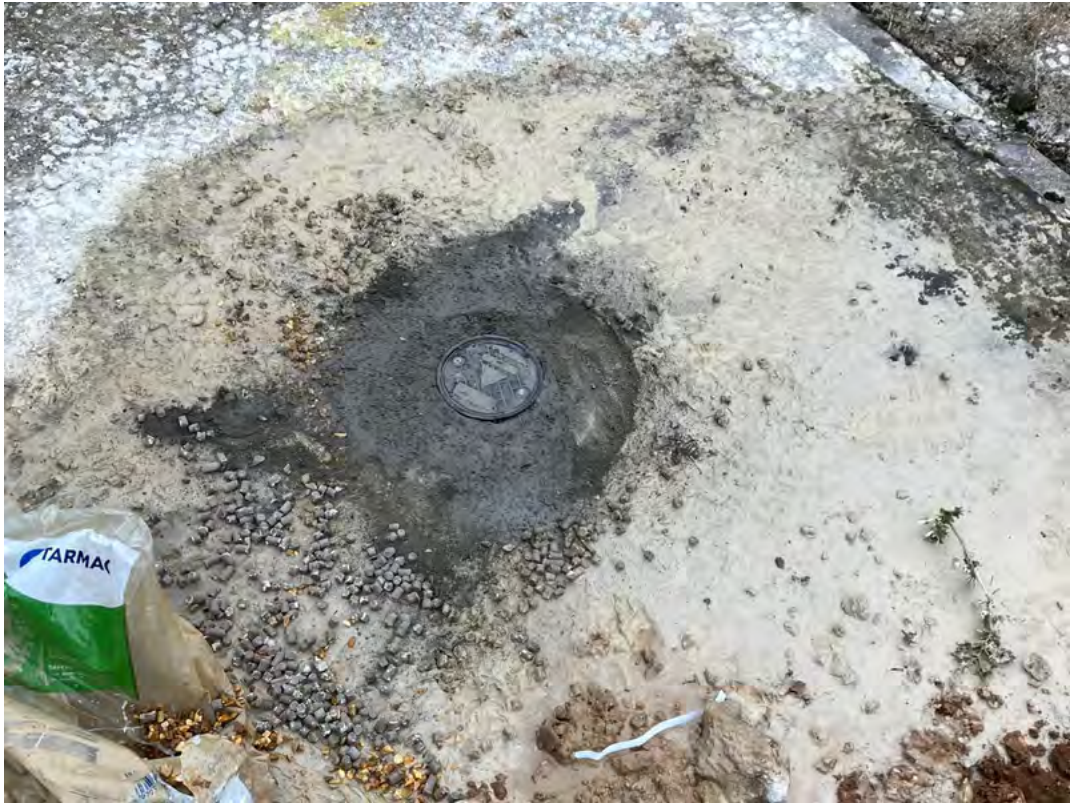
| Photo No. | Date | |
|---|---|---|
| 23 | 09/10/2023 | |

| Photo No. | Date | |
|---|---|---|
| <b>Description</b><br>WS103 - Monitoring well install | | |

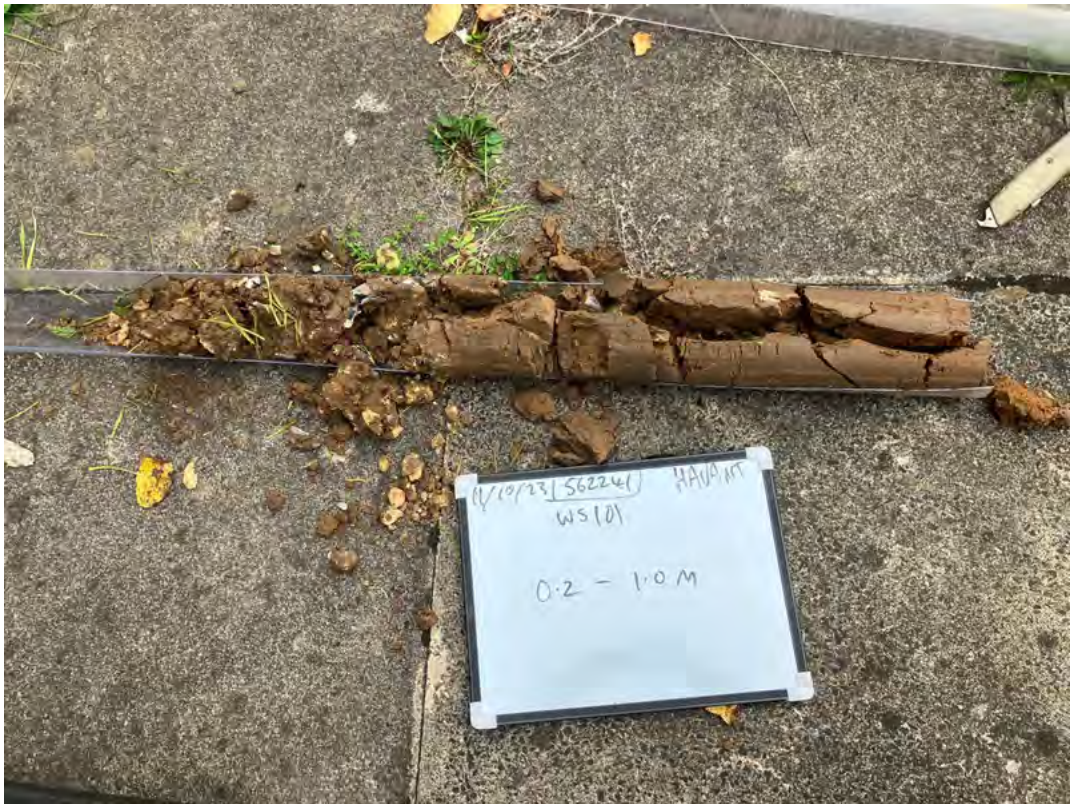
| Client: | | Site Location: | Project No.: |
|---|---|---|---|
| 24 | 09/10/2023 | | |

The shallow foundations should be taken below any cohesive (silty / clayey) sublayers of the River Terrace Deposits, which were recorded during the ground investigation mainly in the southern area of the Site (WS101

and WS103) at depths between 0.50m – 1.20m bgl. Where these cohesive sublayers are present, it is recommended that the provisions Chapter 4.2 of the NHBC Standards for a medium volume change potential soil are followed with regards to heave protection measures of the foundations.

| Client: | | Site Location: | Project No.: |
|---|---|---|---|
| <b>Description</b><br>WS101 - recovery from 0.2m to 1.2m bgl | | | |

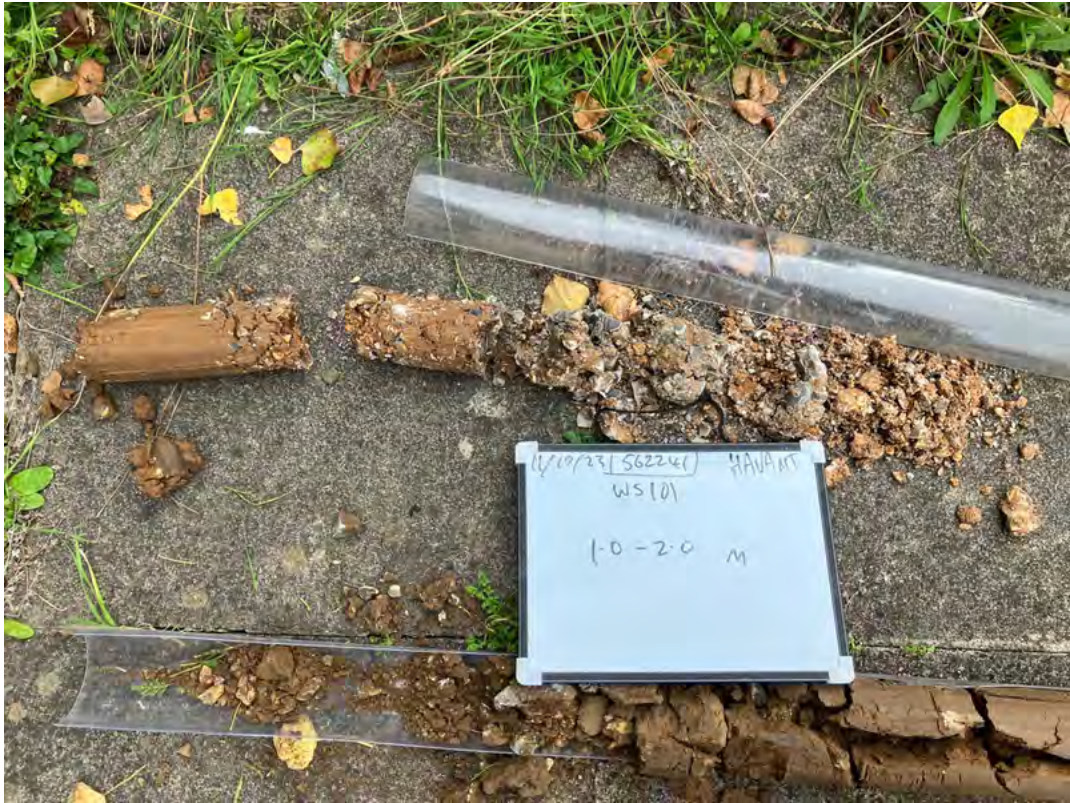
| Photo No. | Date | | |
|---|---|---|--|
| 25 | 09/10/2023 | | |

| Photo No. | Date | | |
|---|---|---|--|
| <b>Description</b><br>WS101 - recovery from 1.0m to 2.0m bgl | | | |

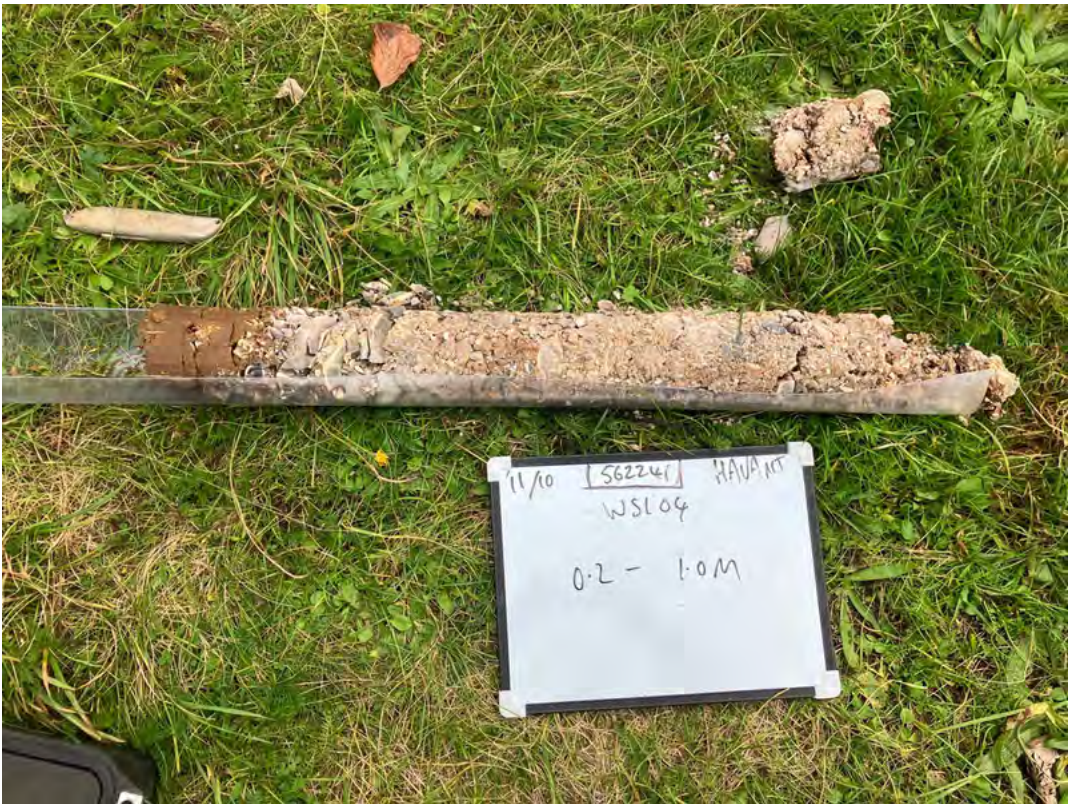
| Client: | | Site Location: | Project No.: |
|---|---|---|---|
| 26 | 09/10/2023 | | |

| Client: | | Site Location: | Project No.: |
|---|---|---|---|
| <b>Description</b><br>WS104 - recovery from 0.2m to 1.0m bgl | | | |

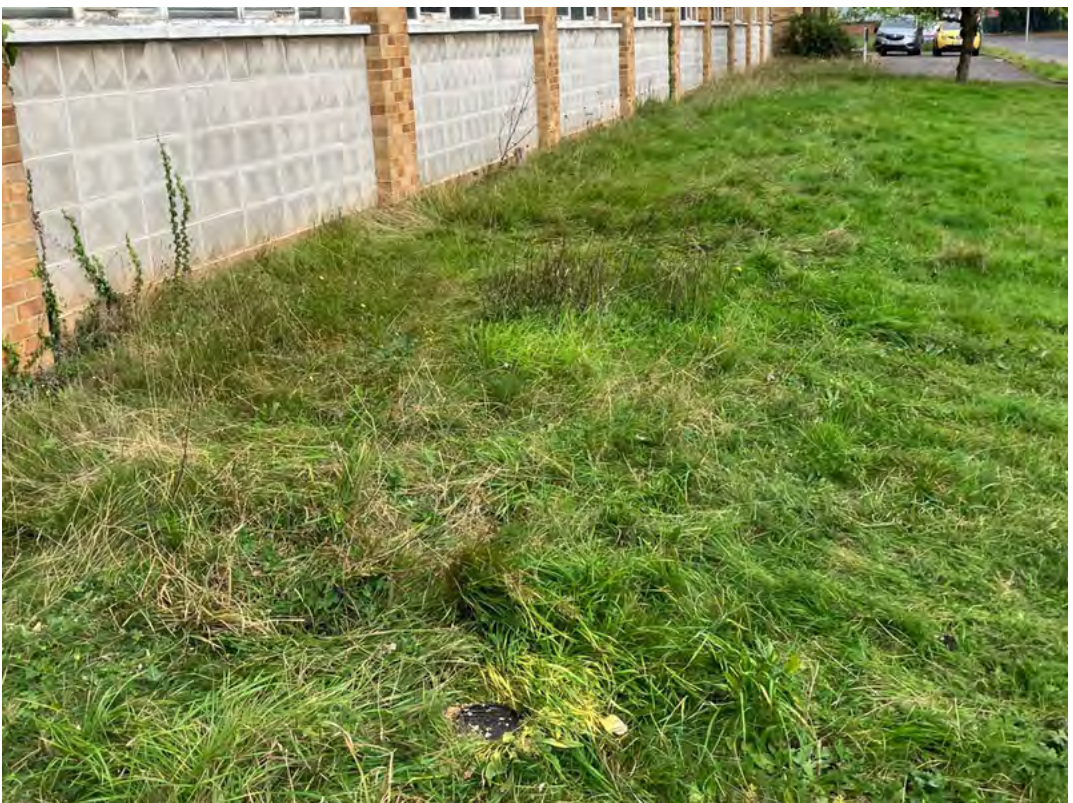
| Photo No. | Date | |
|---|---|---|
| 27 | 09/10/2023 | |

| Photo No. | Date | |
|---|---|---|
| <b>Description</b><br>WS104 - monitoring well install | | |

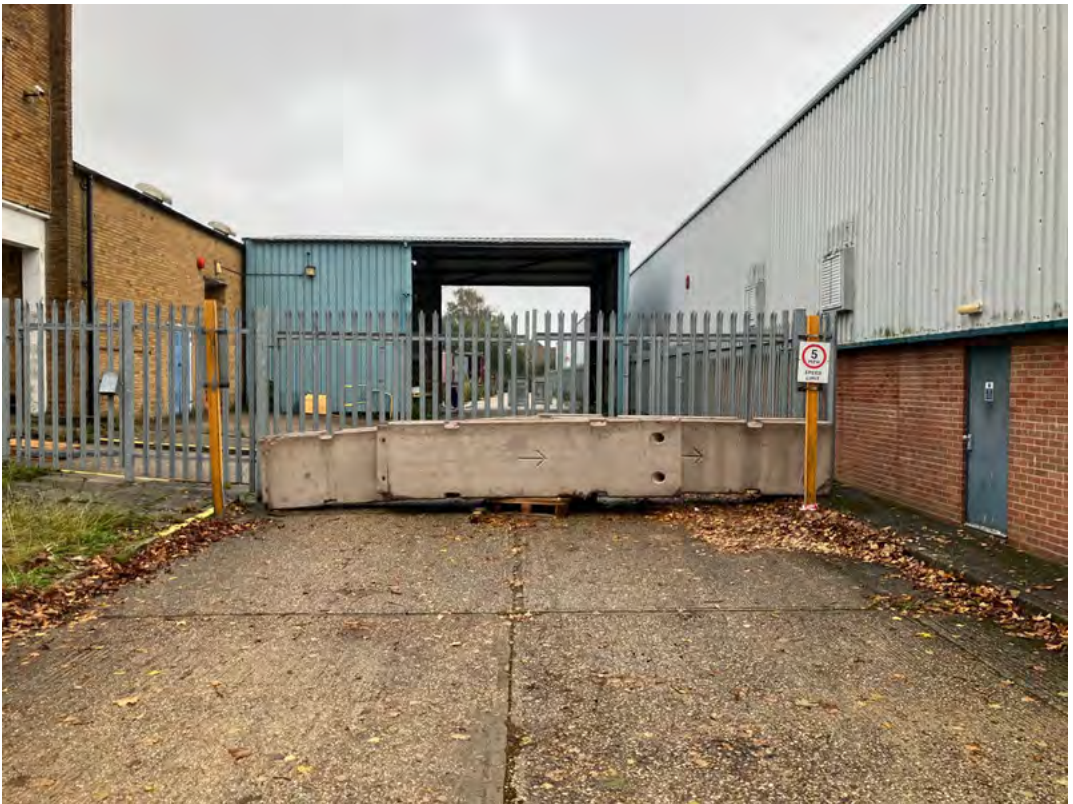
| Client: | | Site Location: | Project No.: |
|---|---|---|---|
| 28 | 09/10/2023 | | |

| Client: | | Site Location: | Project No.: |
|---|---|---|---|
| <b>Description</b><br>Concrete barrier put back into place by lorry | | | |
